**CITY OF FREDERICKSBURG
HISTORIC REVIEW BOARD**

Tuesday, July 14, 2015

**Historic Review Board
Application Information**

Application for Certificate of Appropriateness

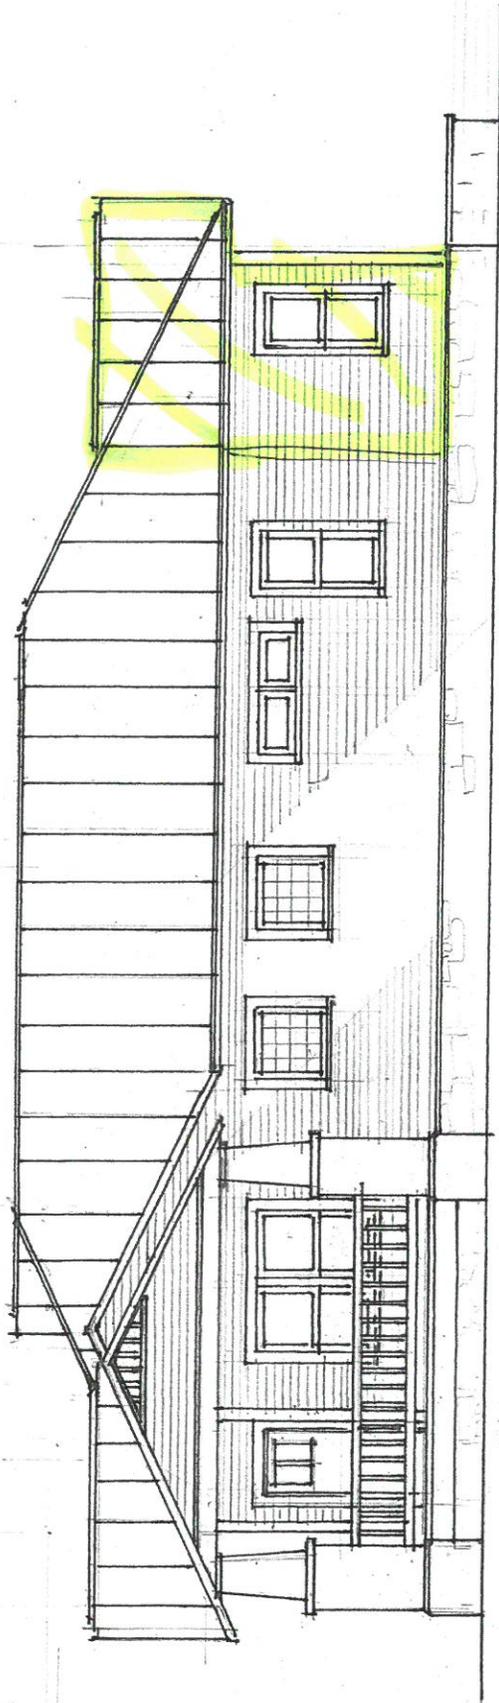
SOUTHWEST ELEVATION

Description of External Alteration/Repair or Demolition: ADDING FIFTEEN FEET TO BACK OF HOME TO ACCOMMODATE NEW BEDROOM AND LIVING SPACE. MATCH EXISTING WOOD SIDING AND COLORS.

Description of how the proposed change will be in character with the architectural or historic aspect of the structure or site: ADDITION WILL MATCH EXISTING STRUCTURE IN DESIGN AND APPEARANCE.

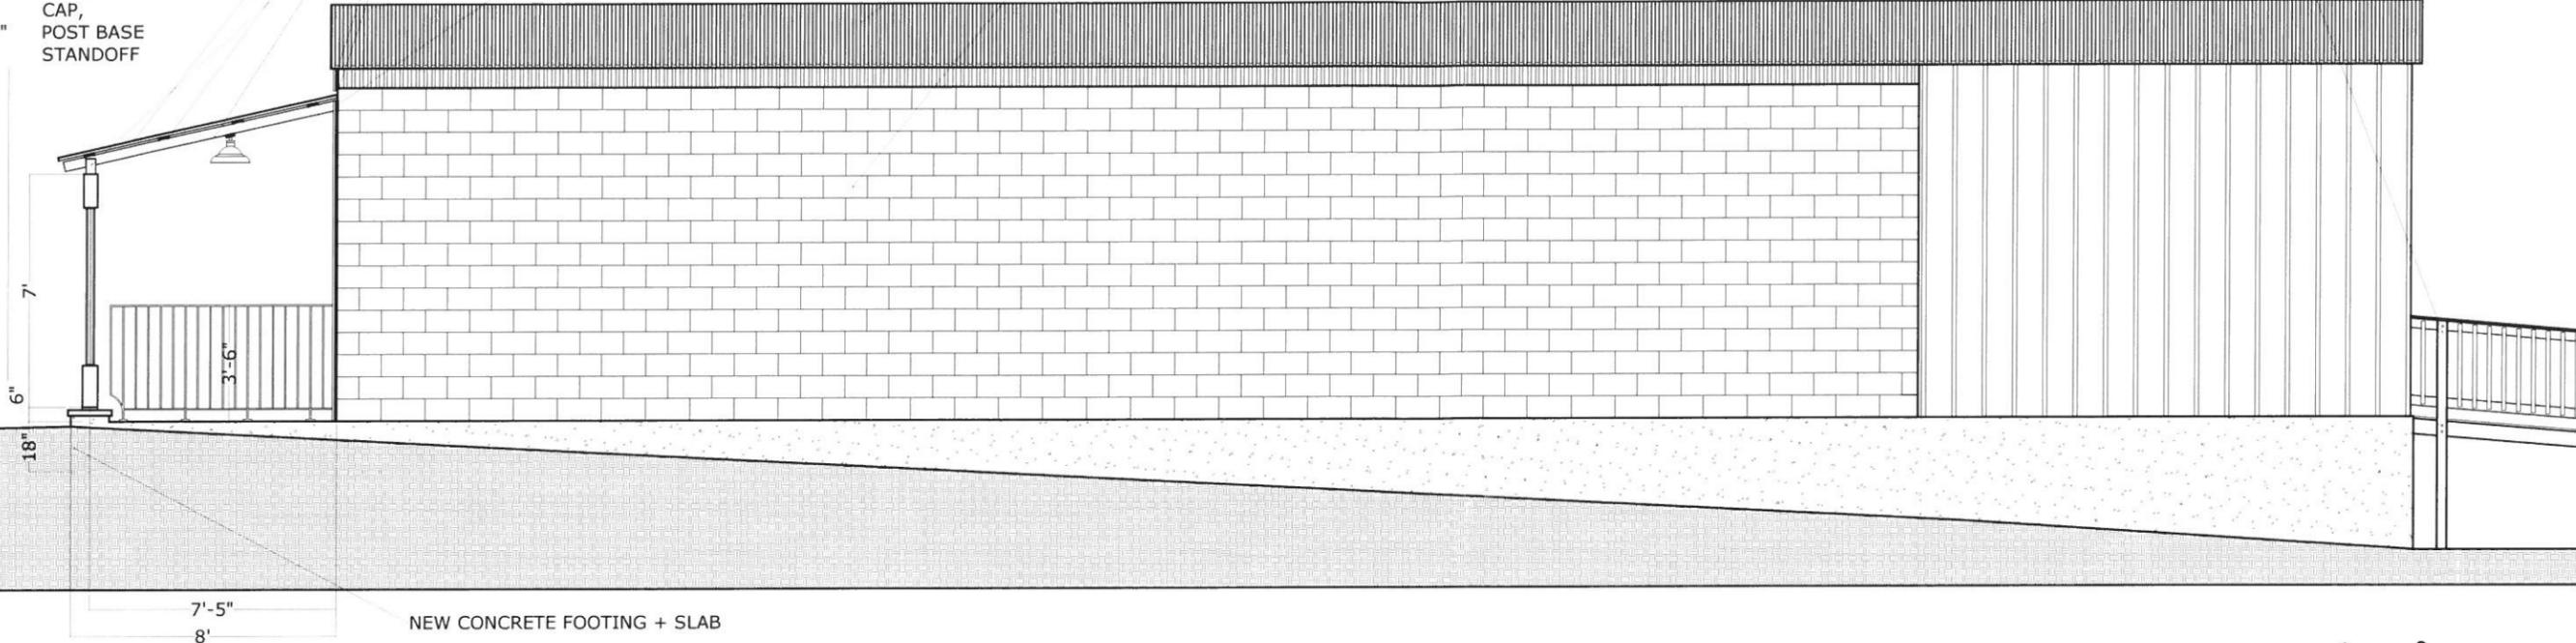
1 "The Coop" West Alley Elevation
3/16" = 1'-0"

NEW CORRUGATED METAL ROOF
1 X 4 PURLIN STRAPING
4 X 4 JOIST
4 X 6 BEAM
NEW BOARD + BATTON SHEATHING WITH MOISTURE BARRIER
NEW FLASHING

EXISTING CORRUGATED METAL ROOF
EXISTING CMU EXTERIOR ENVELOPE

RAMP TO BACK PATIO

SIMPSON STRONG TIE HUC44XSLD13
4 X 4 JOIST TO CMU HANGER

3" COLUMN
FOOTING UPLIFT,
THICK LIMESTONE
CAP,
POST BASE
STANDOFF

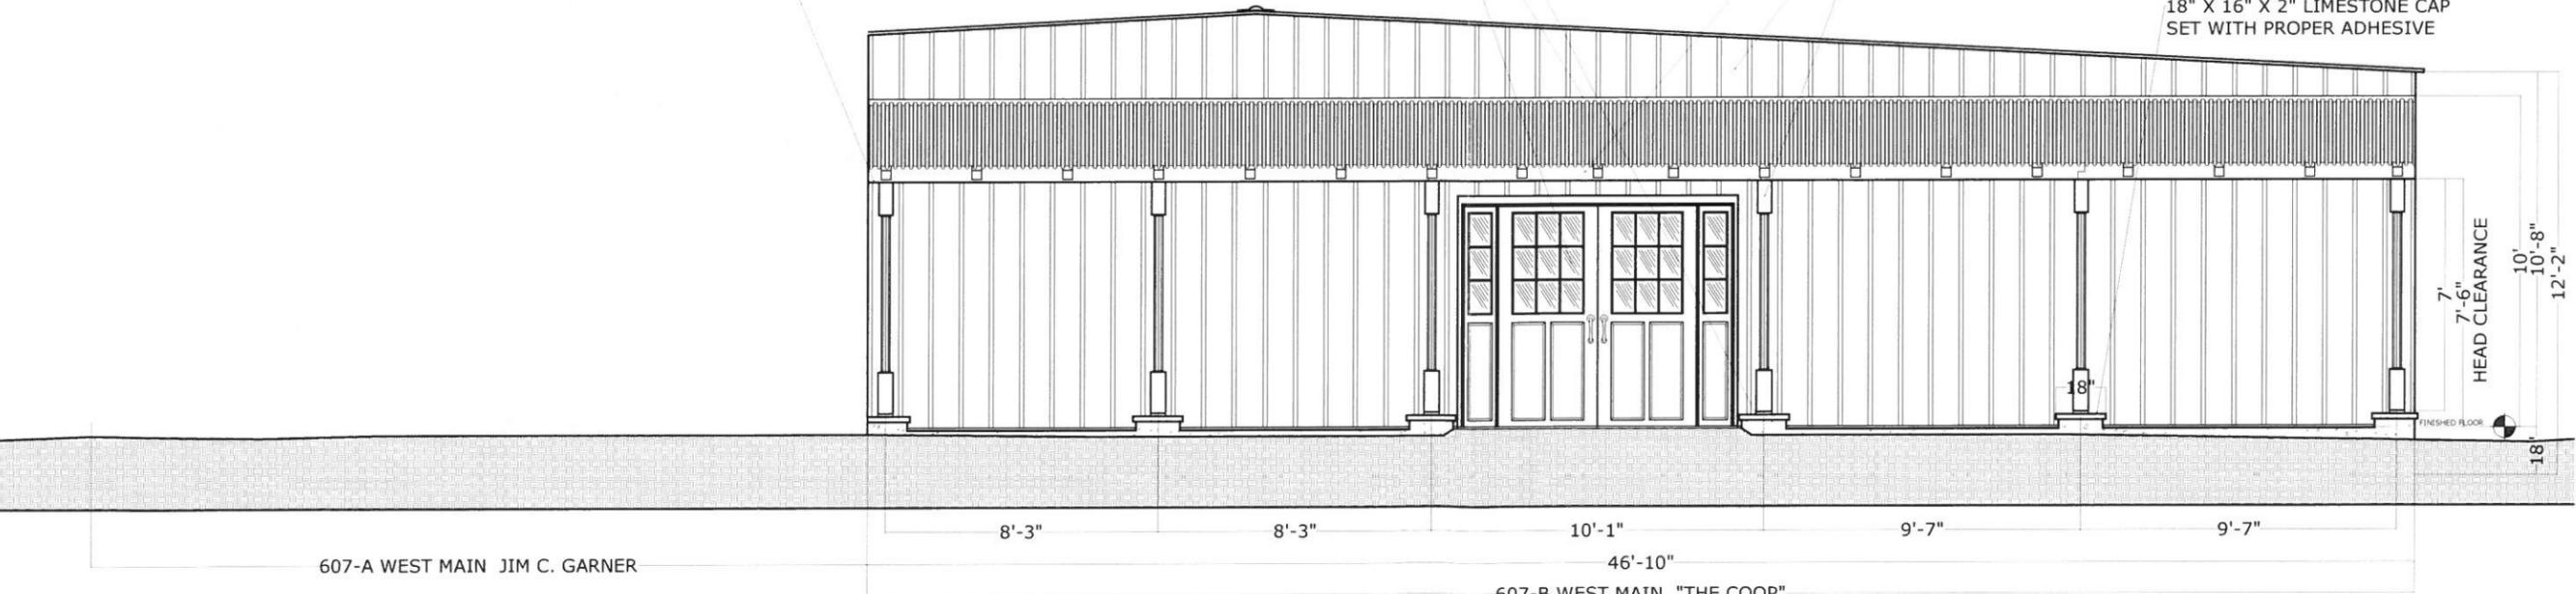
2 "The Coop" Street Frontage Elevation
3/16" = 1'-0"

SIMPSON STRONG TIE CONCEALED POST BASE WITH 1" STANDOFF
NEW FLASHING + CORRUGATED METAL ROOF
ARCHITECTURAL SALVAGE DOORS AND SIDELIGHTS
4 X 4 JOIST
NEW BOARD + BATTON SHEATHING WITH MOISTURE BARRIER
ARCHITECTURAL SALVAGE COLUMNS
18" X 16" X 2" LIMESTONE CAP
SET WITH PROPER ADHESIVE

ALLOW FOR PASSAGE OF DOWNSPOUT FROM 607-A CORNER GUTTERS

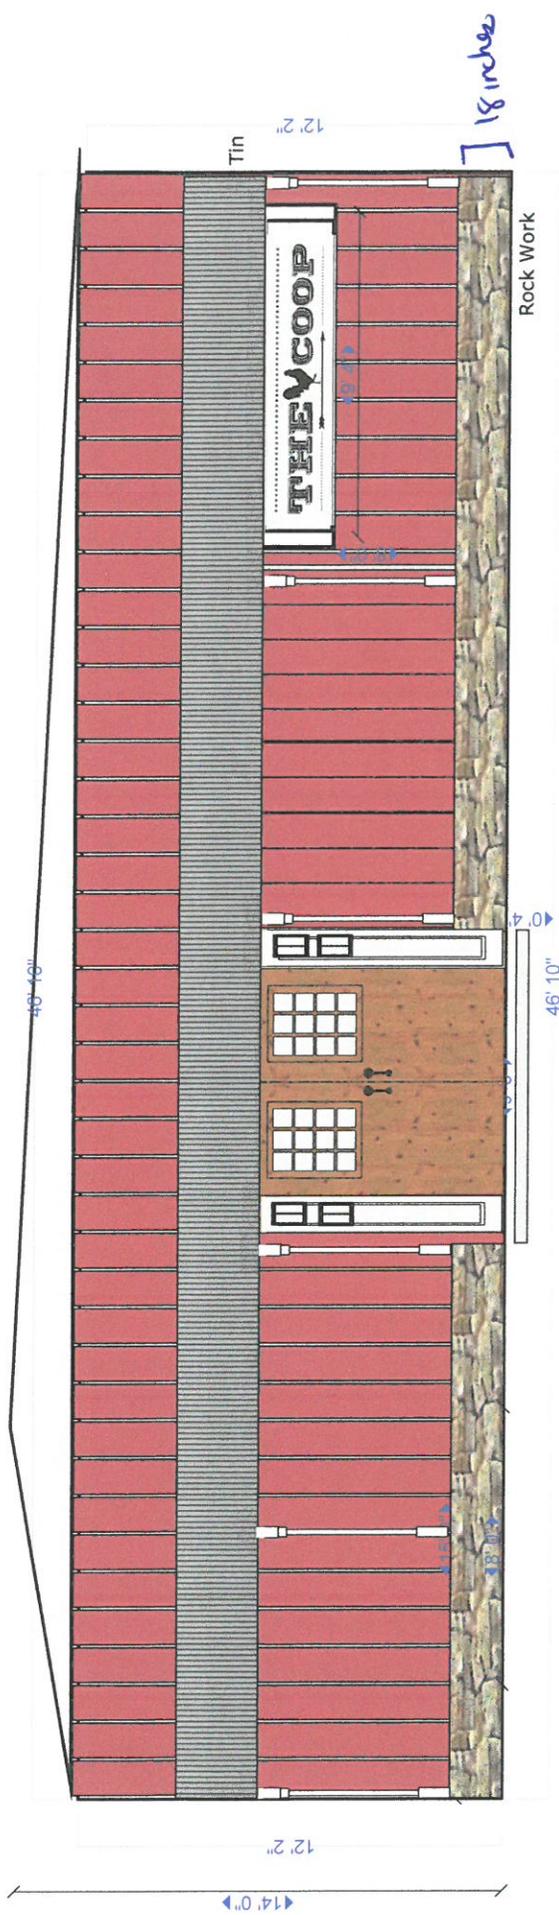
ELEVATION

Hardboard and baton
with batons every 12 inches.

Hardboard: Benjamin Moore Chili Pepper
Columns and Small Panel near Doors: Valspar Dairy Bell
Stain on Doors: Dark Mahogany

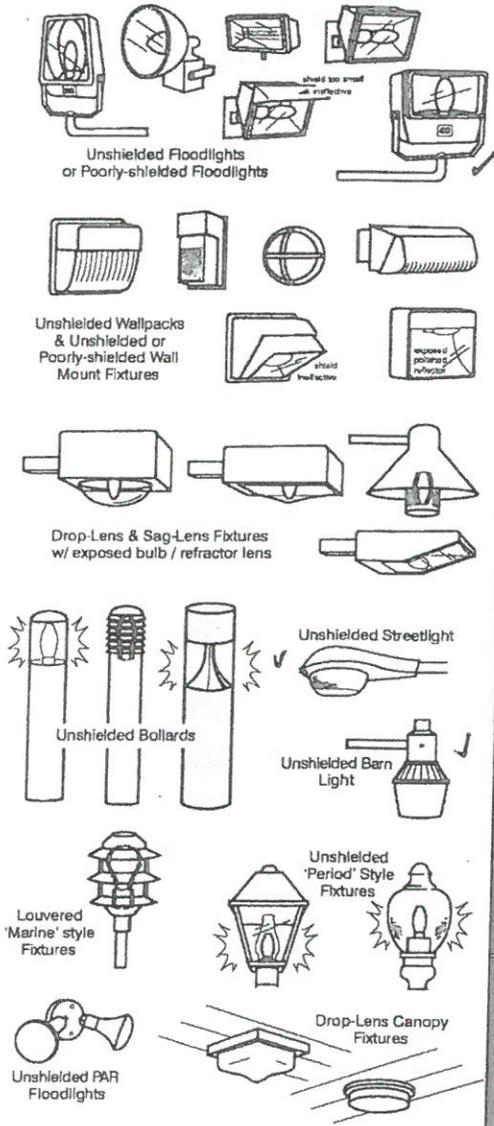
FIGURE C

Unacceptable / Discouraged

Fixtures that produce glare and light trespass

The lights on the left are non-conforming due to inadequate shielding. Those on the right can be used in most cases; however, the mounting height and proximity to the property line may require additional shielding to prevent the luminous elements from being visible from any other property.

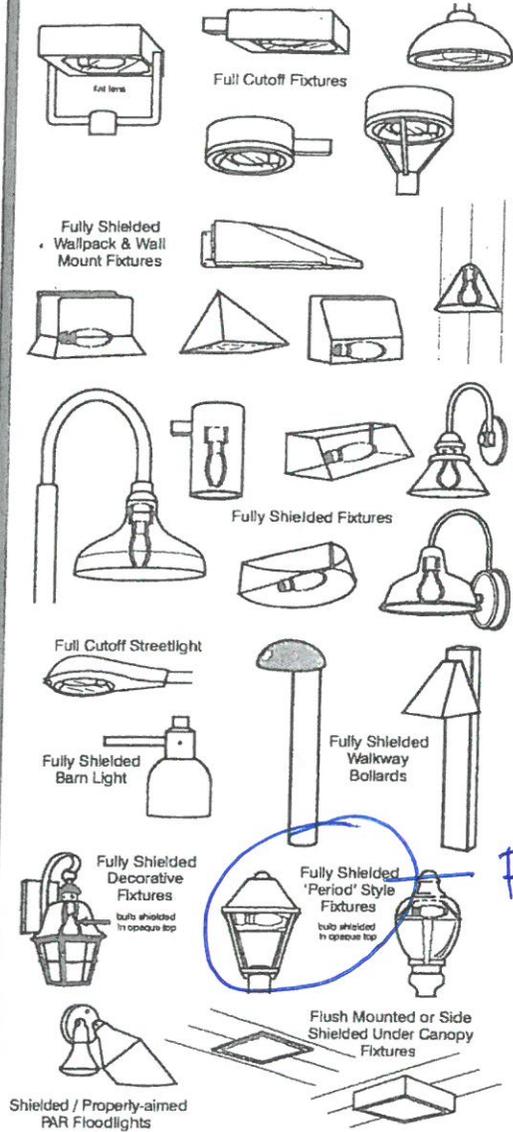
FIGURE D

Acceptable

Fixtures that shield the light source to minimize glare and light trespass and to facilitate better vision at night

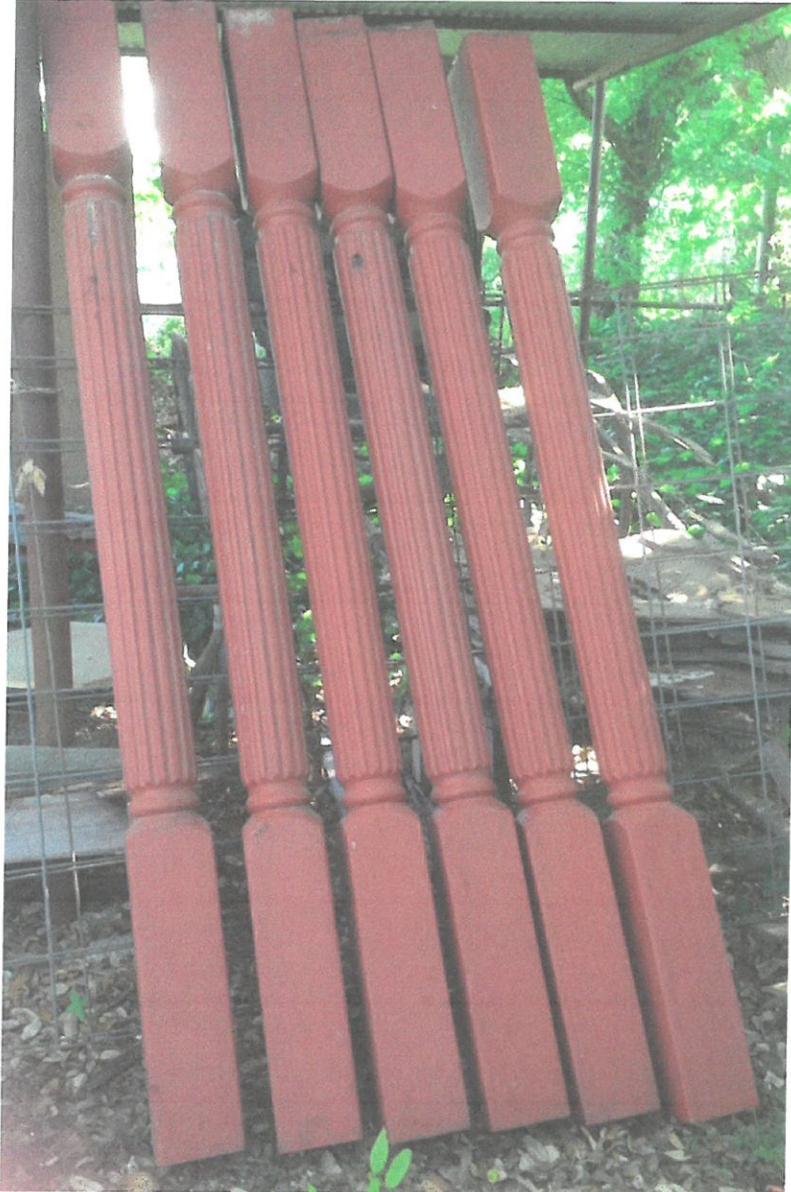
Columns for Front Patio
Measurements: 7 x 5 ¾

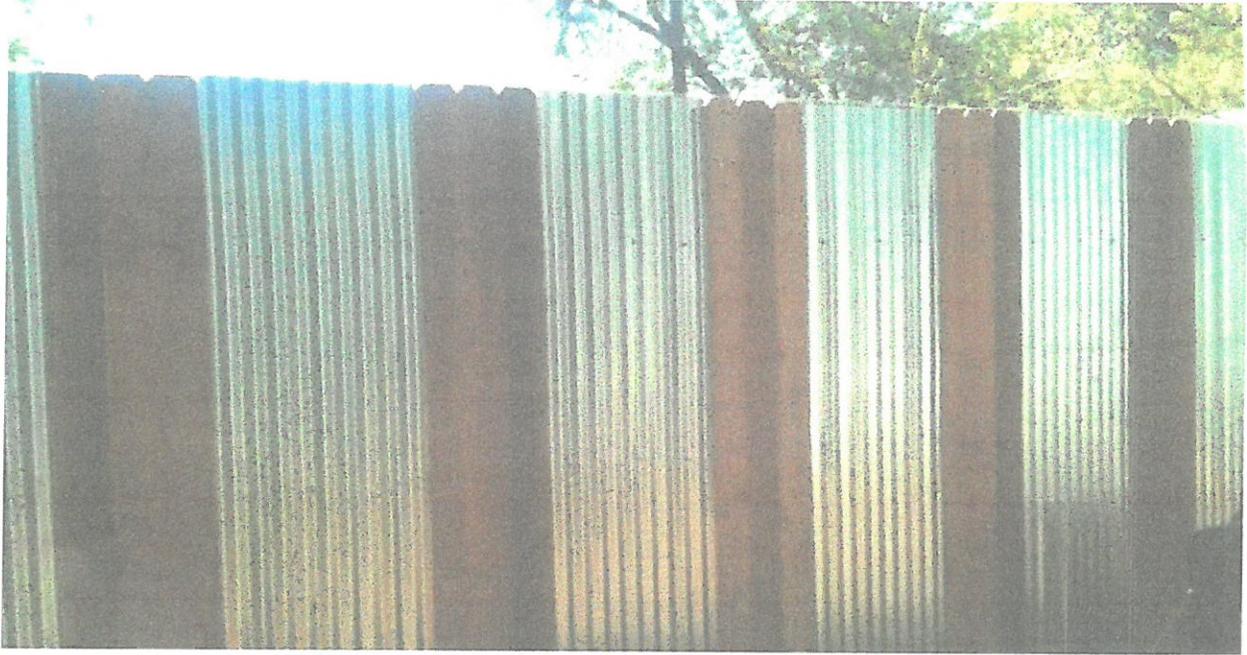
Tin and Wood Fence

Materials: Old Tin and Cedar Pickets
