**CITY OF FREDERICKSBURG
HISTORIC REVIEW BOARD
TUESDAY, DECEMBER 13, 2011
CITY HALL
CONFERENCE ROOM
126 W. MAIN ST.
5:30 P.M.**

3. Application #11-81 by Mammal Design on behalf of Capraia Partners, Ltd. at 230 E. Main to: *Pp 4 -24*
 - 1) Remove many of the existing multi-glazed windows and replace with traditional transom and showroom windows

230 EAST MAIN STREET
FREDERICKSBURG, TEXAS

*Documentation to supplement the
Application for Certificate of Appropriateness,
presented to the Historic Review Board for the
December 13, 2011 meeting.*

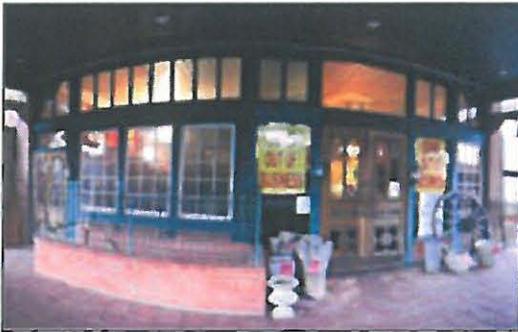
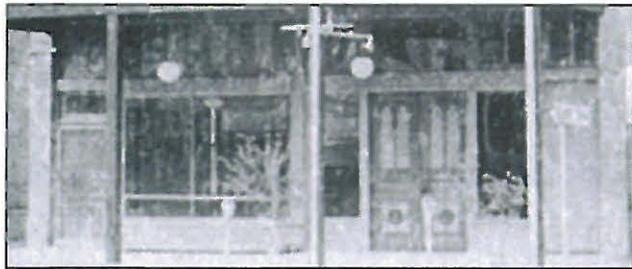
Above Left: Current configuration of windows and doors. Detailed front elevation included in drawing set. Above Right:

The current state of the storefront is the result of many changes that were made at different points in the history of this building. The result is a storefront which is lacking the consistency in design both historically and today. The goal is to remove many of the existing multi glazed windows, and replace them with traditional transom and showroom windows. Please reference the attached elevations and renderings for the details on the new configuration of windows and doors.

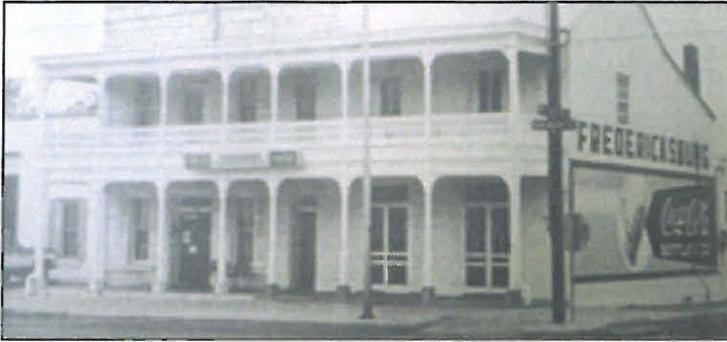
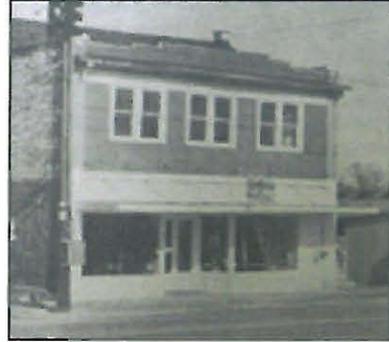
Examples of full glazed showroom windows and transom windows.

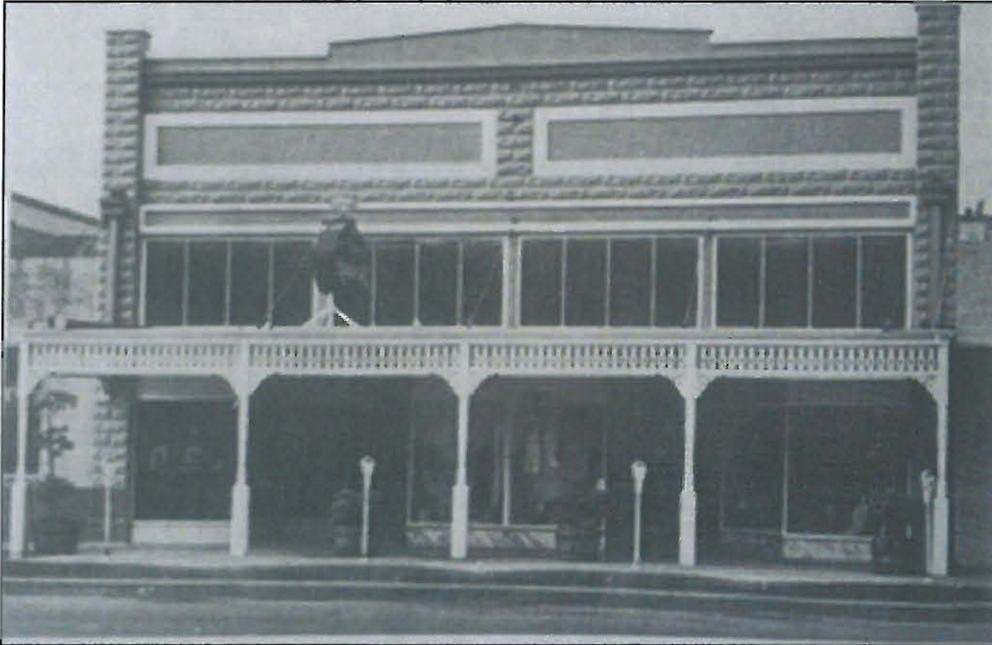
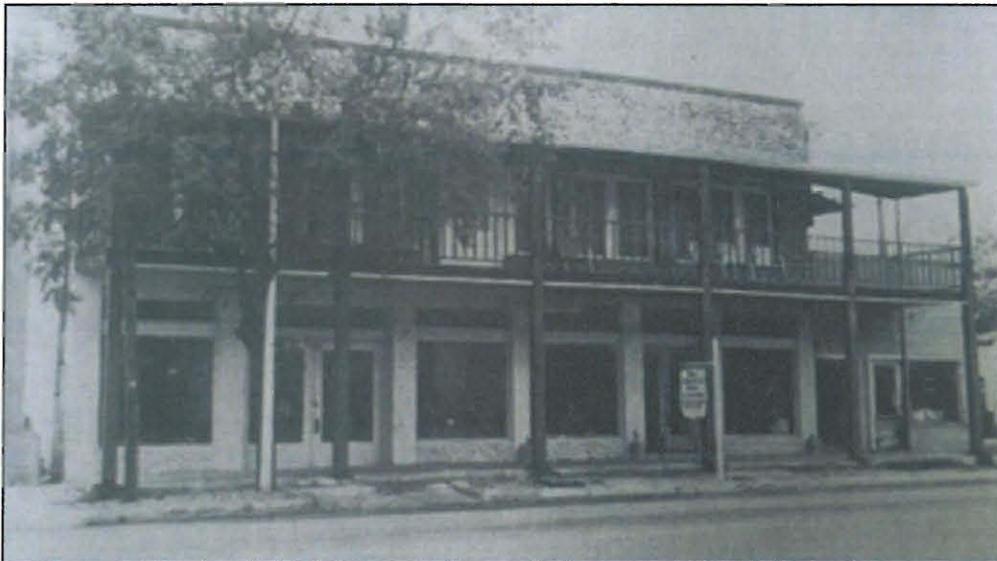
Examples of full glazed showroom windows and transom windows.

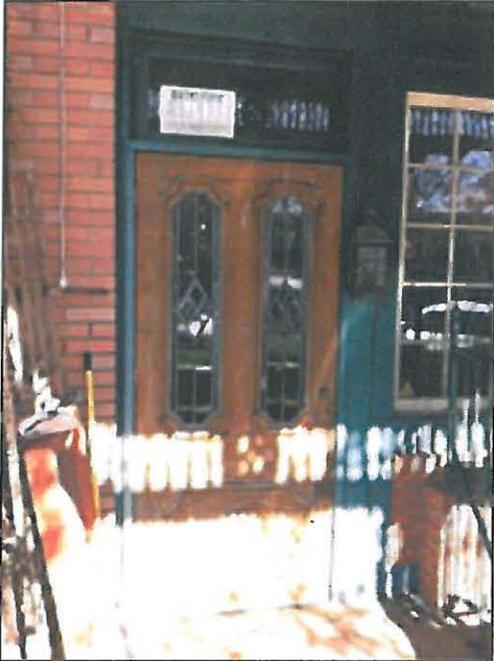
2. REPLACE SINGLE DOOR:

The single door located on the left side of the elevation including the single transom window will be removed. In its place, we will install a full glazed door with a painted wood frame to mimic the repetition of the three storefront windows we are proposing to the right.

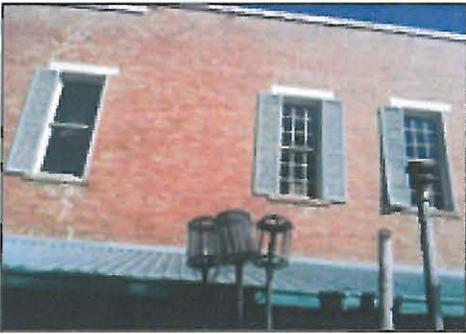
Existing Shutters

The condition of the existing shutters is quite defective. Shutters on the east, west, and front sides of the structure will be removed.

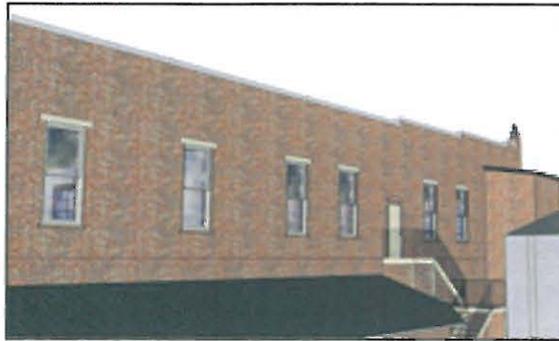
Proposed Removal of Shutters

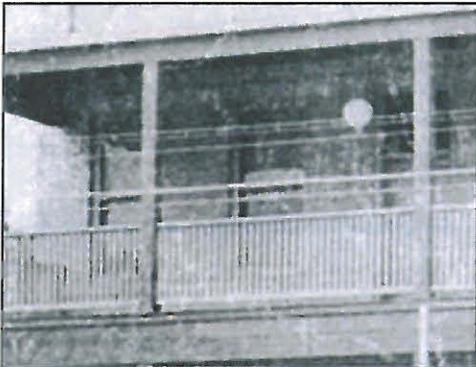
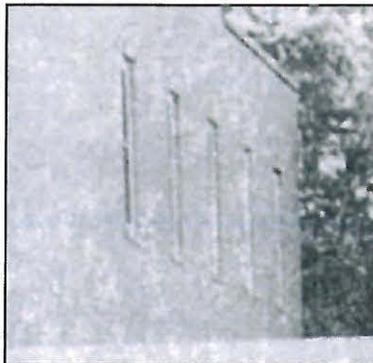
Shutters not present in historic photograph dated 1973

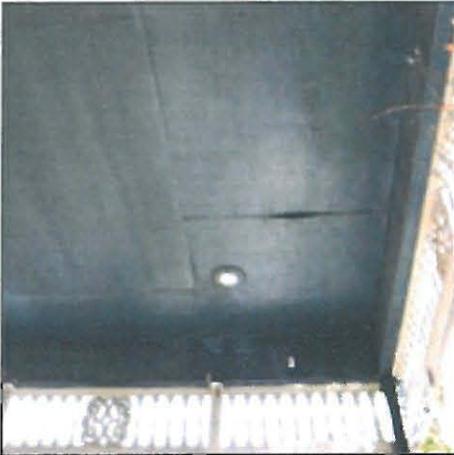
Existing material at patio ceiling.

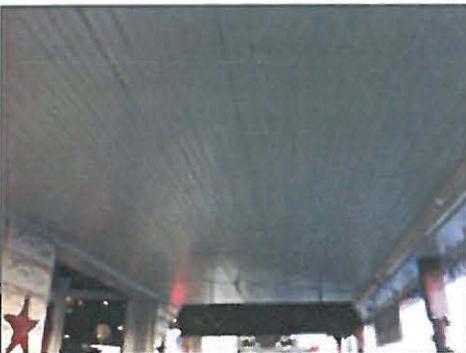
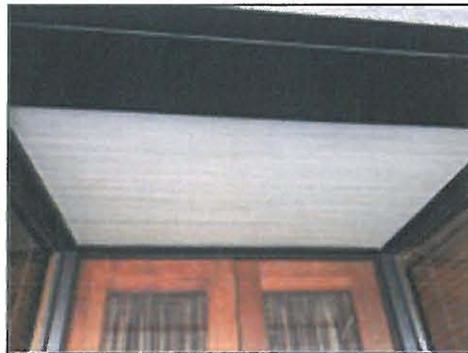
Examples of beaded board currently installed along Main St.

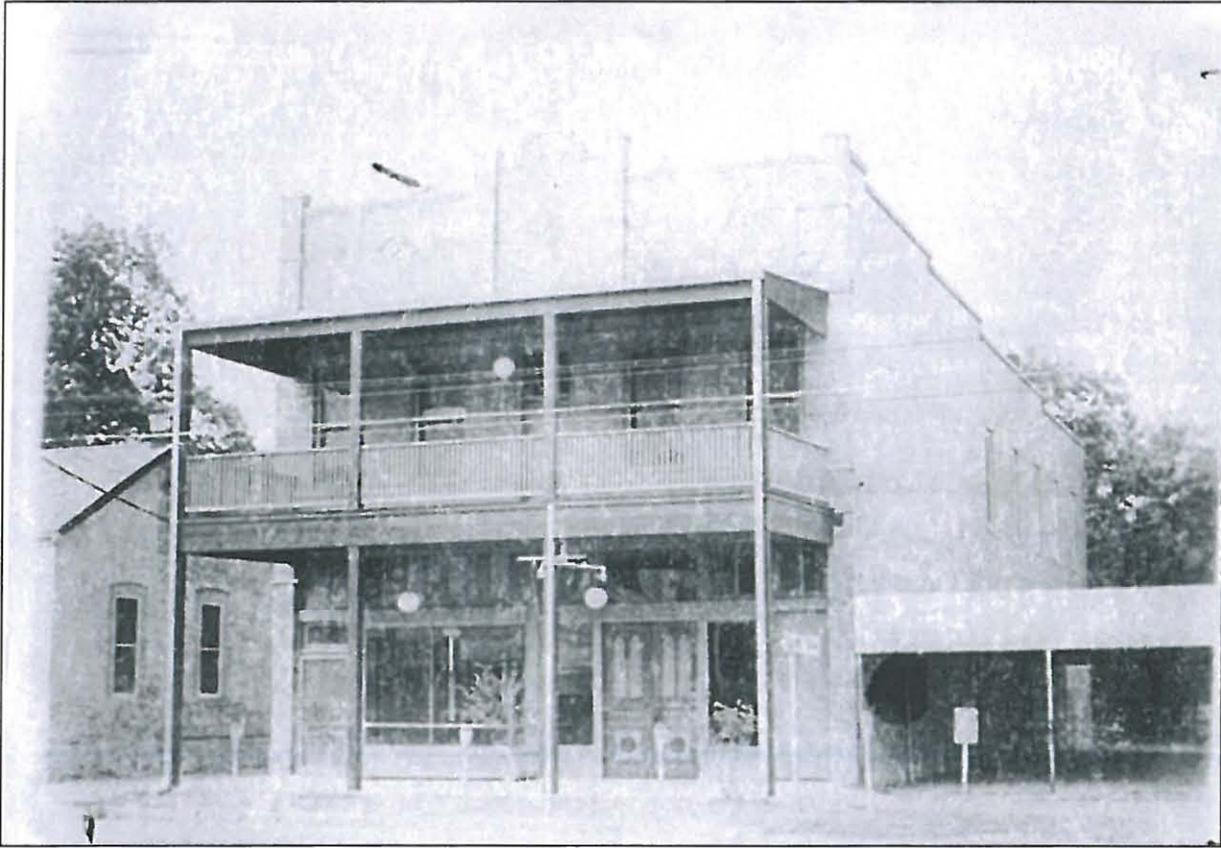
Photograph courtesy of Bill Waring, c. 1973

Photographs: We have been able to find one good photograph of the front of the building from 1973, taken by Bill Waring whom had recently purchased the building. This photograph was taken after Bill's addition of the front patio. See the last page of this presentation for a full-size copy.

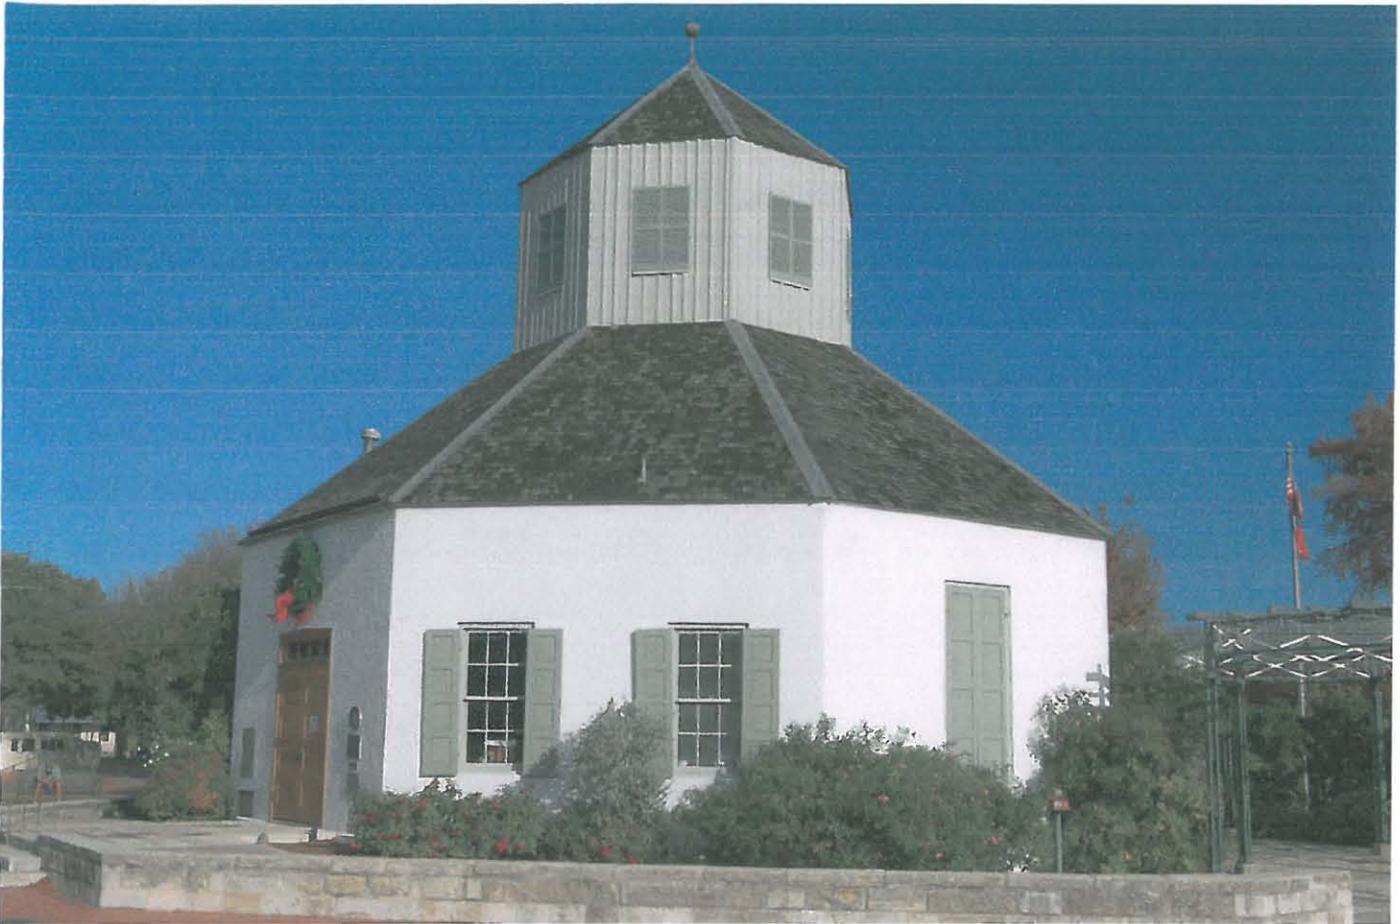
Replace deteriorating 1996 red cedar shingle roof with “Endurashake”. This product is installed on St. Mary’s Church, Dambach/Besier House, and various structures at Herb Farm and Herb Farm Restaurant.

Install new flashing, metal ridge caps and stainless steel nails.
