**CITY OF FREDERICKSBURG
HISTORIC REVIEW BOARD
Tuesday, December 10, 2013
City Hall
Conference Room
126 W. Main St.
5:30 P.M.**

3. Application #13-93 by John Akin on behalf of Henry & Charlsie Haynes at 406 Sycamore to construct a bathroom and closet addition over the existing kitchen and replace rotted porch decking with composite decking *Pp 3 - 12*
4. Application #13-97 by Shayna Thompson on behalf of Capraia Partners at 415 & 417 E. Main Street to repair and paint existing historic structures and construct eight new bed and breakfast units *Pp 13 - 28*

**Historic Review Board
Application Information**

Application Number: 13-97
Date: December 6, 2013
Address: 415/417 E. Main
Owner: Capraia Partners
Applicant: Shayna Thompson
Rating: High
Proposed Modifications: See attached.
Neighborhood Characteristics: The subject property is in the Historic District.
Staff Comments: The scope of the project justifies Board review.

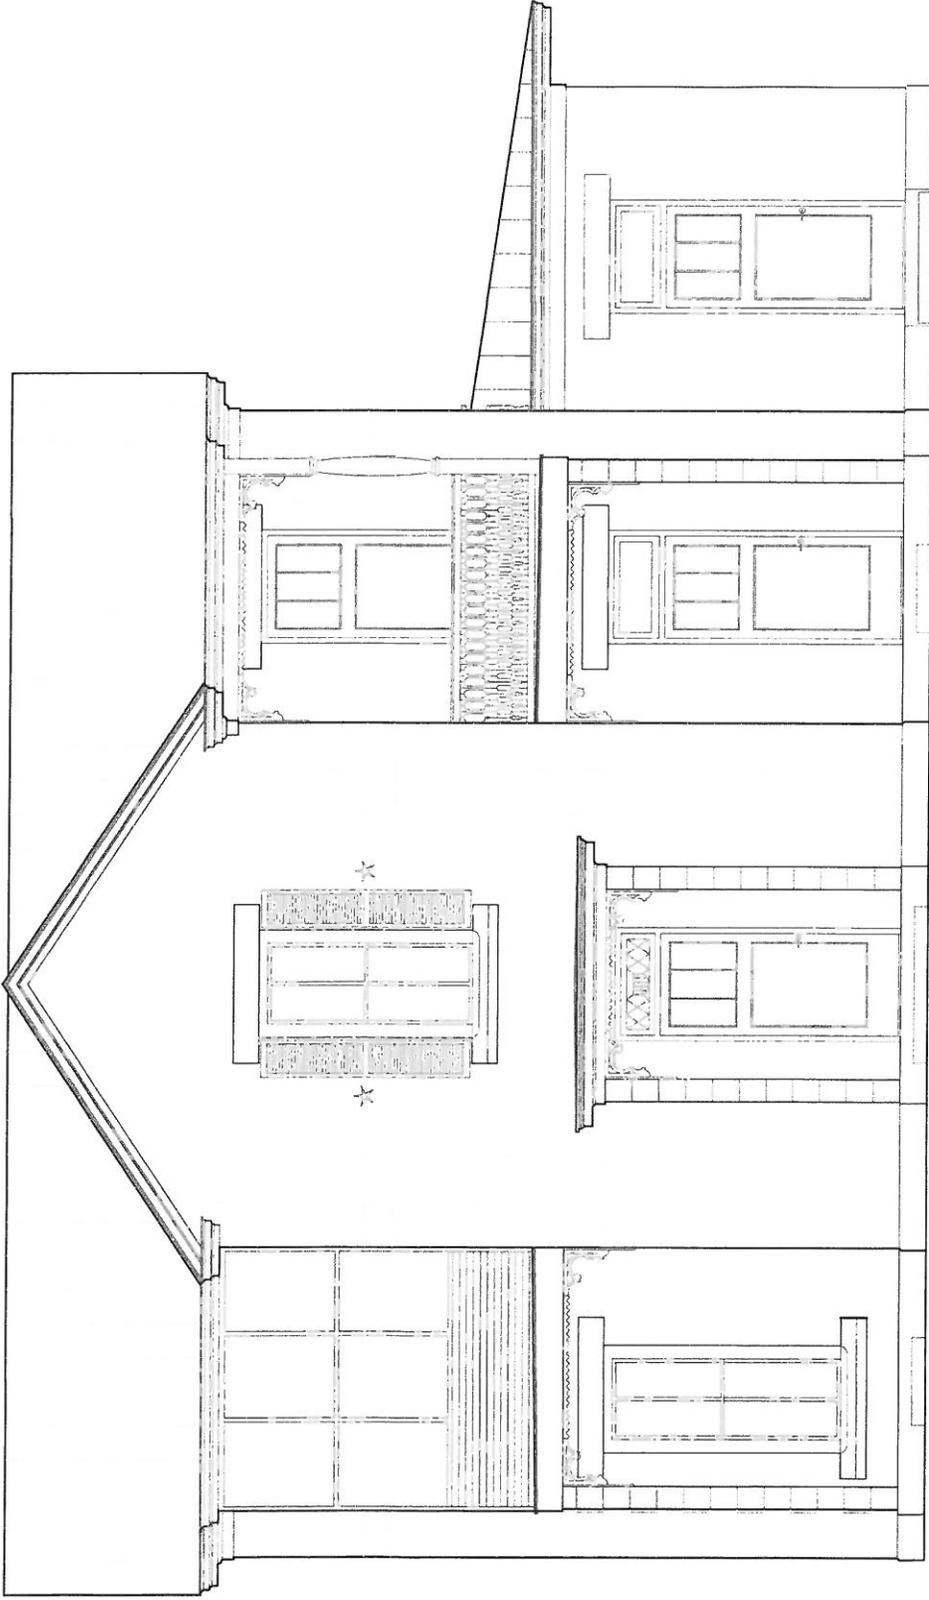
SOUTH ENTRY ELEVATION (FRONT - FACING SYCAMORE ST.)

Description of External Alteration/Repair or Demolition: ADDITION OF A BATHROOM AND CLOSET OVER THE EXISTING KITCHEN. REPLACE ROTTED PORCH DECKING WITH COMPOSITE DECKING.

Description of how the proposed change will be in character with the architectural or historic aspect of the structure or site: EXISTING ORIGINAL WINDOWS WILL BE RE-USED ON STREET VIEWS AS WELL AS HORIZONTAL SIPING OR PLASTER TO COMPLEMENT THE BASSE BLOCK STRUCTURE. STANDING SEAM GALVALUME ROOF.

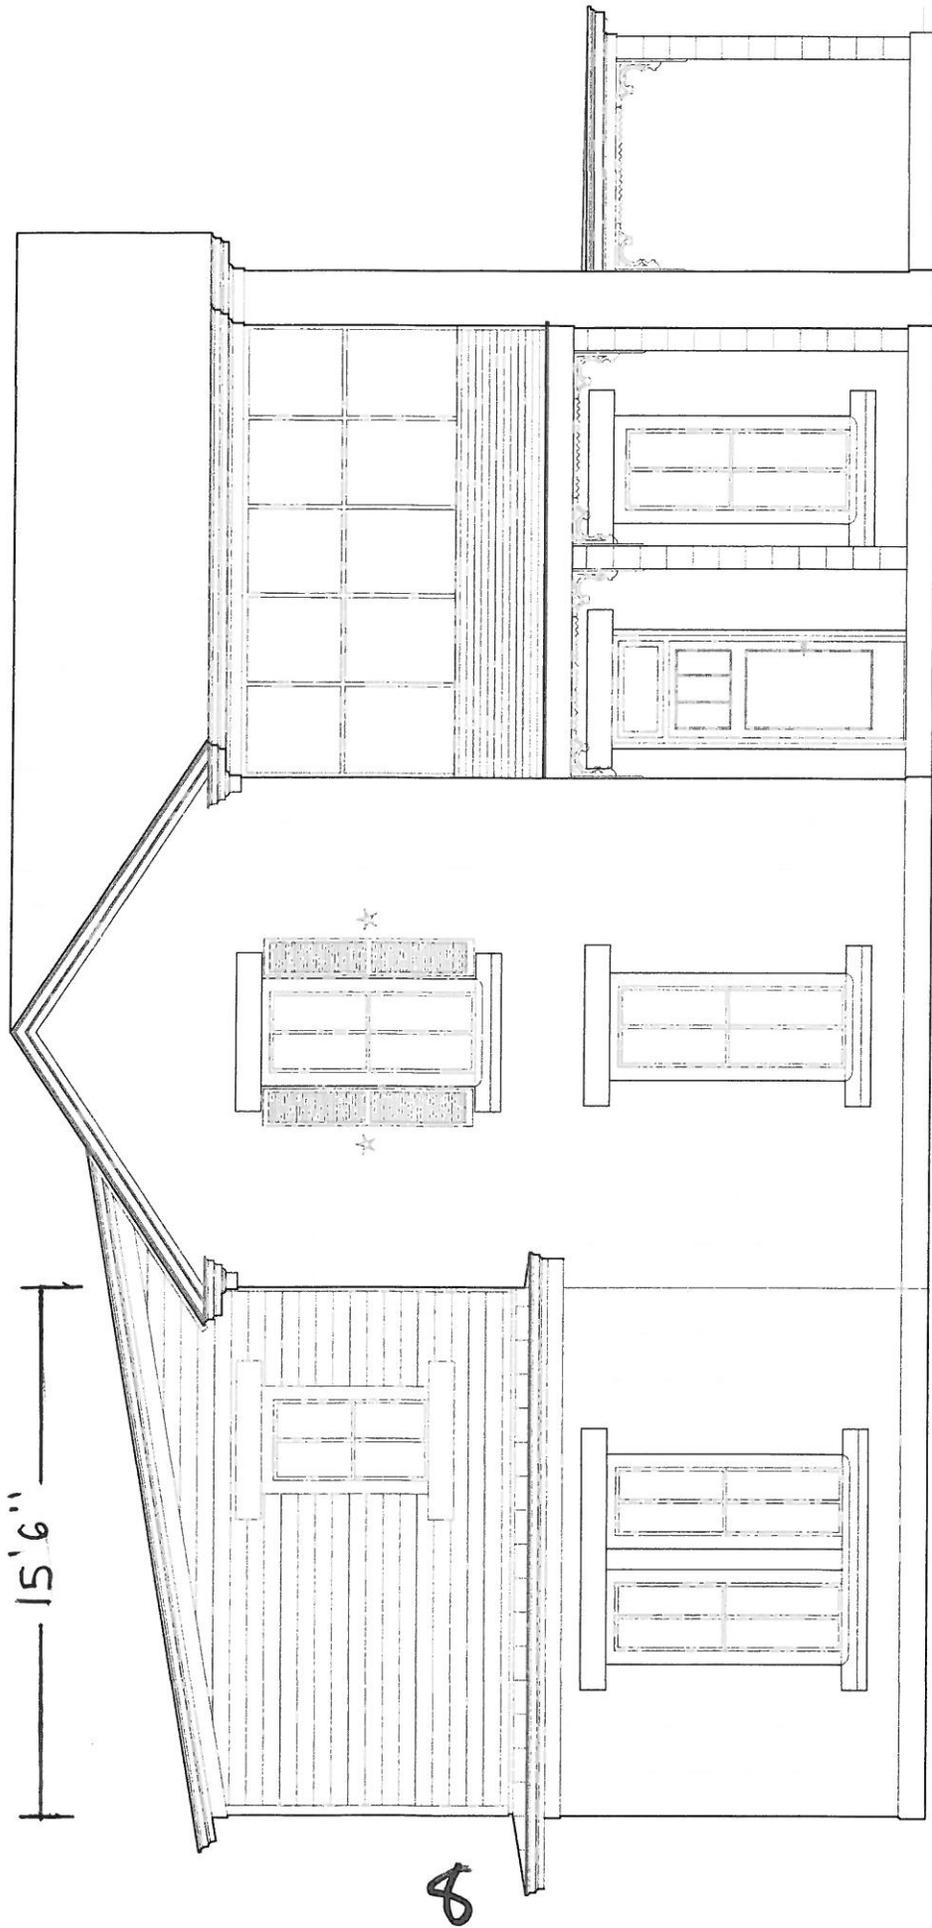
WEST SIDE ELEVATION

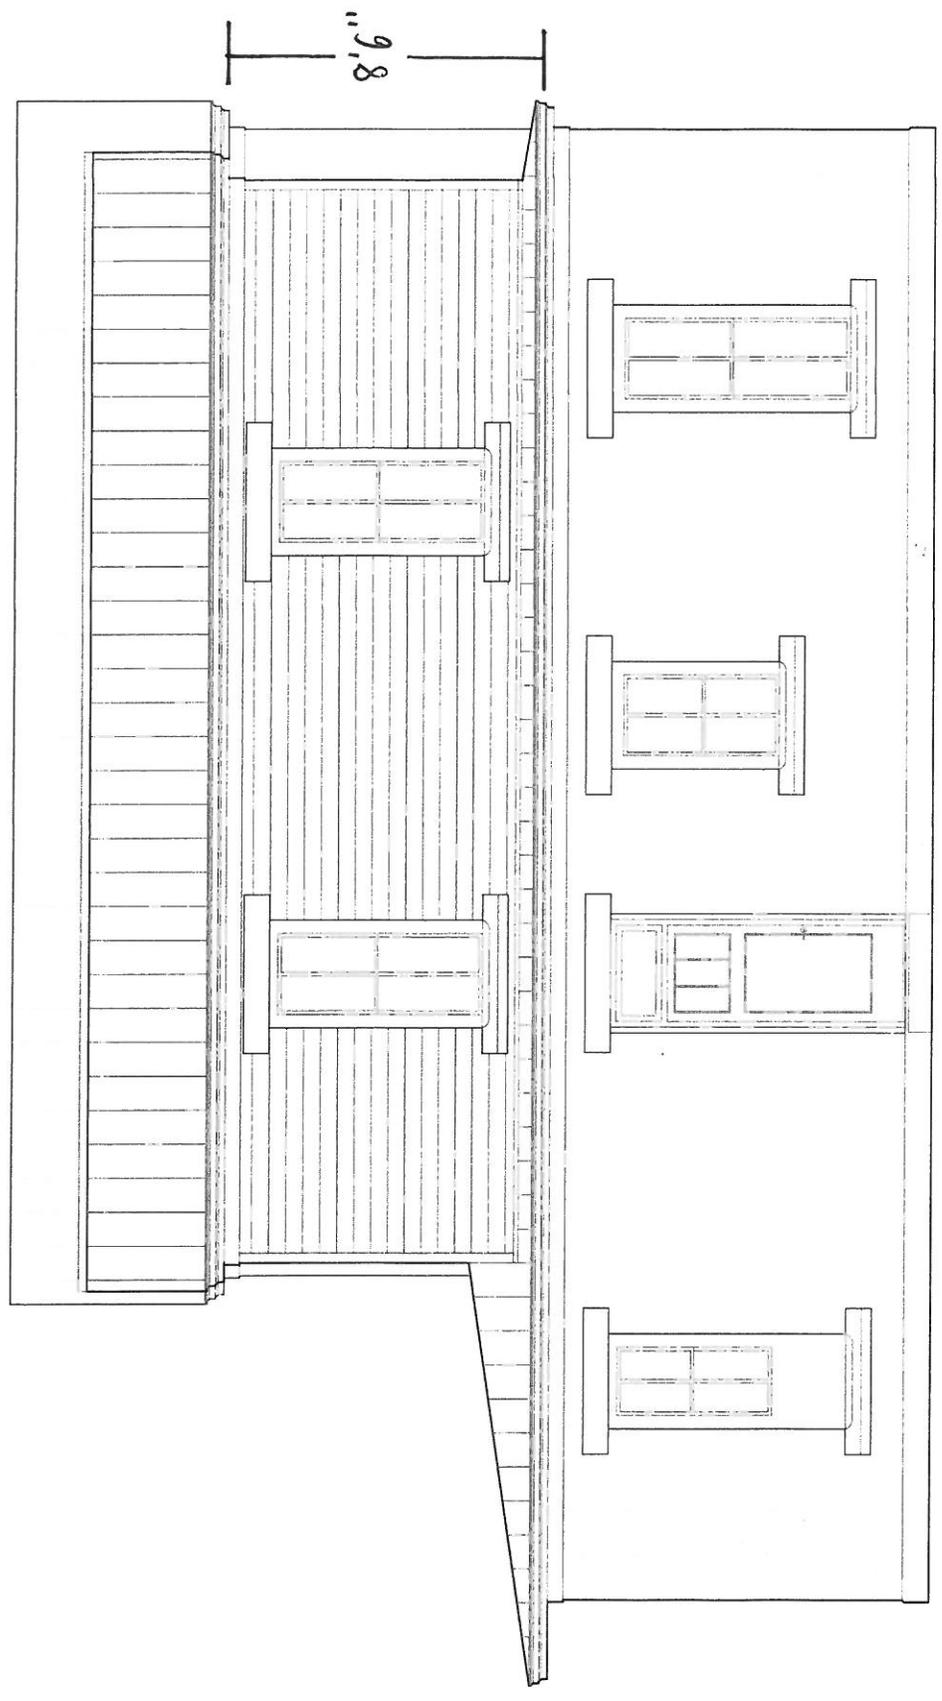
NORTH ELEVATION (FACING REAR OF HOUSE)

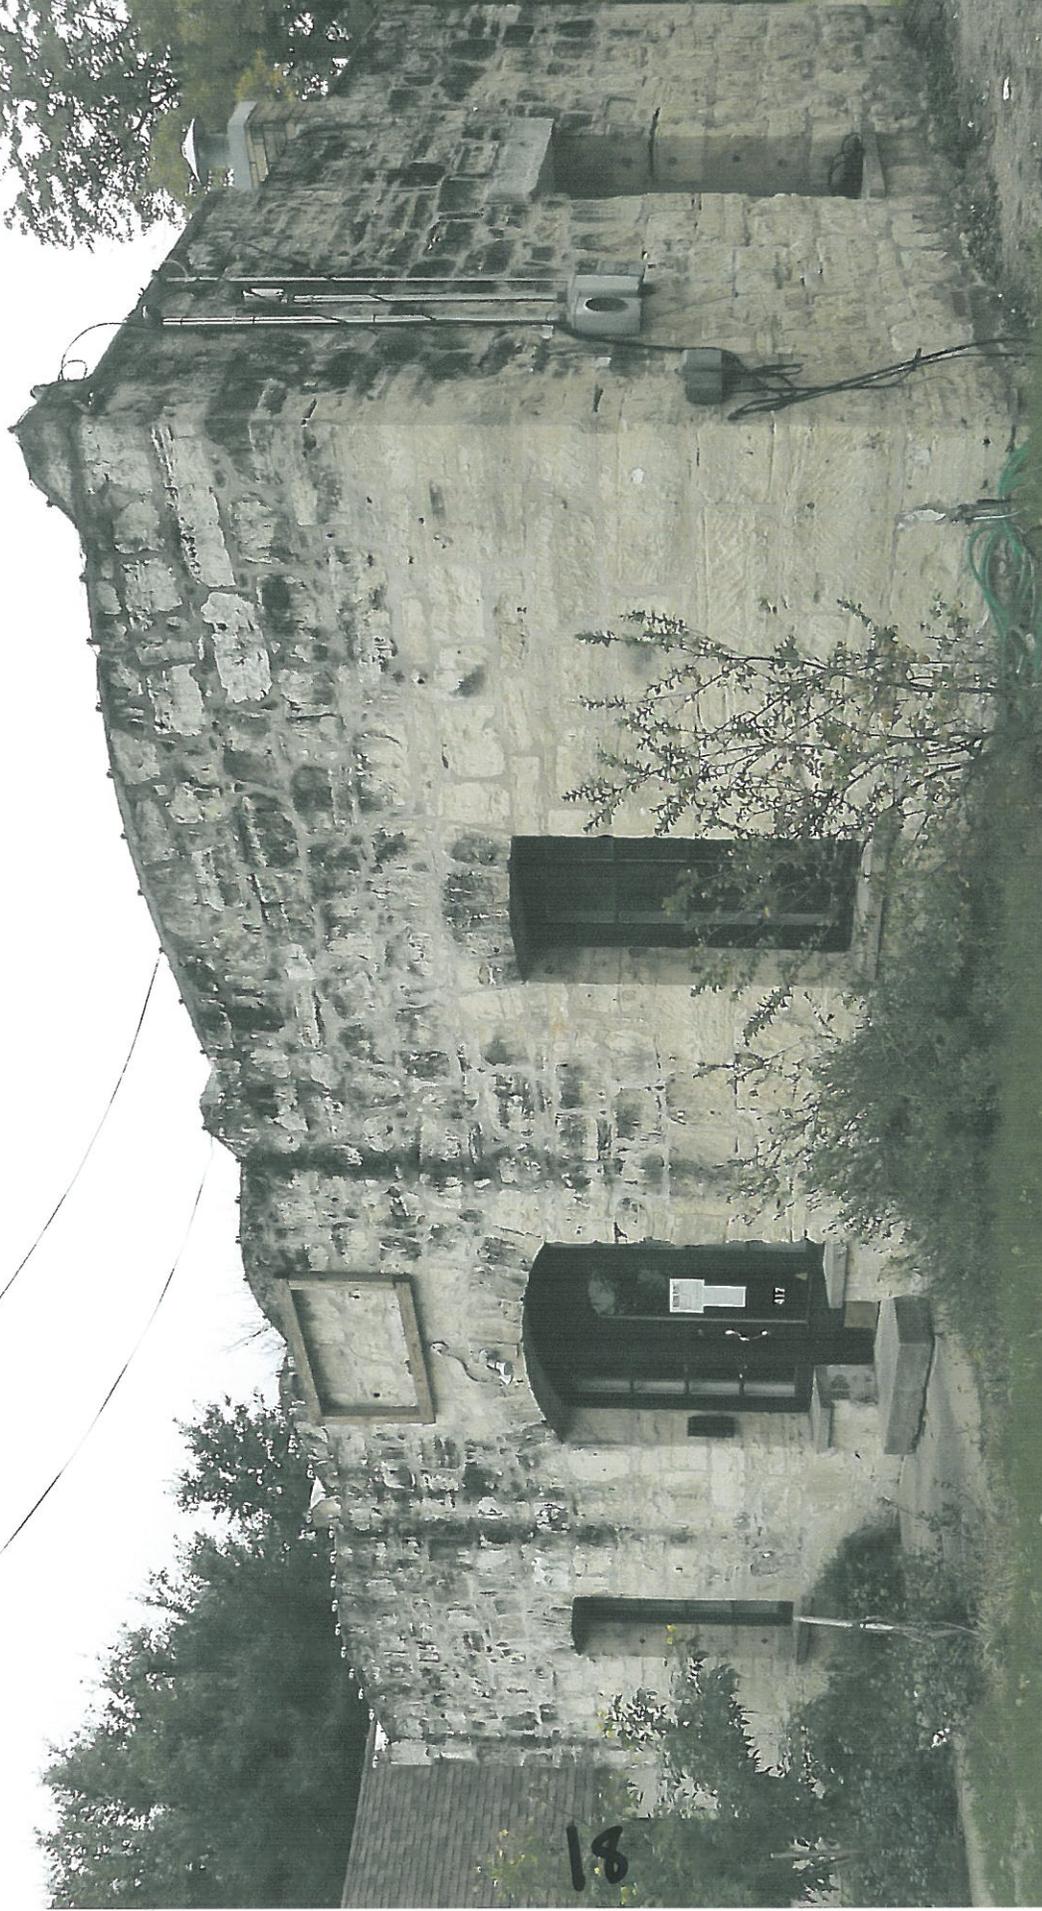
Existing 417 E. Main St. Building.

- Repaint windows & doors
- Remove overhead services / boxes on side of building.

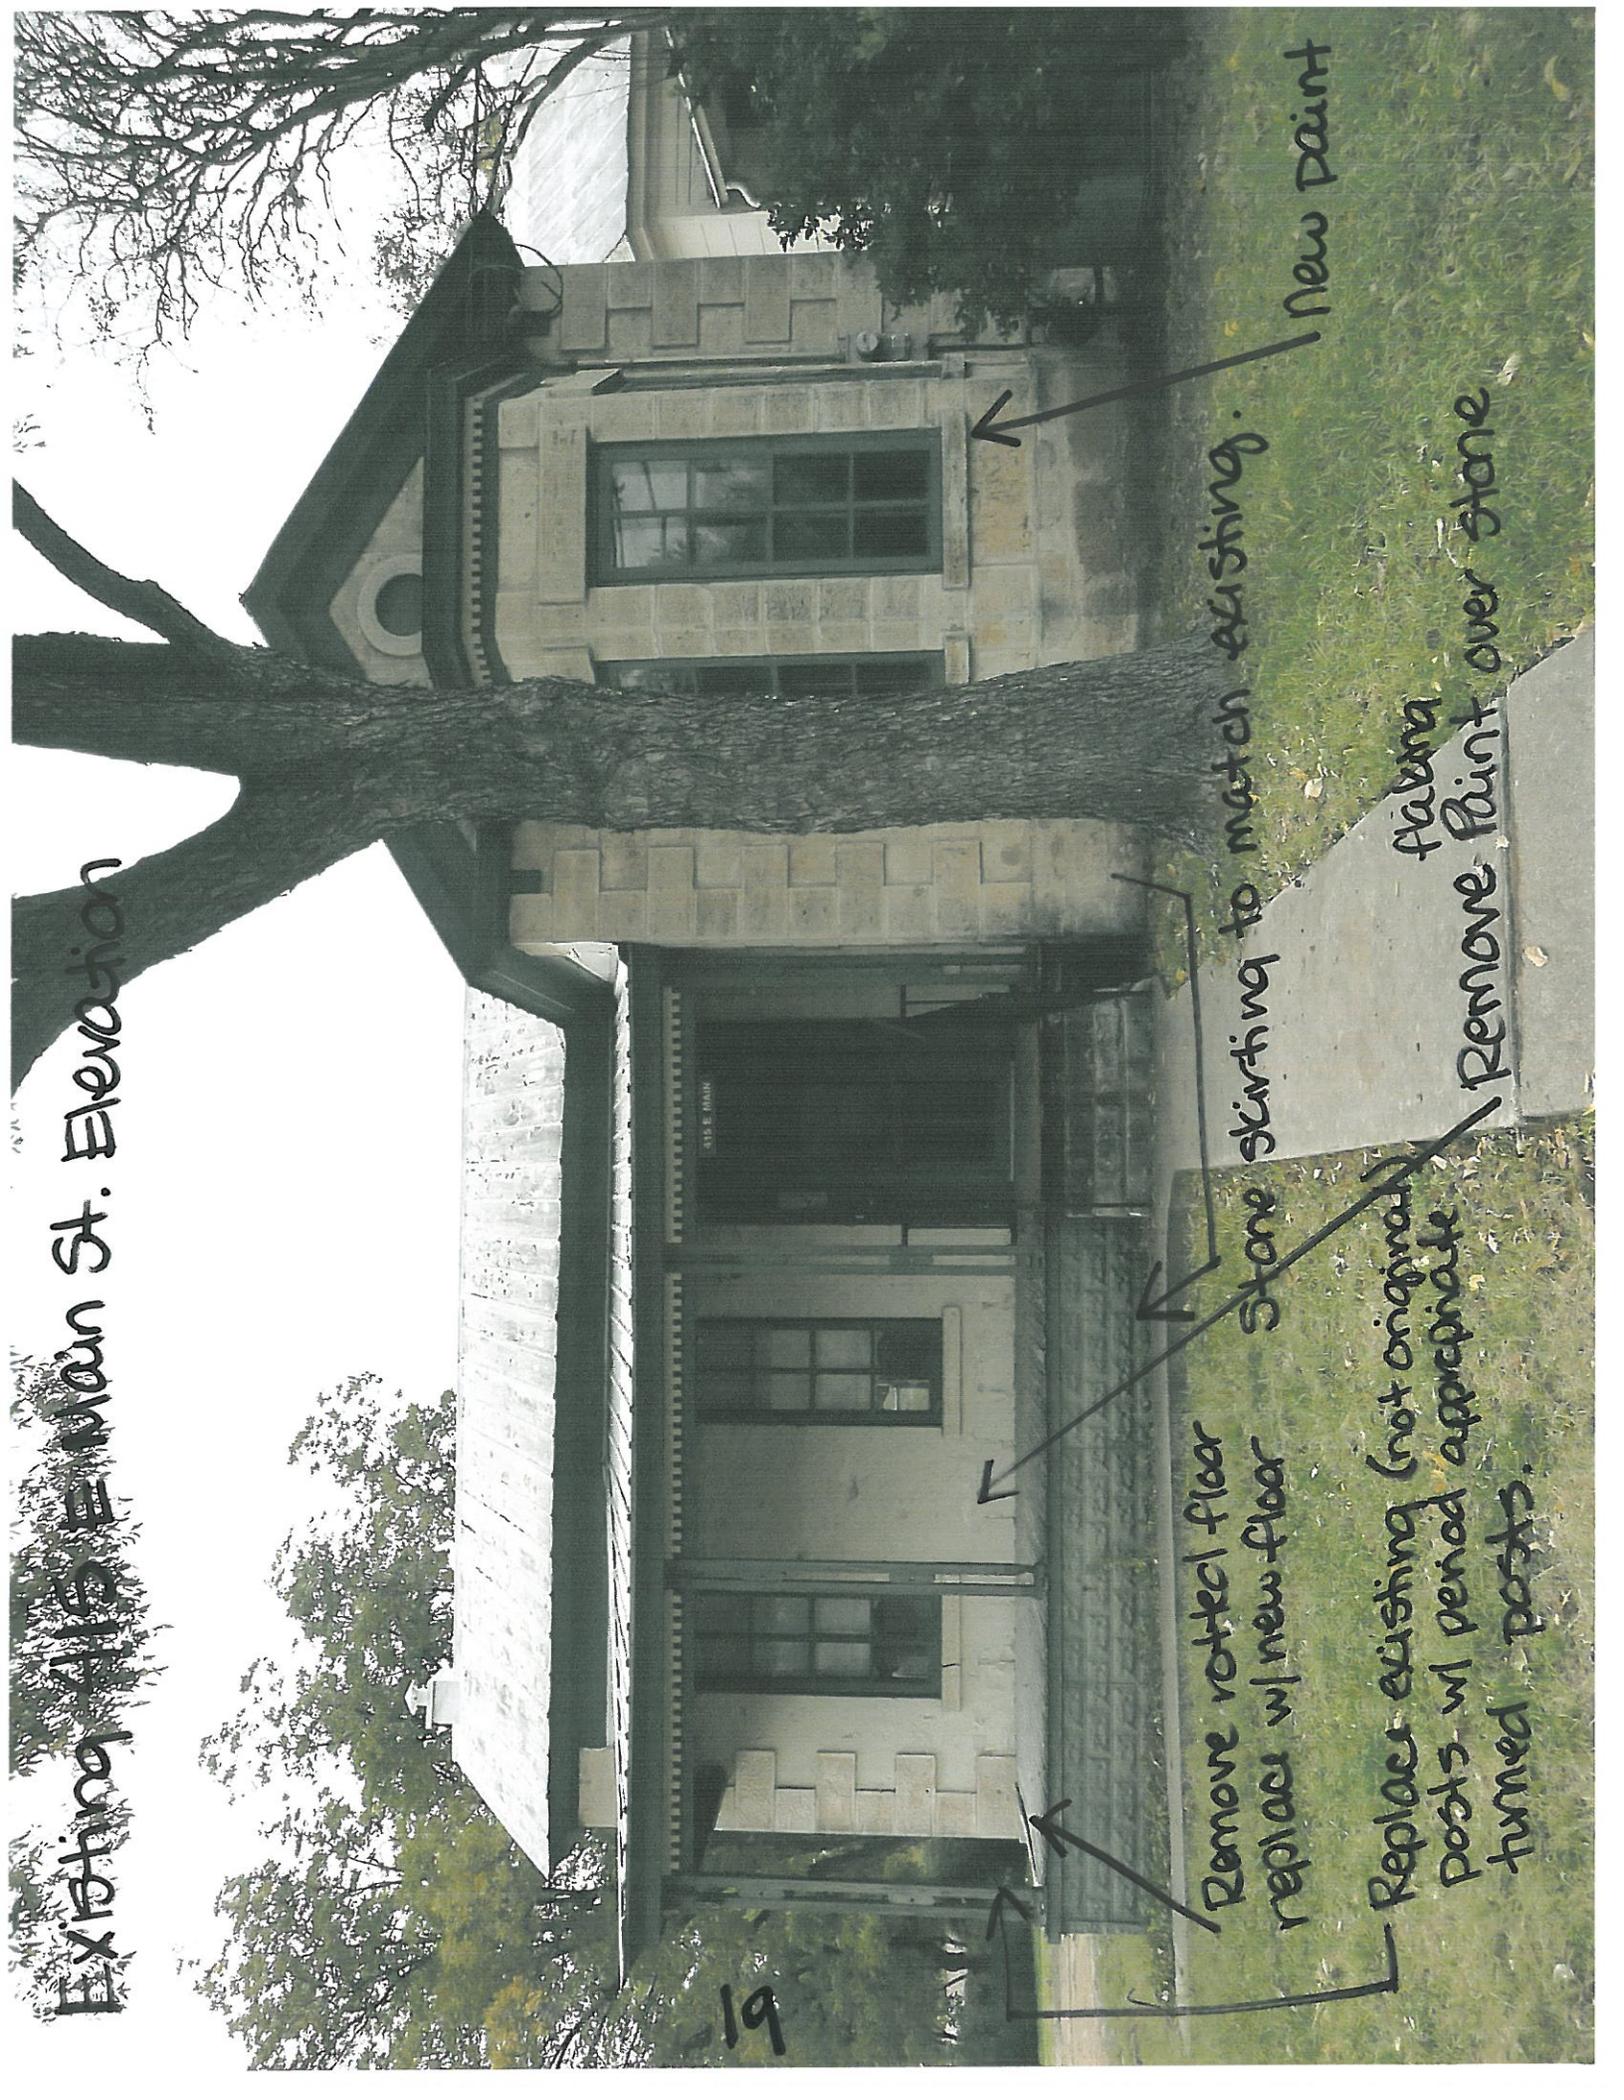
Existing 415 E Main St. Elevation

Remove rotted floor
replace w/ new floor

Replace existing (not original)
posts w/ period appropriate
turned posts.

Remove flint over stone
flint

New Paint

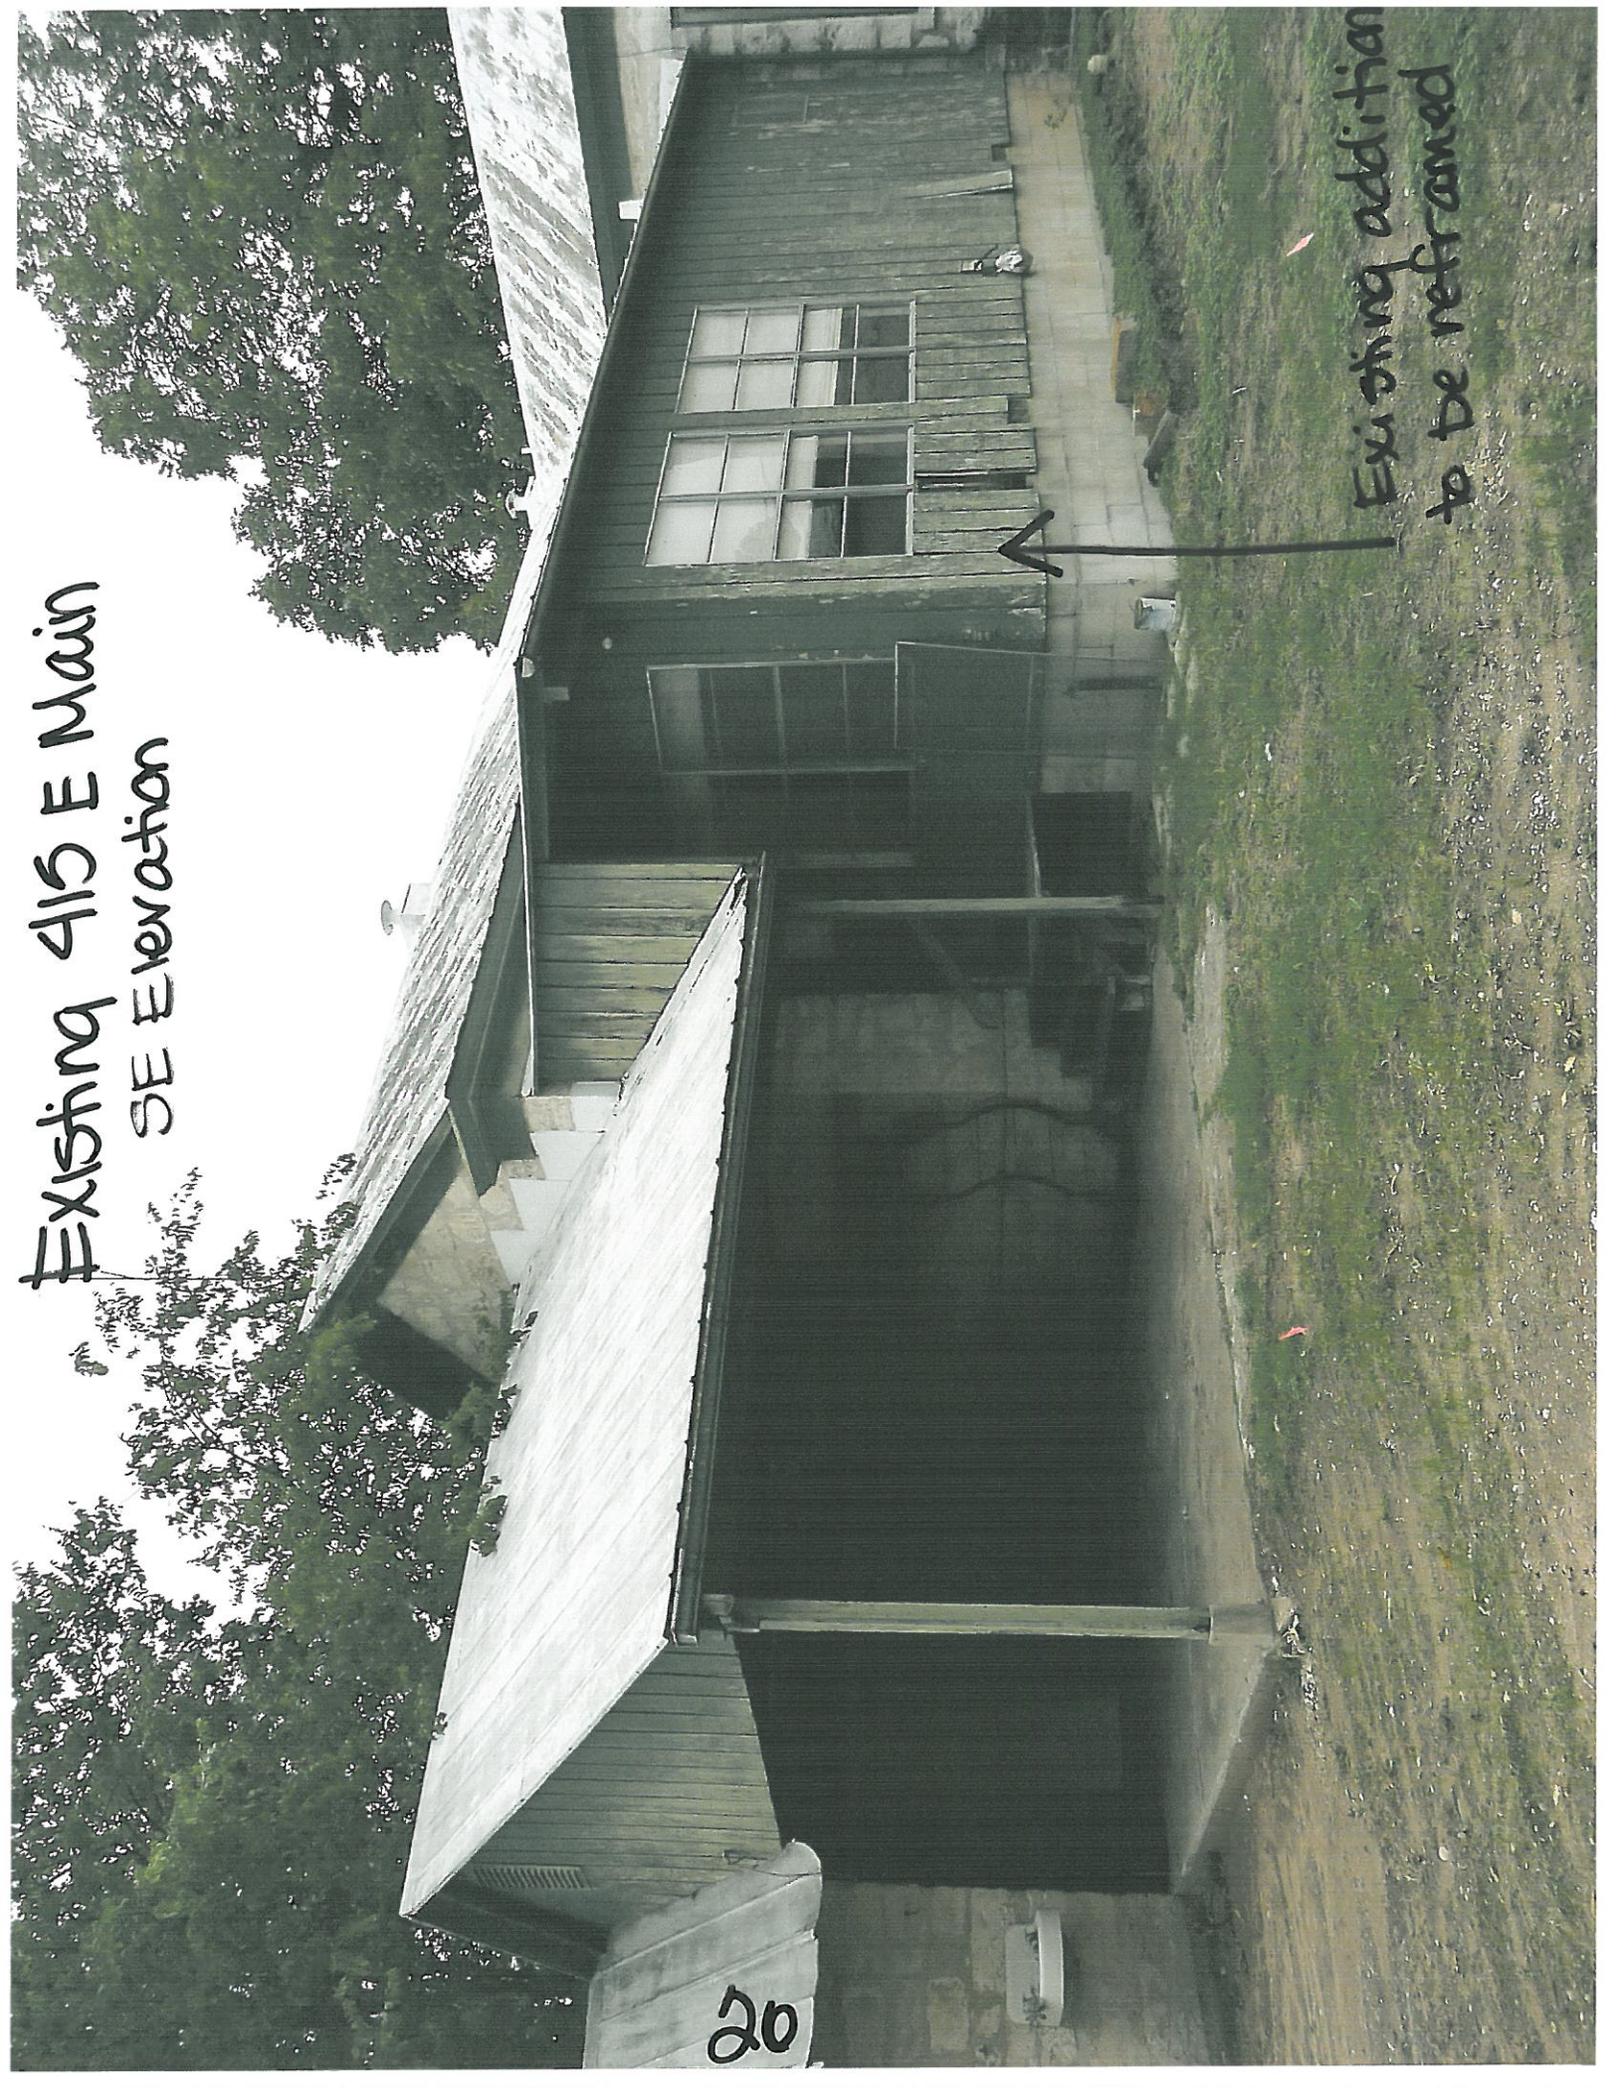
Existing 415 E Main
SE Elevation

Existing addition
to be reframed

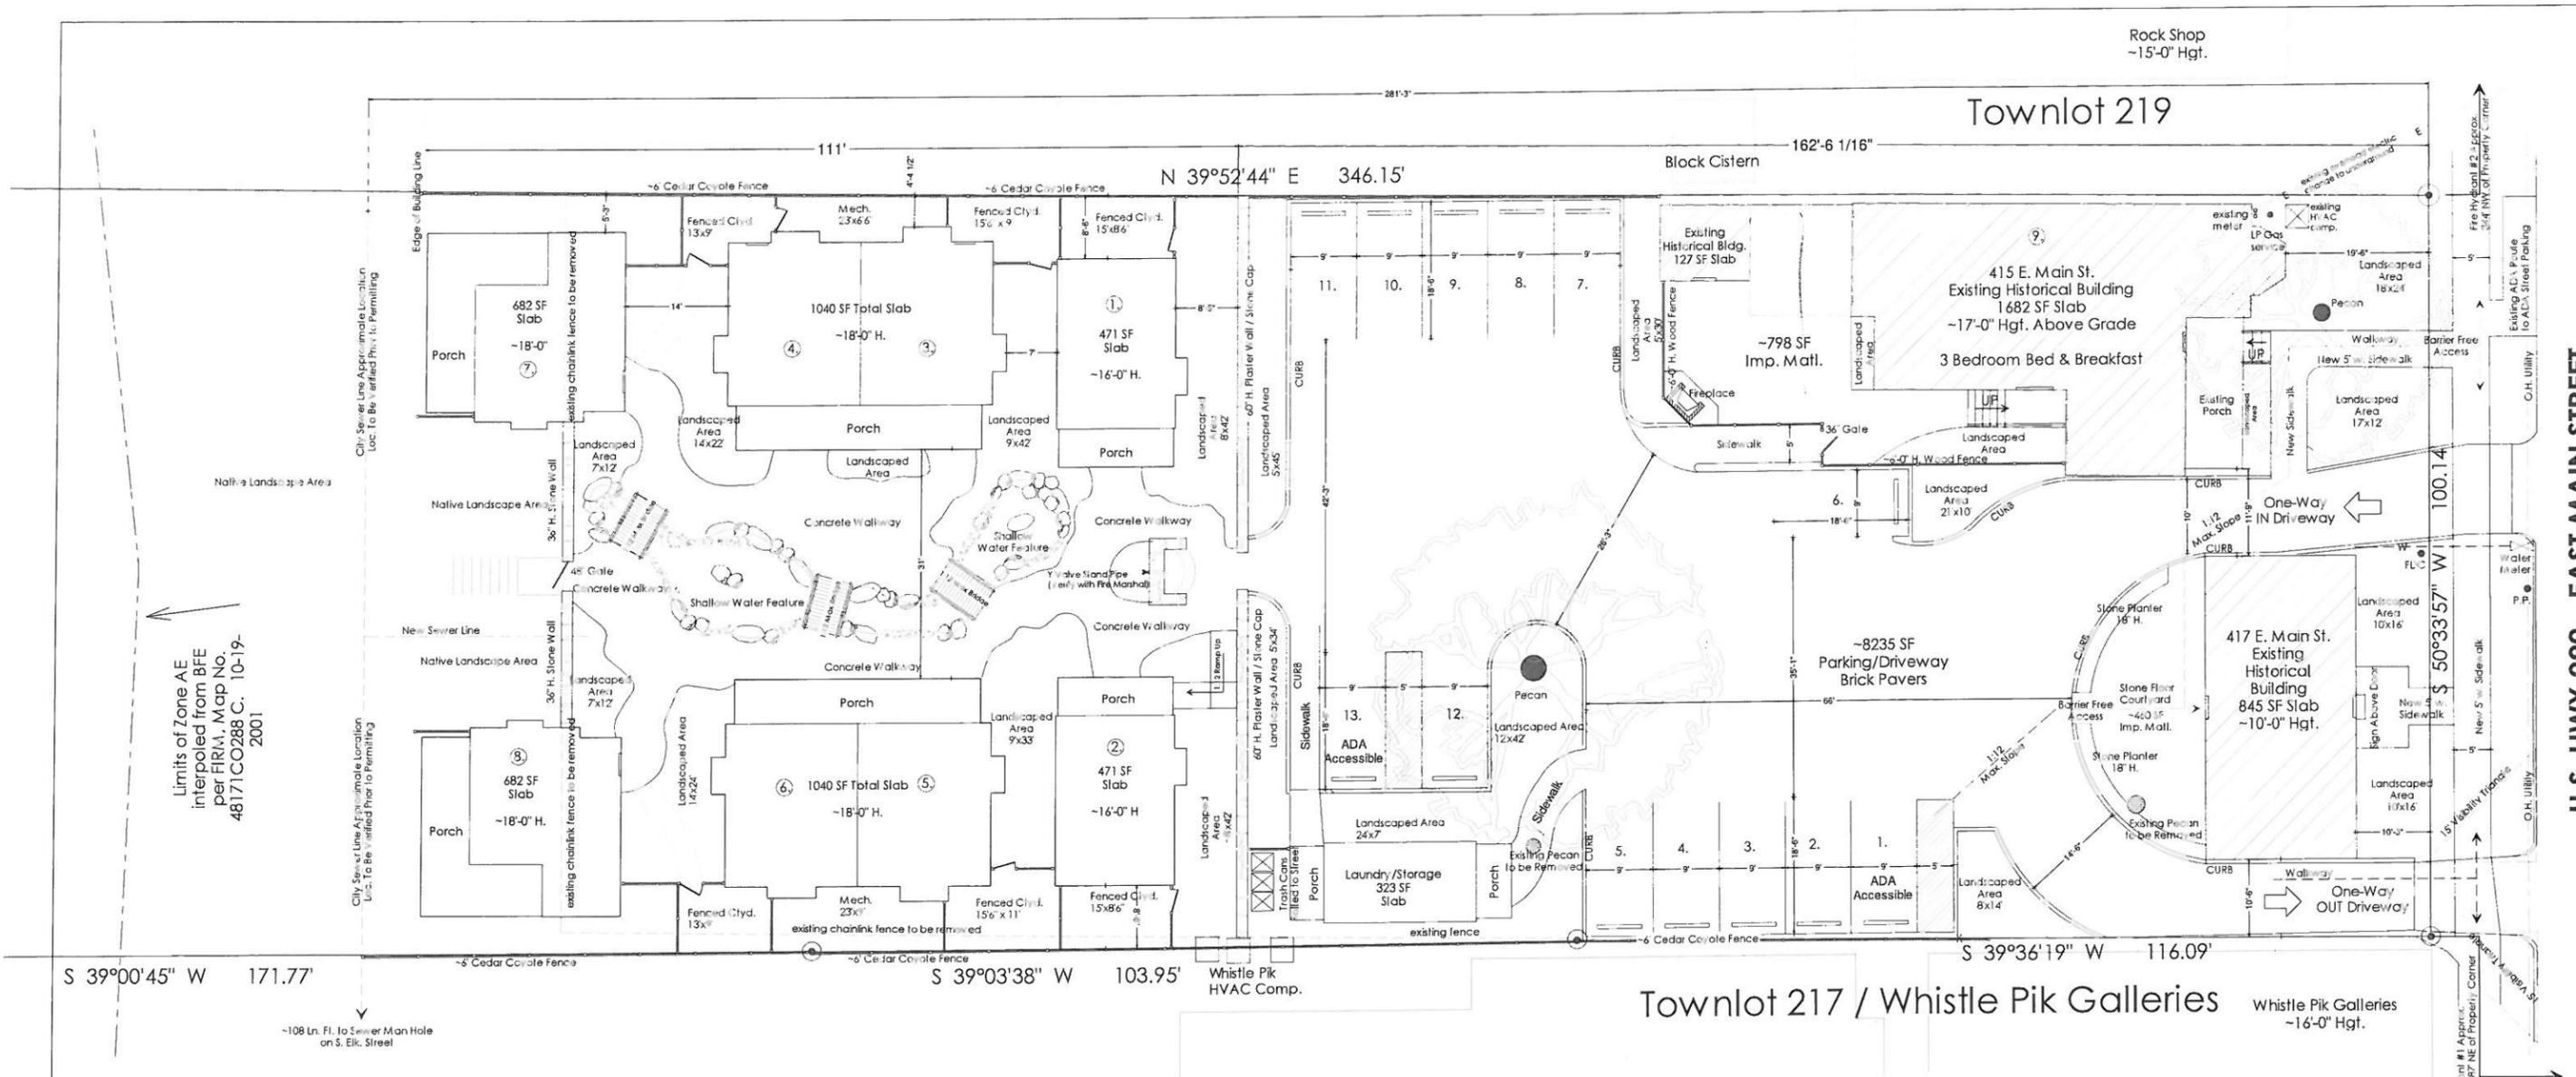
EXISTING PROPERTY PLAT:

Rock Shop
~15'-0" Hgt.

Limits of Zone AE
interpolated from BFE
per FIRI, Map No.
48171CO288 C. 10-19-
2001

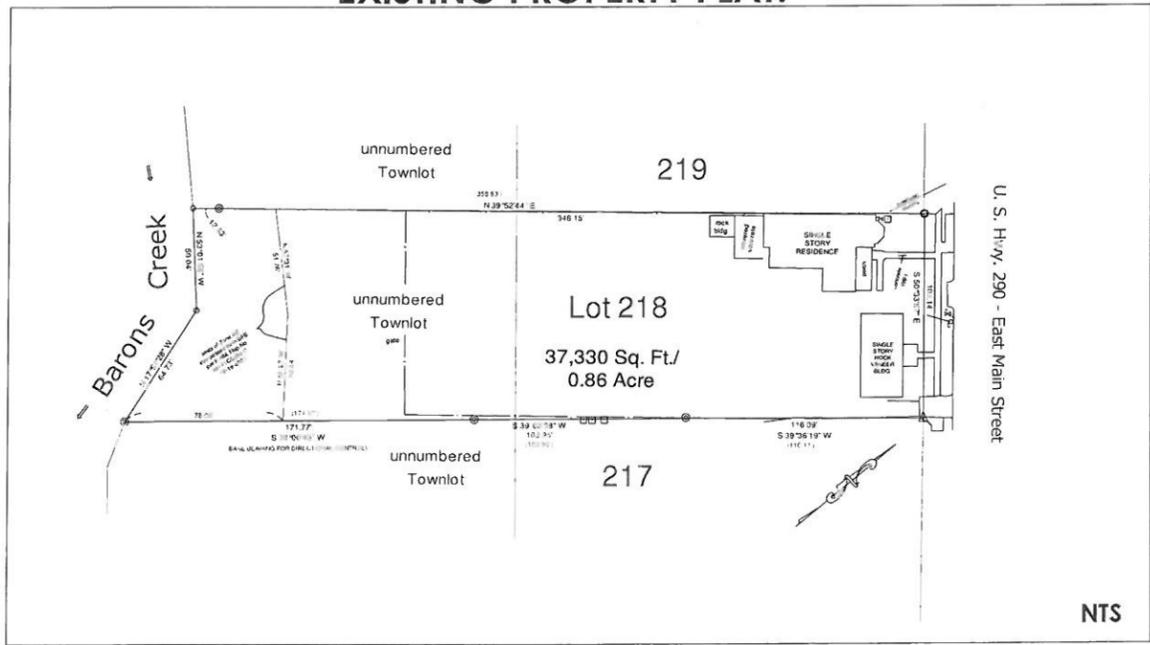
- Proposed Business: The property will be comprised of a 9 Unit Bed & Breakfast operation. The existing historical structure on 415 E. Main Street will be a Bed & Breakfast unit with 3 bedrooms and the historical structure on 417 E. Main Street is a proposed Lobby/Lounge for the operation. 8 additional Bed & Breakfast units are proposed to the rear of the lot. Both Main Street historical properties will be restored to keep the historical integrity of the buildings and further beautify Main Street frontage.

- Perimeter Fencing: Existing Fencing to be removed & replaced with 6' Hgt. Cedar Coyote Privacy Fencing.
- All Exterior Lighting to be Hooded / Dark Sky Compliant

- Existing Townlot 218 and Unnumbered Townlot in process of replatting into 1 lot
- Buildings Finished Floor Heights will be determined and noted with Grading Plan & Stormwater Control Evaluation.

- Fire Department Connection to Y valve is noted inside the proerty line in front of the buildings.

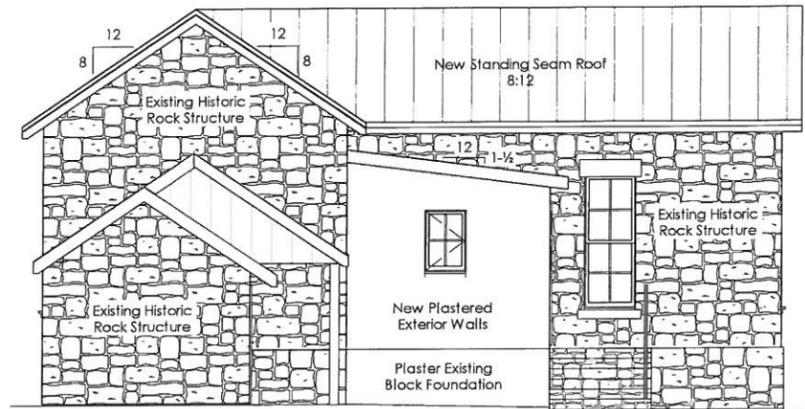
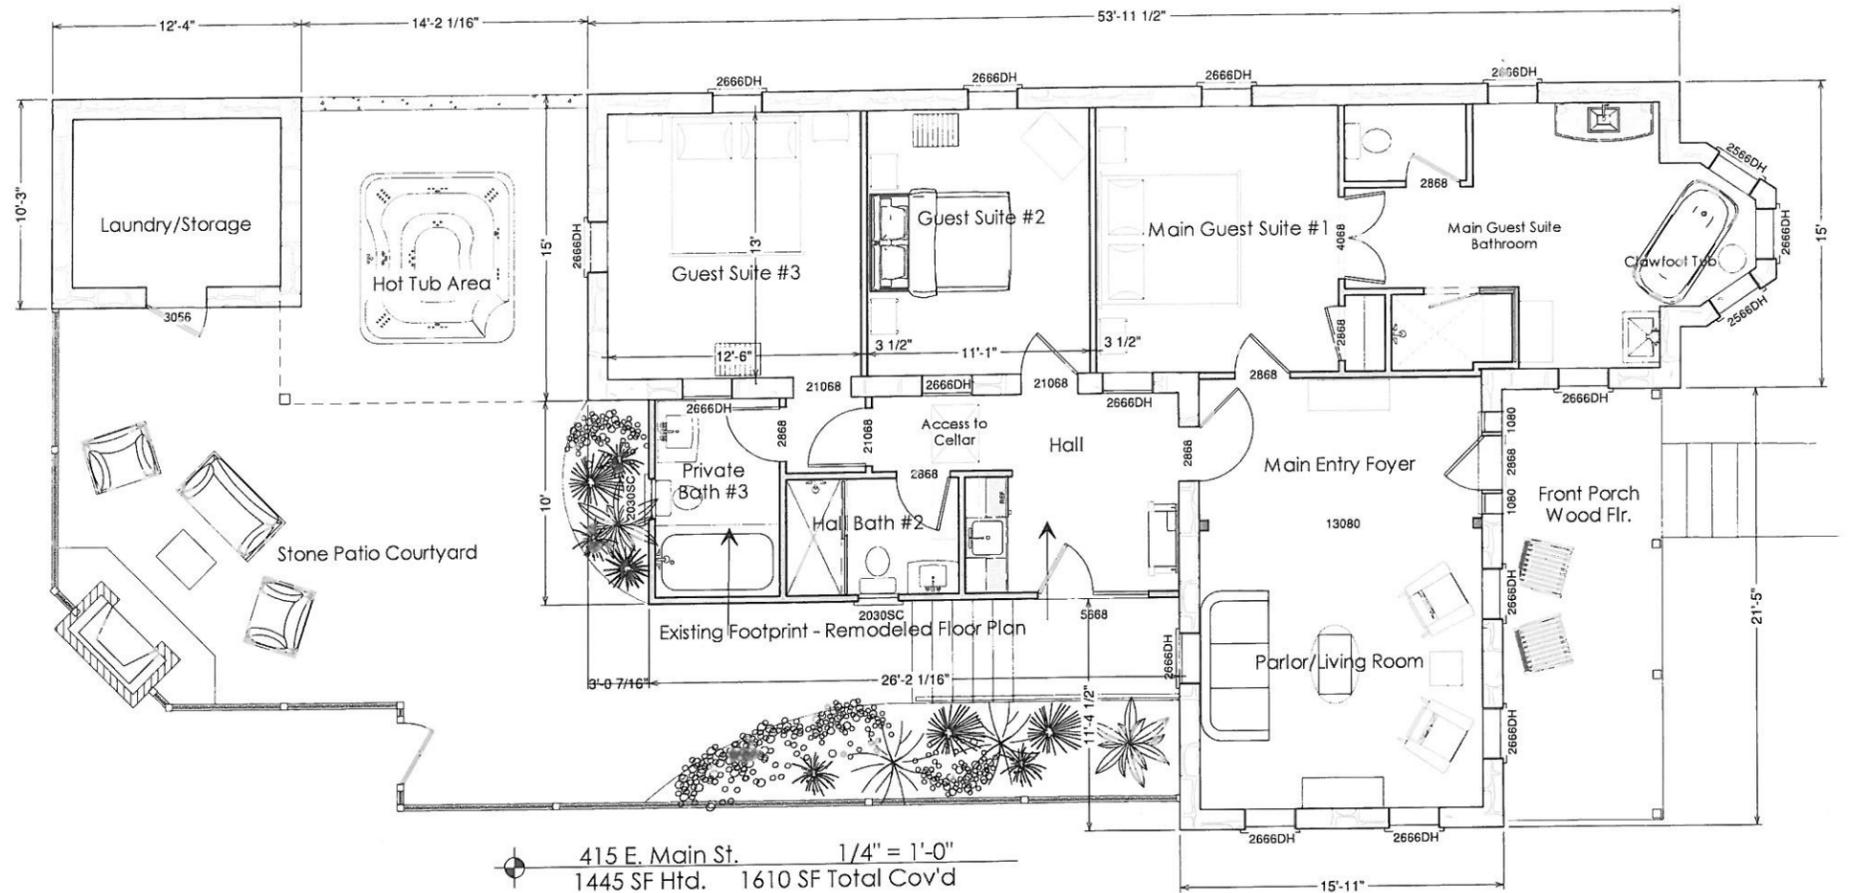
415 E. Main St. 1/4" = 1'-0"
1445 SF Htd. 1610 SF Total Cov'd

- No significant exterior changes in structure/design
- Existing wood windows remain - strip & repaint & caulk
- New standing seam galv alum roof
- New paint on windows/overhang trim (colors TBD)
- New Front Porch skirting - stone to match existing foundation stone
- New Front Porch flooring
- New Front Porch Posts - Turned Wood Posts (design of posts to mirror more accurate for late 1800's)
- Existing Addition on SE side of building will have new Plaster Siding and new interior floor plan
- New stone steps to back entrance

South Elevation

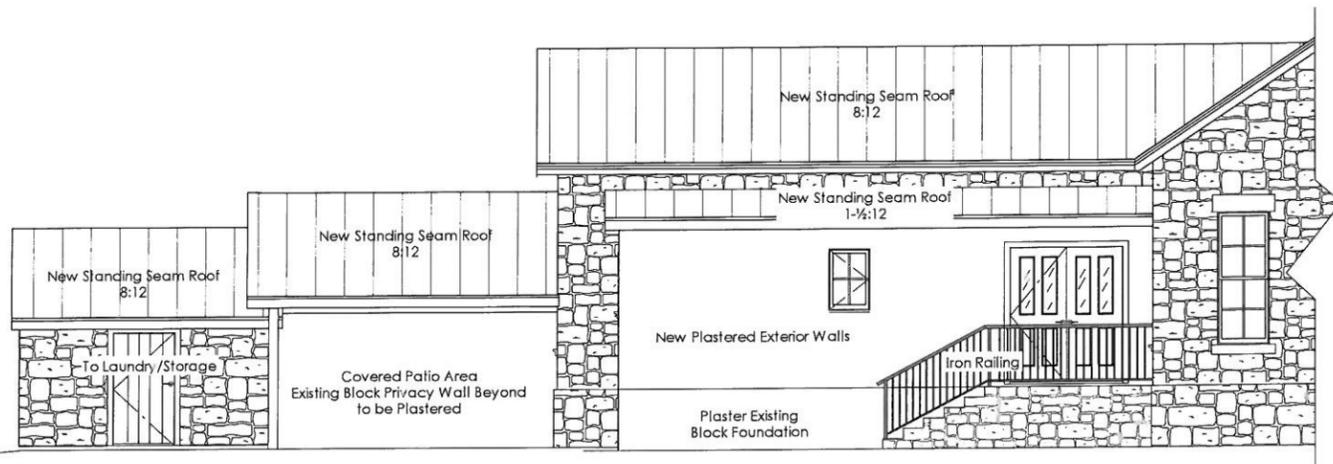
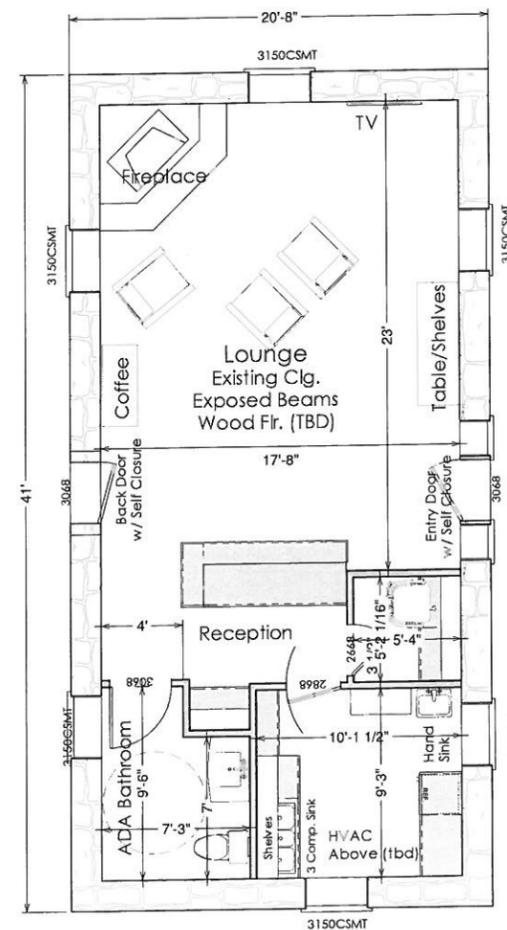
417 E. Main St. 1/4" = 1'-0"
843 SF Htd./Slab

East Elevation

- No significant exterior changes in structure/design
- Existing wood windows remain - strip & repaint & caulk
- New standing seam galv alum roof
- Interior Changes Only
