# City of Fredericksburg Historic District Design Guidelines & Standards

Fredericksburg, Gillespie County, Texas  
Final Draft Adopted July 19, 2021

Prepared for  
The City of Fredericksburg

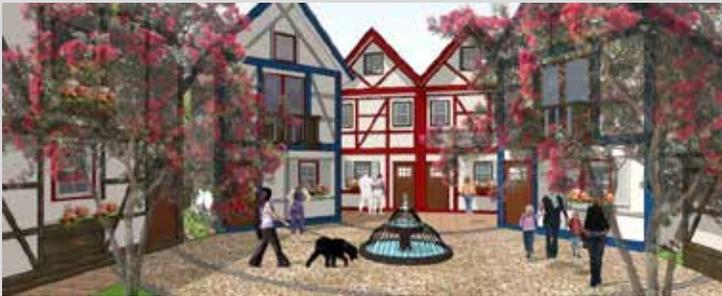
Application of faux half-timbering creates a false sense of the building’s structural system. In the image at the left, the use of faux half-timbering becomes especially confusing when combined with building scales too large to be authentic in Fredericksburg, as well as an irregular, clustered site plan configuration not historically found in Fredericksburg. If the public interpreted these buildings as authentically from period of early settlement, they could gain false ideas about the scale, massing, and site planning that characterized Fredericksburg’s early history. Source: (left) City of Fredericksburg Historic Review Board, accessed February 26, 2020, <http://fbqtx.org/DocumentCenter/View>.

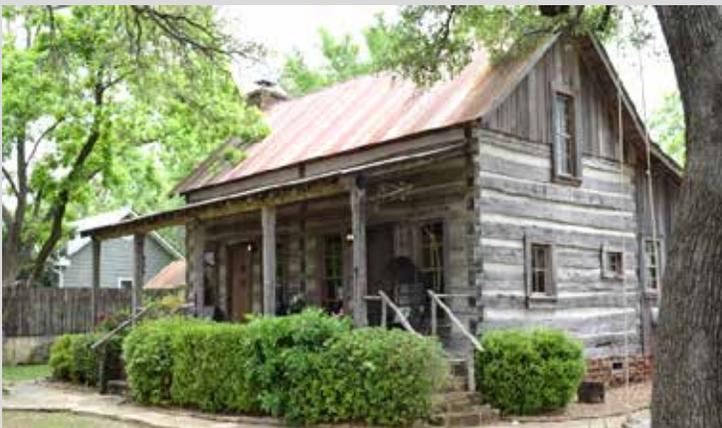
This log cabin shown in the photo at the left was constructed in Kentucky and relocated to 409 East Travis Street in Fredericksburg in the 1990s. The materials used in its construction are not native to Central Texas, and the methods of workmanship do not accurately reflect those used by Fredericksburg’s early German settlers. No signage explains that the building was relocated. As a result, this cabin can appear original to its site, creating a false sense of Fredericksburg’s history. Other relocated cabins that are not original to Fredericksburg are located at 217 Mistletoe (the “Town Creek Log Cabin”) and 508 East Travis Street (part of the former SAS retreat property). Source: (left) Cox McLain Environmental Consulting (CMEC), “City of Fredericksburg Historic Resources Survey: Phase I,” prepared for the City of Fredericksburg, 2019.

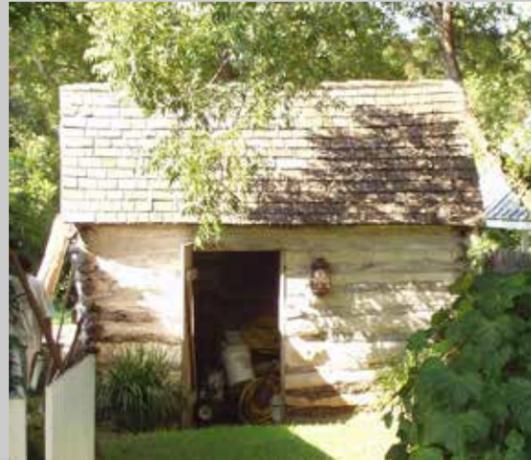
**Ca. 1846**

Vernacular fachwerk and log cabins reflect access to only local materials and limited building tools

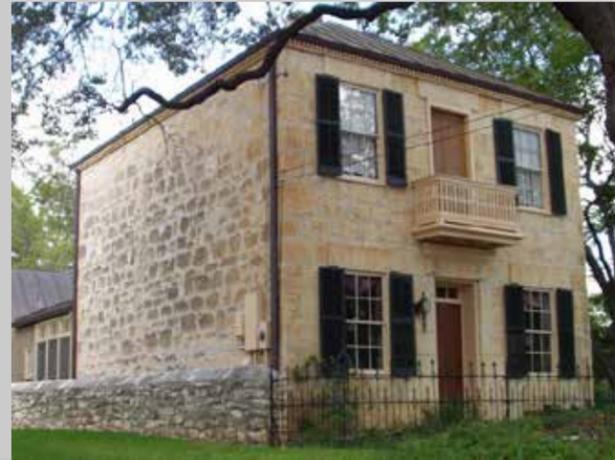
**Ca. 1852**

Stone becomes available with establishment of quarries.

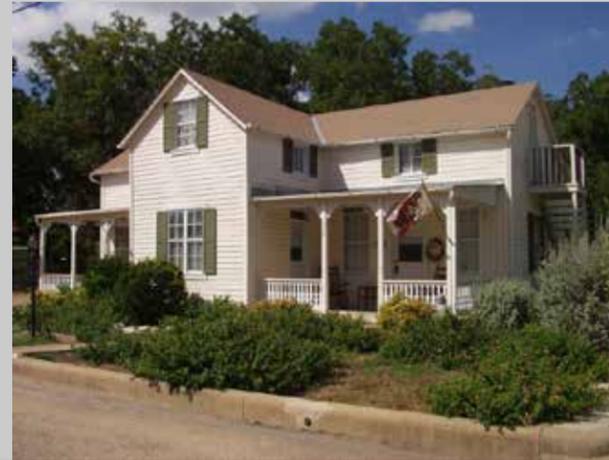
**Ca. 1880**

Circular saw technology and steam power make milled lumber and mass-produced "gingerbread" ornament available

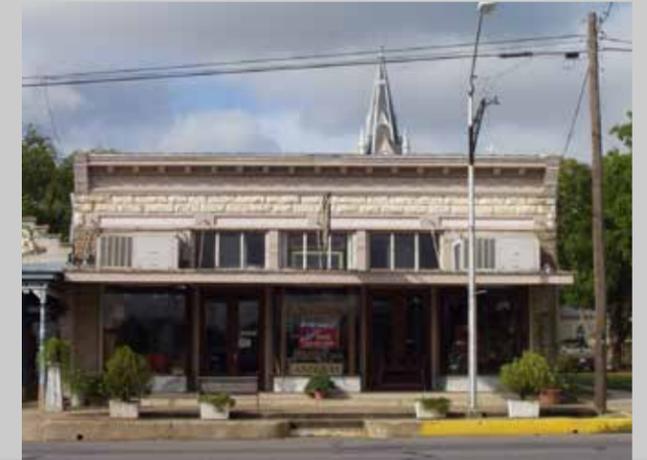
**Ca. 1890**

Cast iron beams and lintels allow wider window openings for glass storefronts, as well as broad open interior spaces

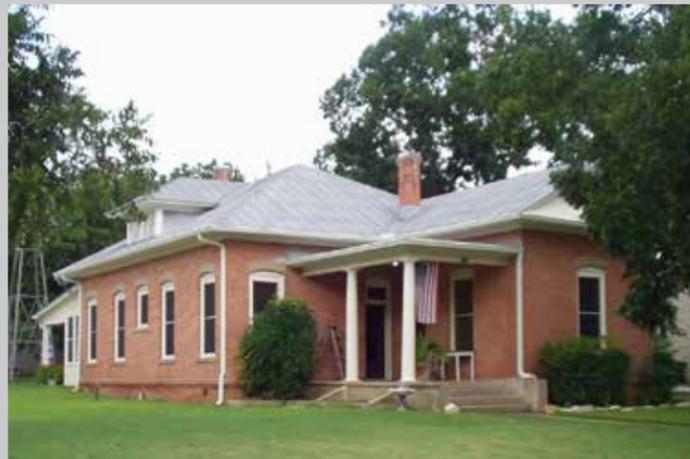
**Ca. 1914**

The arrival of the railroad in Fredericksburg in 1913 brings access to brick

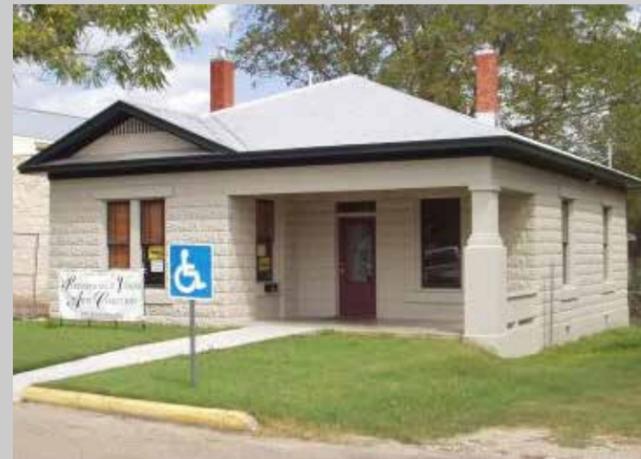
**Ca. 1920**

New iron presses for cast concrete create "Basse Block" and "Roos Block"

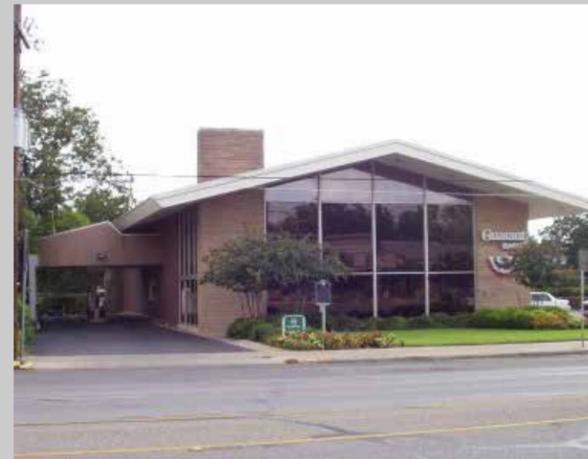
**Ca. 1960**

Industrial-scale production of "float glass" enables large window walls; popularization of air conditioning spurs adoption despite heat exchange

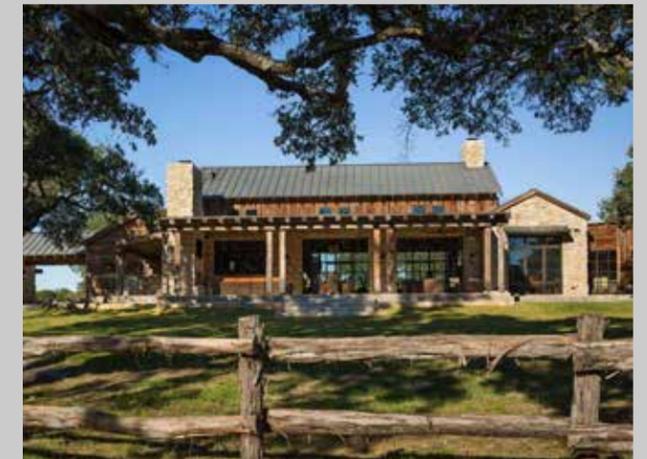
**Ca. 2020**

New research about sustainability inspires return use of local materials and passive climactic features, combined with continued use of steel frames and large glass panes

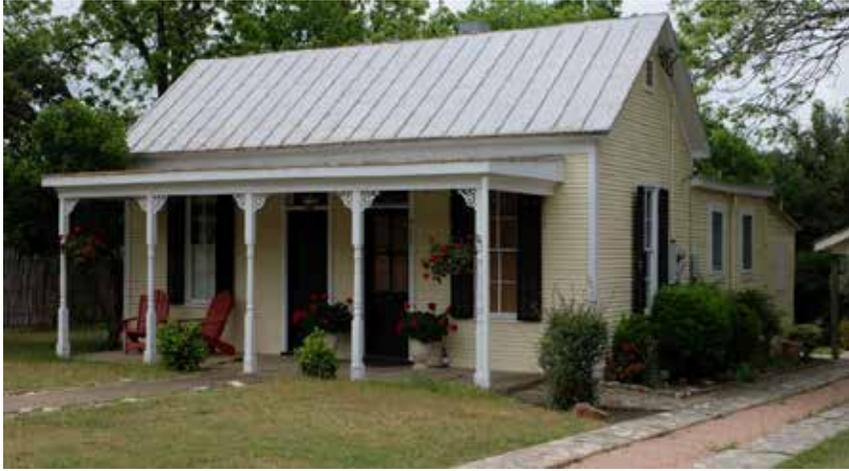
Figure 1-1. This example of a **High Priority** resource at 711 W San Antonio Street holds individual significance as a representative example of the Folk Victorian style. It also retains its integrity to a high degree. Photo by CMEC, 2019.

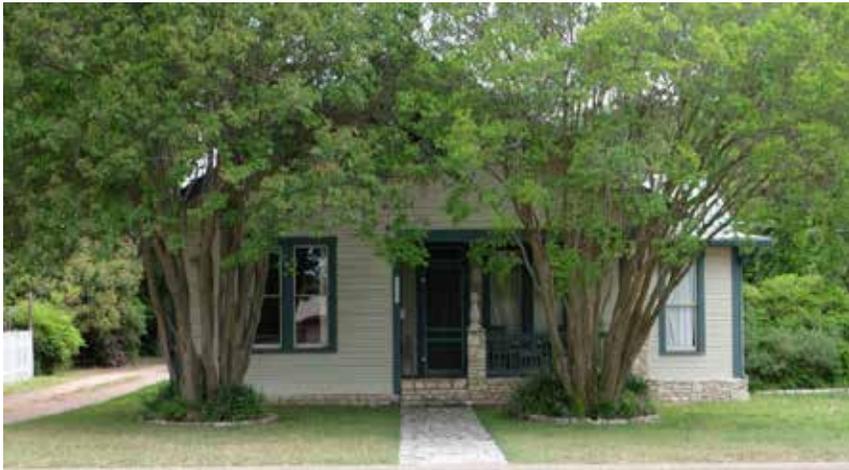
Figure 1-2. Example of a **Medium Priority** property at 714 W Creek Street. The property was constructed prior to 1924 per Sanborn maps and is representative of homes constructed within the historic district at that time. Although the building might not hold individual significance, it contributes to the collective historic character of the overall district. Although the property has a rear addition and some minor alterations, the majority of the fabric visible from the public right-of-way retains its historic character. Photo by CMEC, 2019.

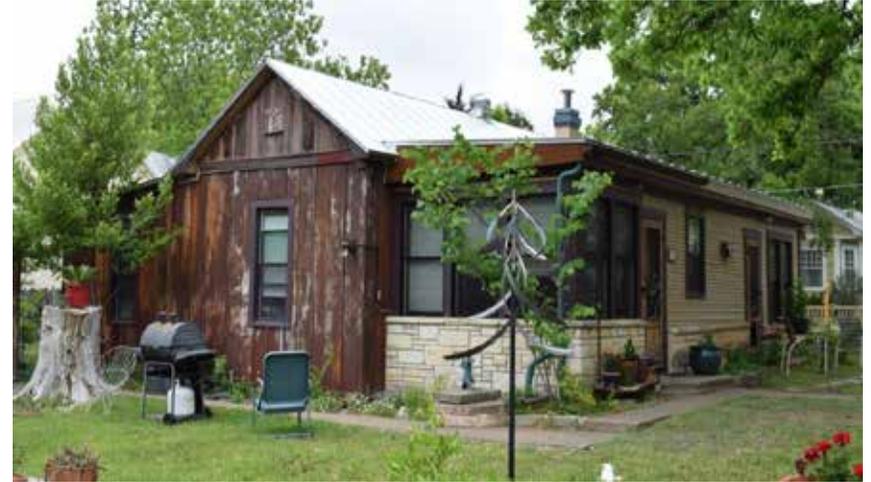
Figure 1-3. Example of a **Low Priority** house at 410 N Pine Street. Although this property was constructed in the early twentieth century, its historic form and materials have been concealed by non-historic additions. If these additions are removed and the historic fabric is uncovered, the building's priority should be reevaluated. Photo by CMEC, 2019.

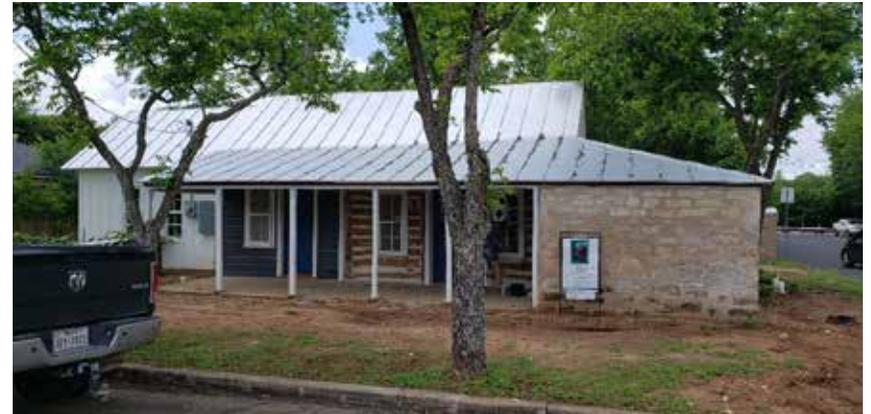
Figure 1-4. Example of the house at 223 W Creek Street, which was considered a low priority during a 2002 survey. Subsequent rehabilitation work revealed historic fabric concealed by later additions, and the house's priority changed to High after it was restored. Photo by City of Fredericksburg

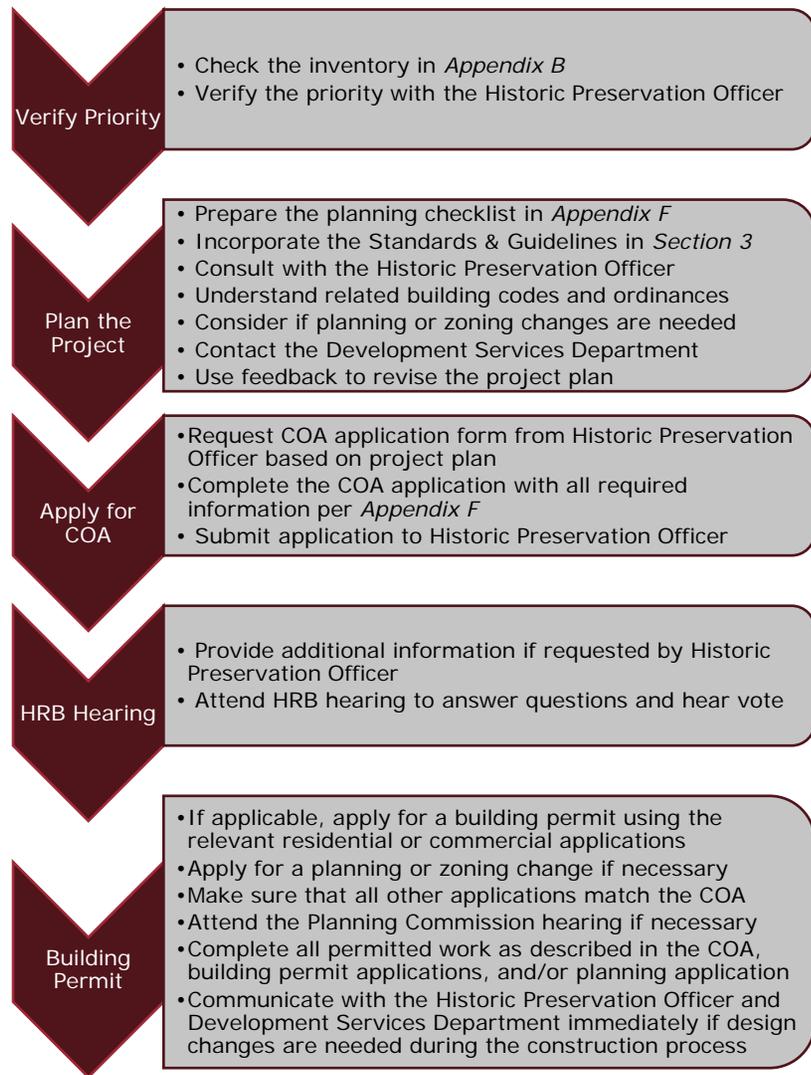
Figure 1-5. Flow chart depicting the recommended process for project planning and Certificate of Appropriateness (COA) review and approval.

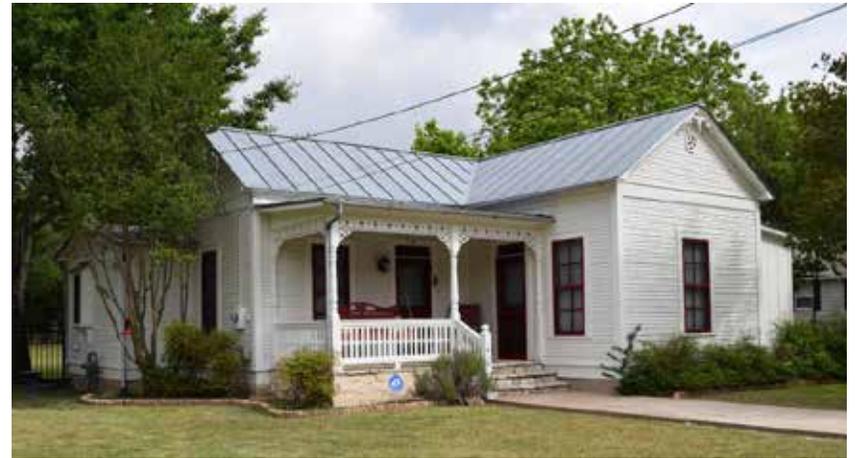
Figure 2-1. Example of an L-plan form constructed around 1910 with Folk Victorian detailing at 610 North Adams Street. Source: CMEC 2018 Historic Resources Survey.

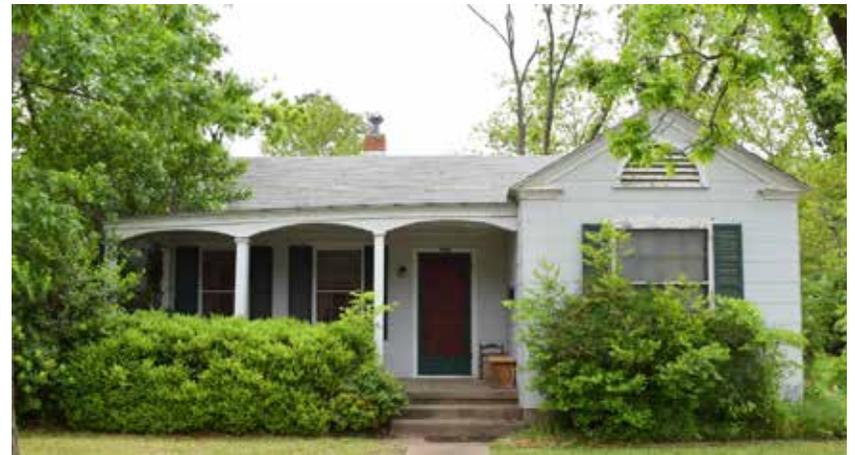
Figure 2-2. Example of an L-plan building form with Minimal Traditional stylistic influences constructed at 208 West Centre Street around 1940 – demonstrating the longevity of building forms, and how a single form can be combined with many different styles. Source: CMEC 2018 Historic Resources Survey.

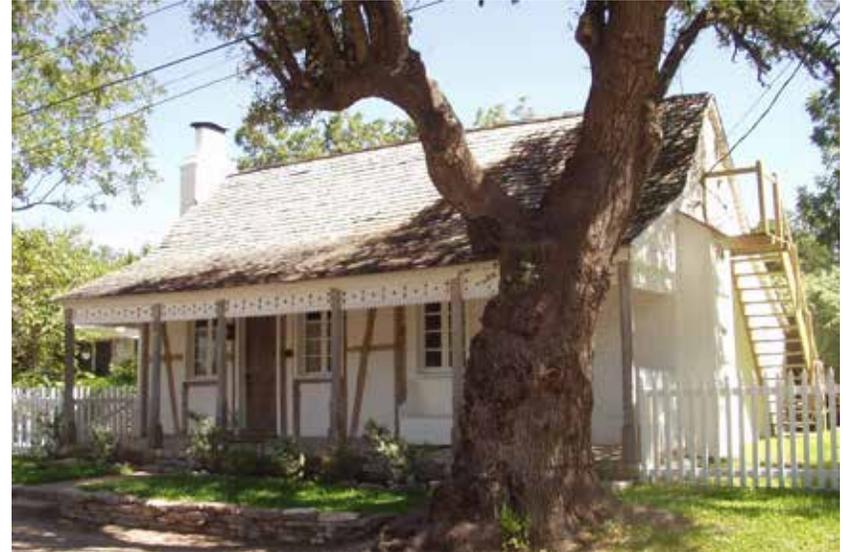
Figure 2-3. Photo of *fachwerk* construction at 512 W. Creek Street. Note the horizontal, vertical, and diagonal framing members. Also note the stucco finish and exterior stair. Source: HHM 2003 Historic Resources Survey.

Many German vernacular homes are characterized by *fachwerk*, a construction technique found within Central Texas communities settled by German immigrants in the mid-nineteenth century, like Fredericksburg. *Fachwerk* has exposed wooden members—typically arranged horizontally, vertically, and diagonally, joined by wooden pegs—with an infill composed of a mix of mortar and aggregate between these wooden members. Other German vernacular homes in Fredericksburg are constructed with limestone masonry rather than *fachwerk*. Both *fachwerk* and masonry examples sometimes were veneered with limestone-based stucco. Regardless of construction technique, the style includes thick walls and narrow windows, handmade craftsmanship, and minimal original applied ornament. Sometimes architectural expression was integrated via functional features – like arched lintels or peaks in the cornice line to allow window openings at the attic level, a feature commonly found in vernacular construction in Europe.

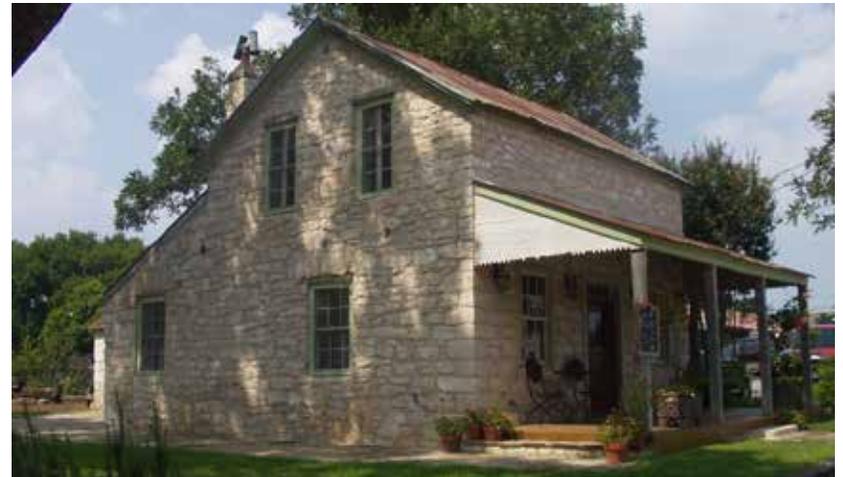
Figure 2-4. Photo of a limestone masonry vernacular house at 206 S. Adams Street. Note the arched lintels at the ground floor. Source: HHM 2003 Historic Resources Survey.

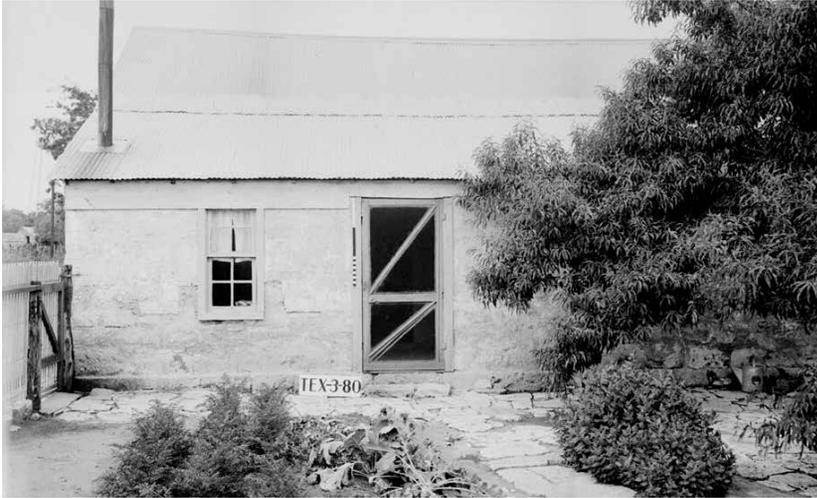
Figure 2-5. Historic American Buildings Survey (HABS) photo of the Heinrich G. Dietz House, Creek & Bowie Streets, ca. 1933. Note the lack of a porch, the small scale of the windows relative to the walls, and the integration of the lintels into the roof framing to conserve lumber. Source: Library of Congress, <https://www.loc.gov/item/tx0337>.

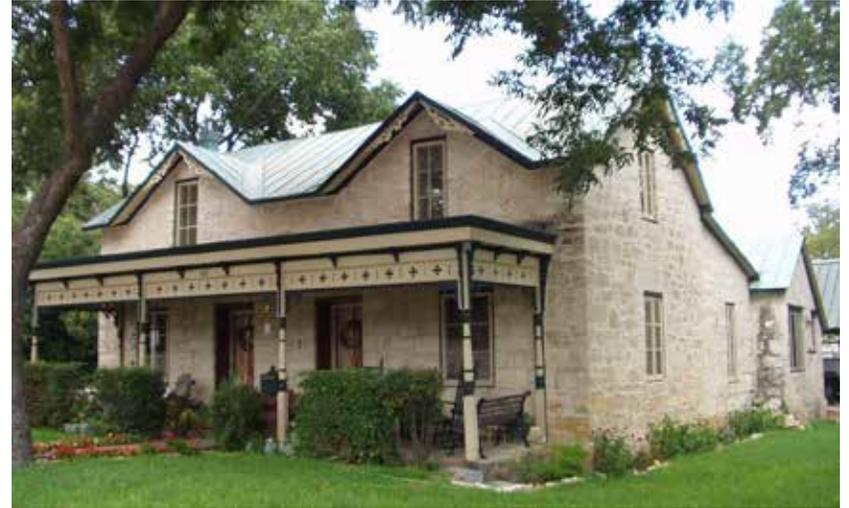
Figure 2-6. Photo of a limestone masonry house at 420 W. Austin Street, featuring peaks in the cornice line to accommodate attic-level windows. Source: HHM 2003 Historic Resources Survey.

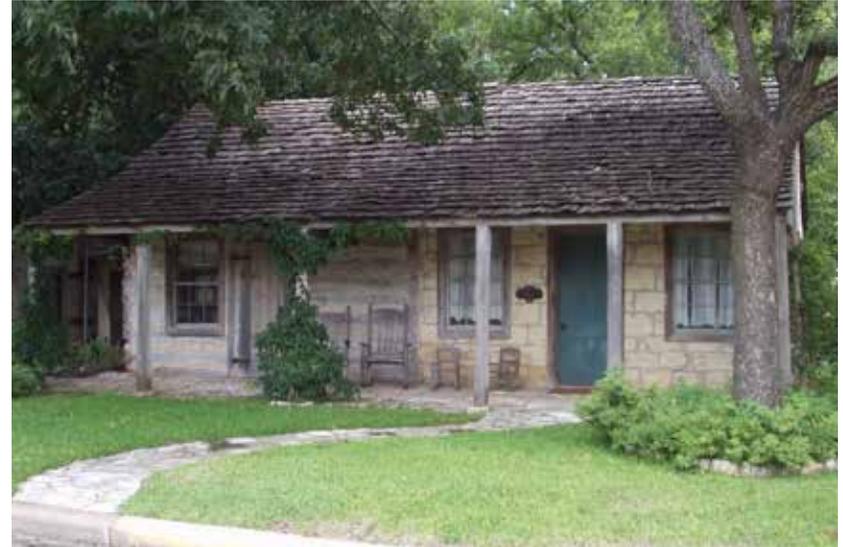
Figure 2-7. Photo of 408 W. Austin Street. The original ca. 1870 mass is the log cabin. Rock portion was added ca.1890. Note the shake roof. Source: HHM 2003-2005 Historic Resources Survey.

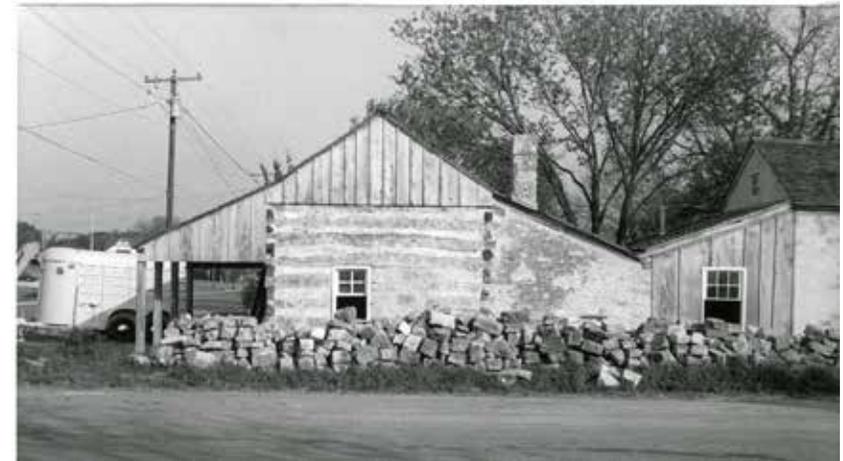
Figure 2-8. Photo of log construction at 517 W. San Antonio Street. Note the wide chinking and limestone masonry rear addition. Source: National Register Nomination, Fredericksburg Historic District, 1983.

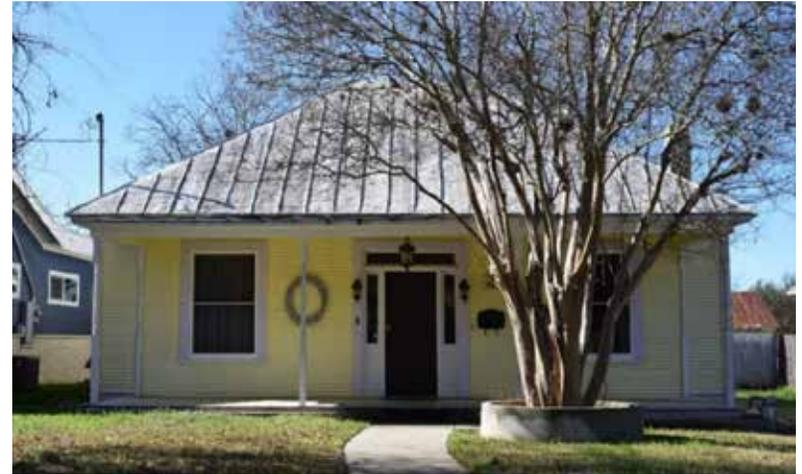
Figure 2-10. Photo of a National Folk house with a hipped-roof square-plan form. Note the horizontal siding, door with transoms, and lack of applied ornament. The turned porch posts likely are not original. Source: HHM, 2020.

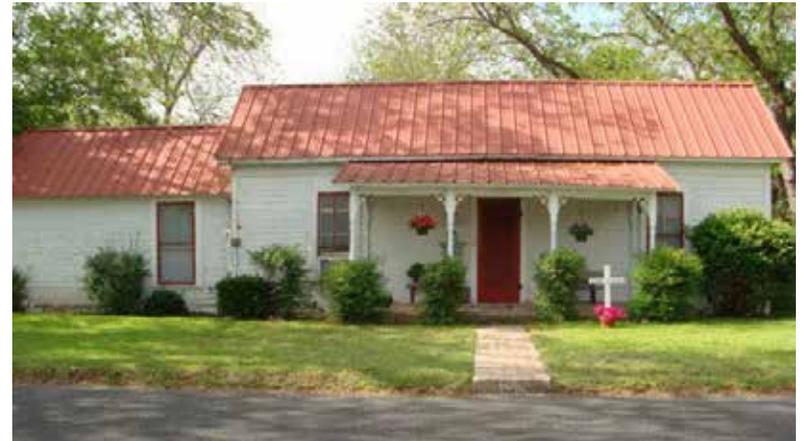
Figure 2-11. Photo of a National Folk house at 609 Apple Street. Note the center-passage plan and fenestration pattern. The porch posts and spindle frieze likely were applied later during the historic period. Source: Realtor.com, accessed April 19, 2020, [https://p.rdcpix.com/v01/173d4b644-m0xd-w1020\\_h770\\_q80.jpg](https://p.rdcpix.com/v01/173d4b644-m0xd-w1020_h770_q80.jpg)

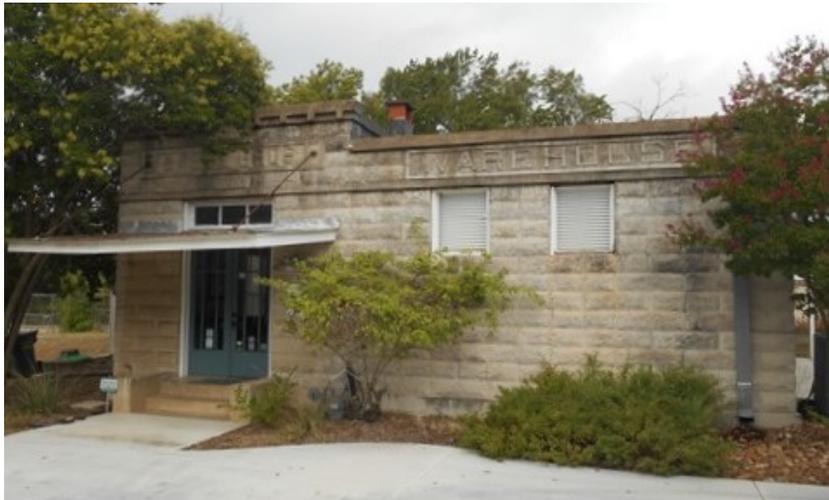
Figure 2-12. Photo of the Basse Warehouse at 304 North Adams Street ca 1919. Source: Michael Barr, “Looking back at: Basse Block,” *Texas Escapes*, accessed January 14, 2021, <http://www.texasescapes.com/MichaelBarr/Basse-Block.htm>.

In the early twentieth century, the trend toward mechanization began to encompass all types of building materials. Cast-concrete blocks were one example of this trend, created using a heavy metal machine that cast uniform blocks and stamped them with textures resembling stone. This allowed builders to replicate the look of traditional stone masonry at a much more affordable price. Two concrete companies in Fredericksburg both produced cast-concrete blocks intended to look like stone: Basse Brothers and the Roos Cement Yard. The Basse Brothers began manufacturing “Basse Blocks” with a Portland cement mixture around 1912. The Roos Cement Yard began manufacturing similar blocks around 1921 at 203 S. Lincoln Street and was operated by Ed Roos and later by his son Marvin until 1964. Although Basse and Roos blocks are nearly indistinguishable, the Roos Blocks can be identified by a small mark that looks like an “L” or a “7.”<sup>2</sup> Roos blocks are also smaller and lighter than Basse. Examples of cast-concrete blocks are shown in figs. 2-12, 2-13, and 2-14.

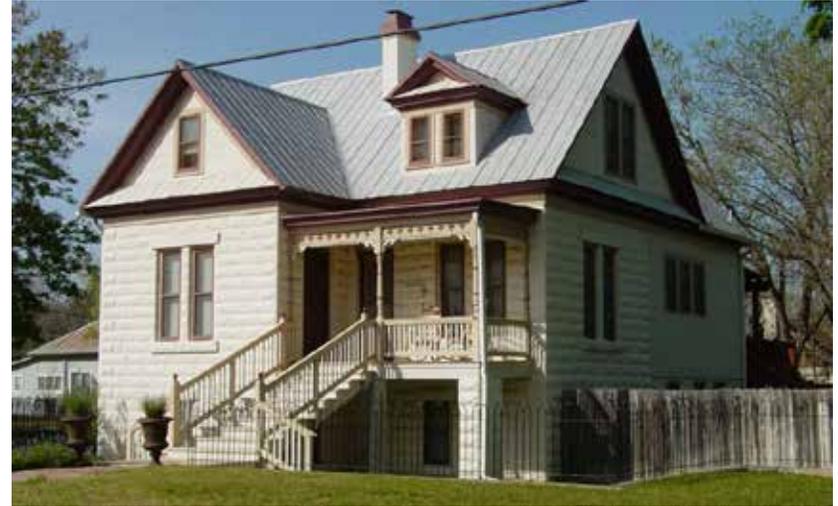
Figure 2-13. Example of Basse Block cast stone block at 112 West College Street. Source: HHM 2003 Historic Resources Survey.

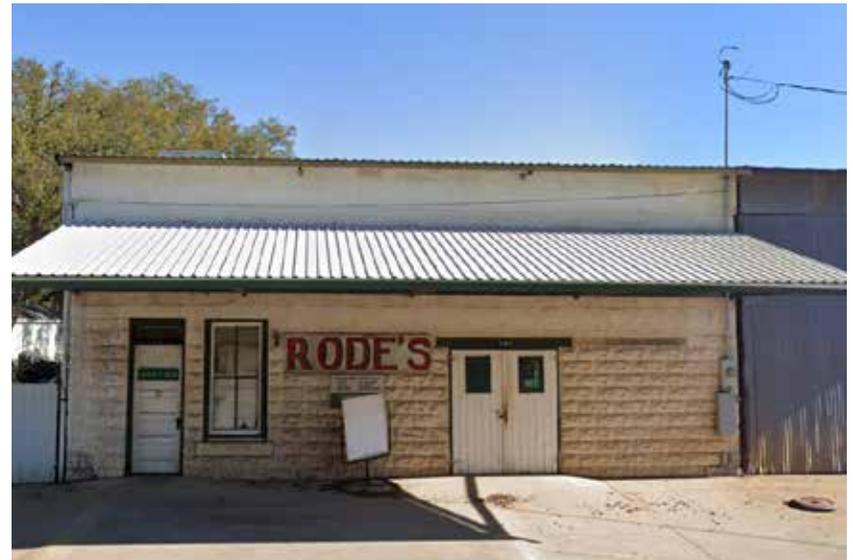
Figure 2-14. Photo of Roos Cement Warehouse at 203 S. Lincoln. Source: Google Street View.

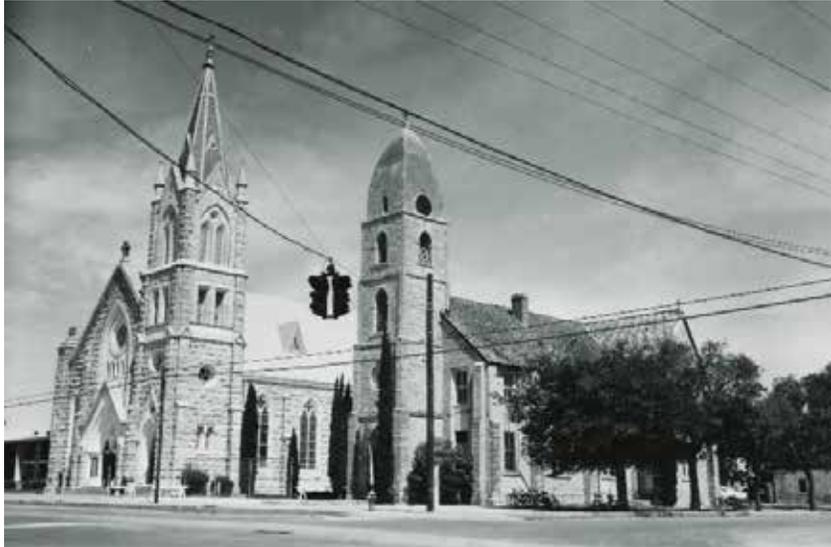
Figure 2-15. (Above) Photo of “Old” St. Mary’s Church, constructed at 302 W. San Antonio Street in 1863 in the Gothic Revival style. Source: National Register Nomination, Fredericksburg Historic District, 1970.

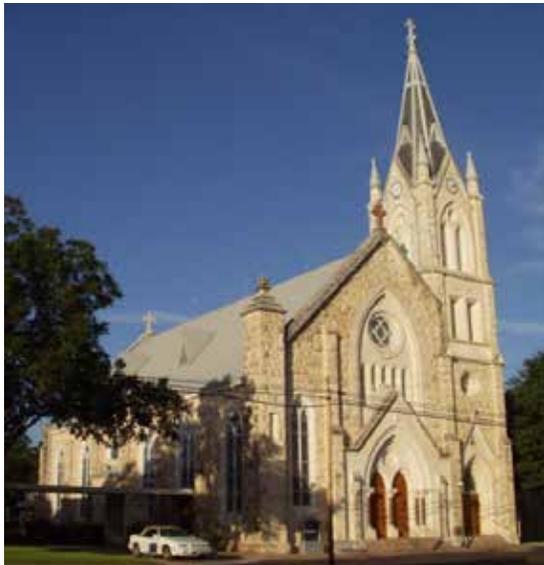
Figure 2-16. (Left) Photo of “New” St. Mary’s Church, constructed at 304 W. San Antonio Street in 1906, also in the Gothic Revival style. The more detailed tracery and larger stained-glass windows communicates the prosperity of second- and third-generation immigrants, while the continued use of the Gothic Revival style and local limestone masonry speaks to the continued sense of connection to the architectural tastes of early immigrants. Source: HHM 2003 Historic Resources Survey.

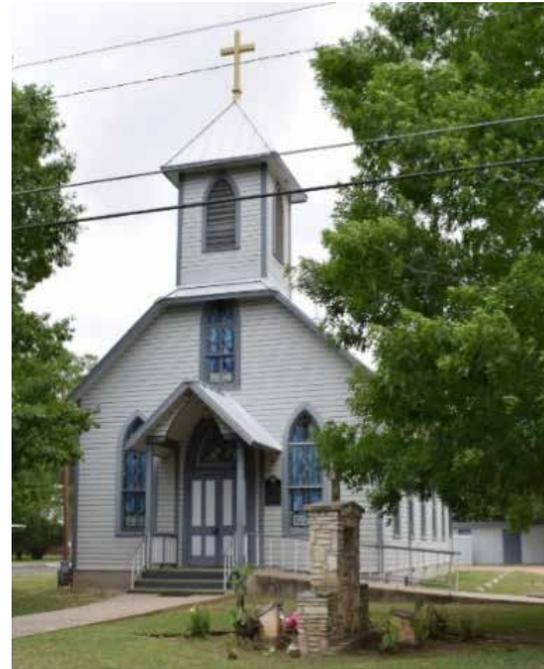
Figure 2-17. (Left) Photo of Our Lady of Guadalupe Church, constructed at 302 E. College Street in 1910 in the Gothic Revival style. The use of wood framing combined with the Gothic Revival style communicates the modest means of this parish, combined with the desire to associate with the style of the larger and more established churches in the community. Source: CMEC 2019 Historic Resources Survey.

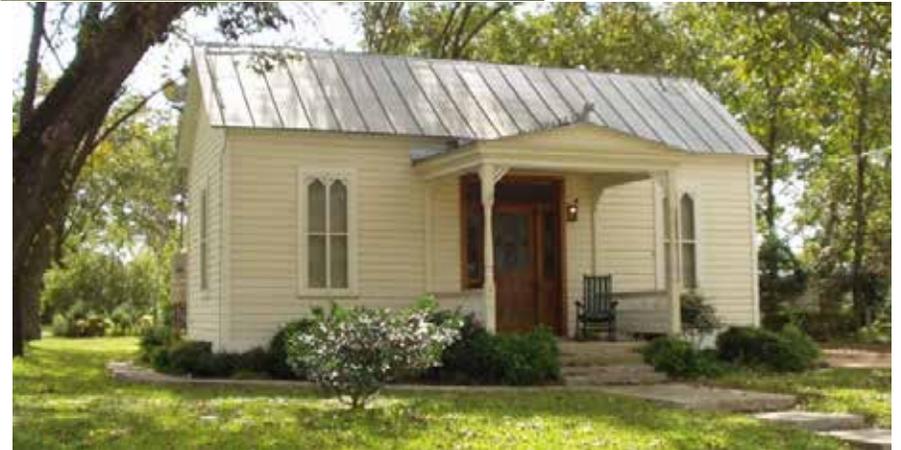
Figure 2-18. (Above) Photo of a Gothic Revival residence at 403 W. Creek Street. Note the Gothic arched window openings and the metal pinnacles at the porch roof’s ridgeline. Source: HHM 2003 Historic Resources Survey.

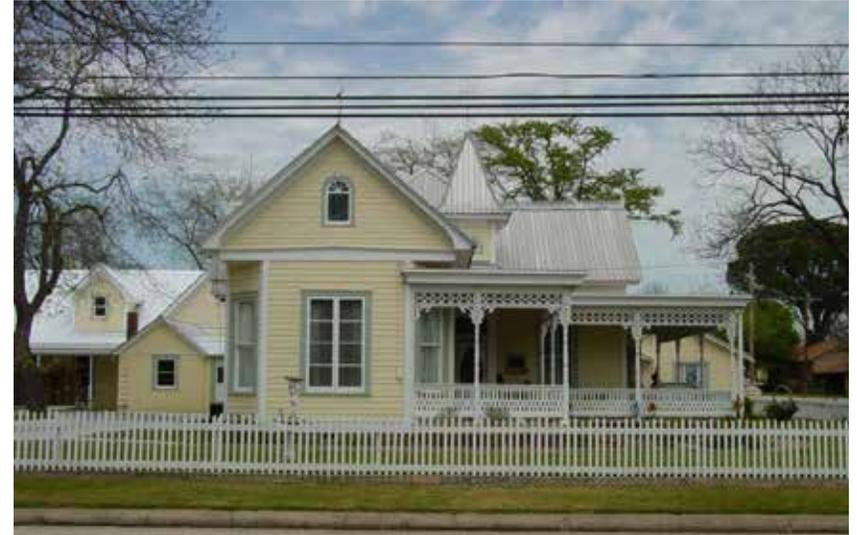
Figure 2-21. Queen Anne house at 302 West Travis Street. Note the bay window at the left. Source: 2002 HHM Historic Resources Survey.

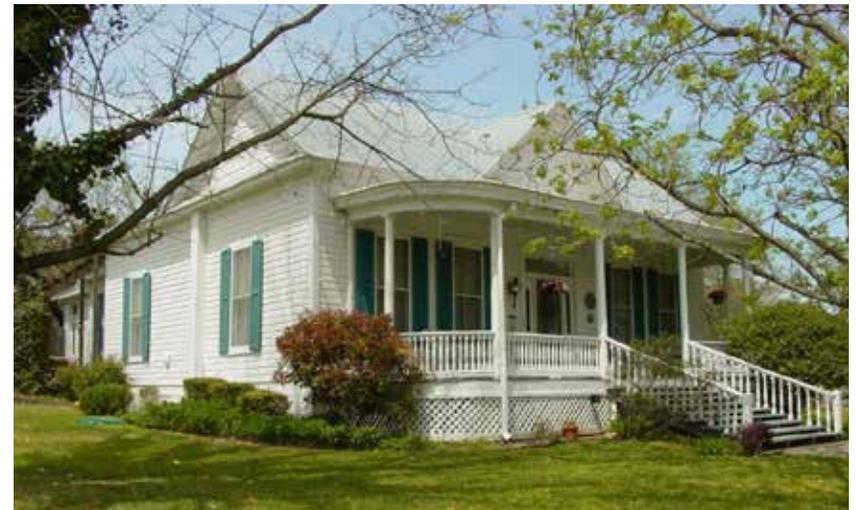
Figure 2-22. Queen Anne style house at 710 Ettie Street. Note the curved porch form and decorative shingles in the gable ends. Source: 2003 HHM Historic Resources Survey.

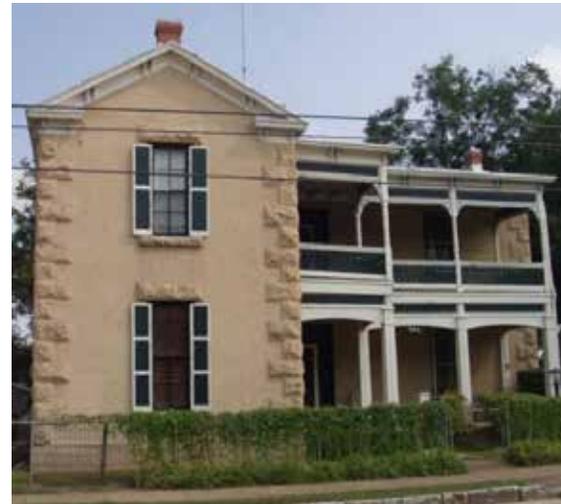
Figure 2-24. Italianate style house at 101 N. Lincoln Street, with quoins at the corners and bracketed eaves. Source: HHM 2003 Historic Resources Survey.

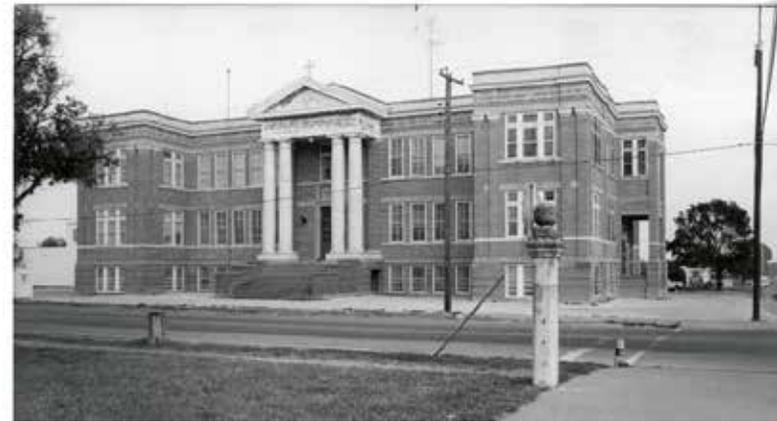
Figure 2-25. Photograph of the Classical Revival school at 214 W. San Antonio Street. Note the stone columns and pediment, inspired by Greek and Roman classical architecture, combined with the brick walls and large banks of grouped windows typical of early-twentieth-century architecture. Source: National Register Nomination, Fredericksburg Historic District, 1983.

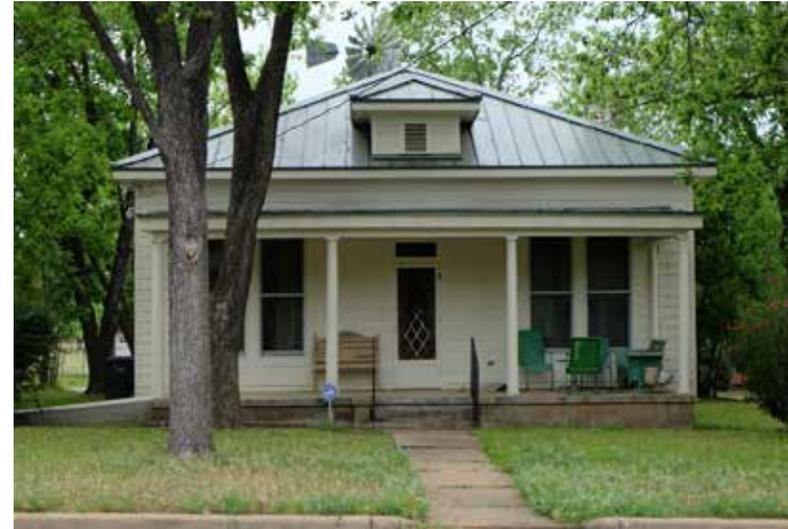
Figure 2-26. Photo of 706 W. Travis Street, illustrating the application of simple classical porch columns on a National Folk hipped-roof square-plan house. Source: CMEC 2019 Historic Resources Survey.

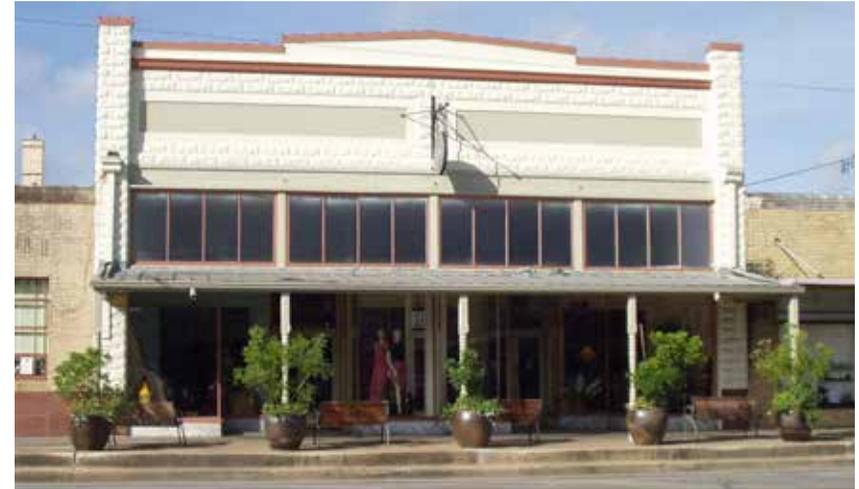
Figure 2-27. A one-part commercial block at 115 E. Main Street in the American Commercial style. Note the wide storefront windows, minimal detailing, and parapet concealing a flat roof behind. Source: HHM 2003 Historic Resources Survey.

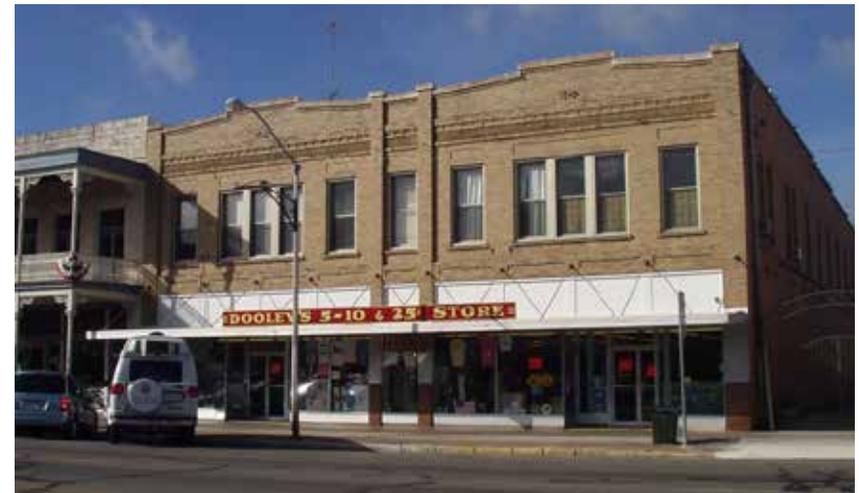
Figure 2-28. A two-part commercial block at 131 E. Main Street in the American Commercial style. Note the wide storefronts, minimal detailing with brick corbelling, and parapet concealing a flat roof behind. Source: HHM 2003 Historic Resources Survey.

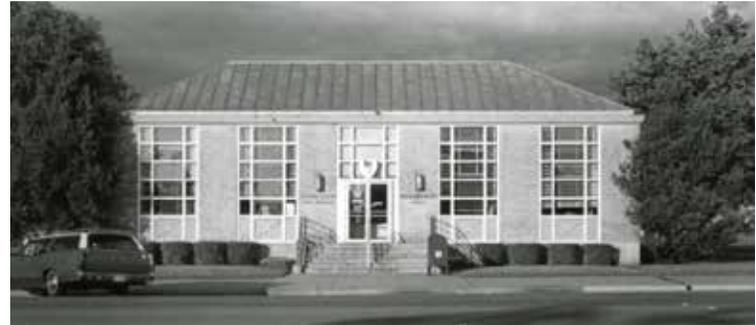
Figure 2-29. Photo of the Post Office at 125 W. Main Street with restrained Art Deco detailing. Source: National Register Nomination, Fredericksburg Historic District, 1983.

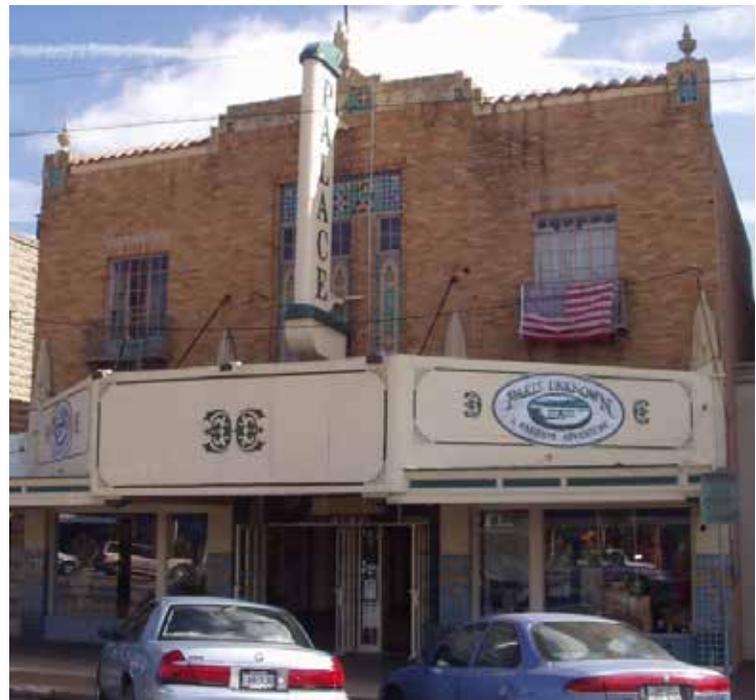
Figure 2-30. Photo of the movie theater at 146 E. Main Street exhibiting bold and colorful Art Deco detailing. Note the geometric tile inlay, geometric tile pinnacle at the parapet, and projecting marquee. Source: HHM 2003 Historic Resources Survey.

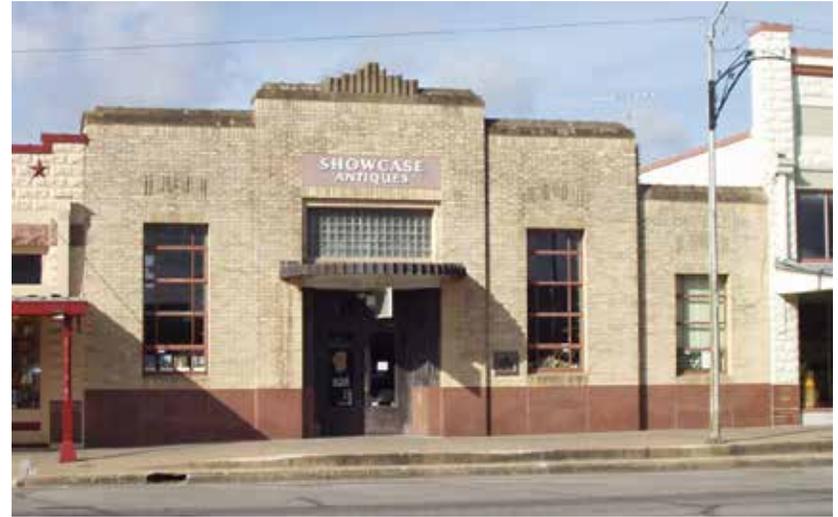
Figure 2-31. Photo of an Art Moderne building at 119 E. Main Street. Note the horizontal emphasis created by the line of stone veneer at the water table, as well as the glass-block transom. Source: HHM 2003 Historic Resources Survey.

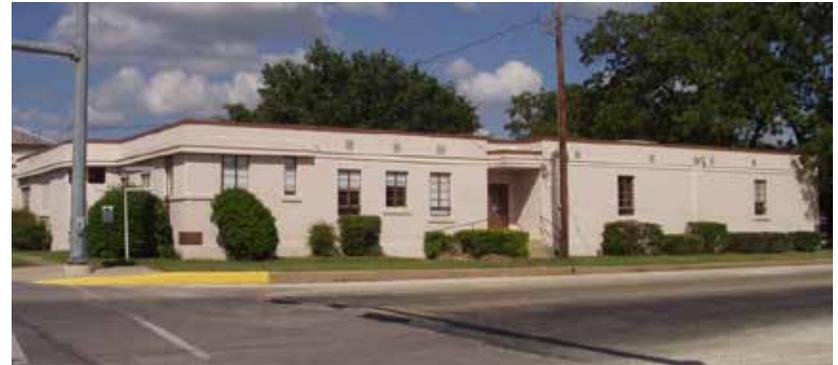
Figure 2-32. Building with Art Moderne stylistic influences at 102 E. San Antonio Street. Note the stucco wall surfaces, horizontal banding, cantilevered awning, and metal casement windows. Source: HHM 2003 Historic Resources Survey.

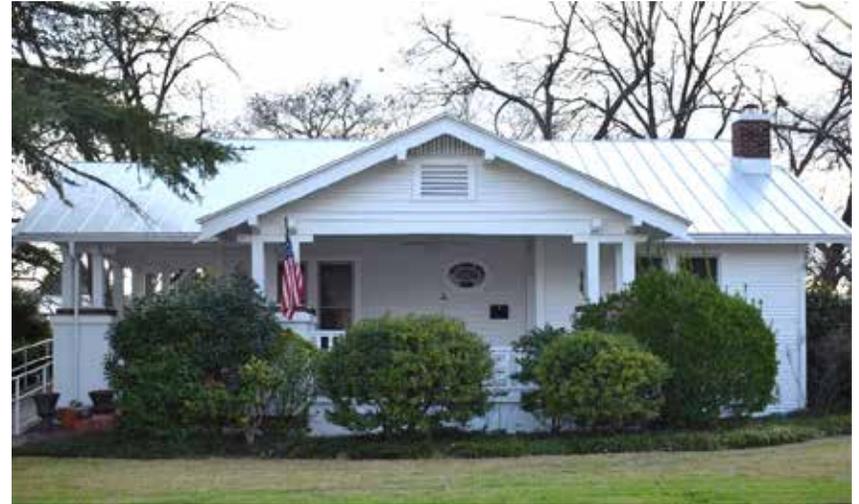
Figure 2-33. Photo of a Craftsman-house. Note the horizontal emphasis with broad eaves and paired windows. Also note the exposed beams and pilasters, exposed to make the building's structure a stylistic feature. Source: HHM, 2020.

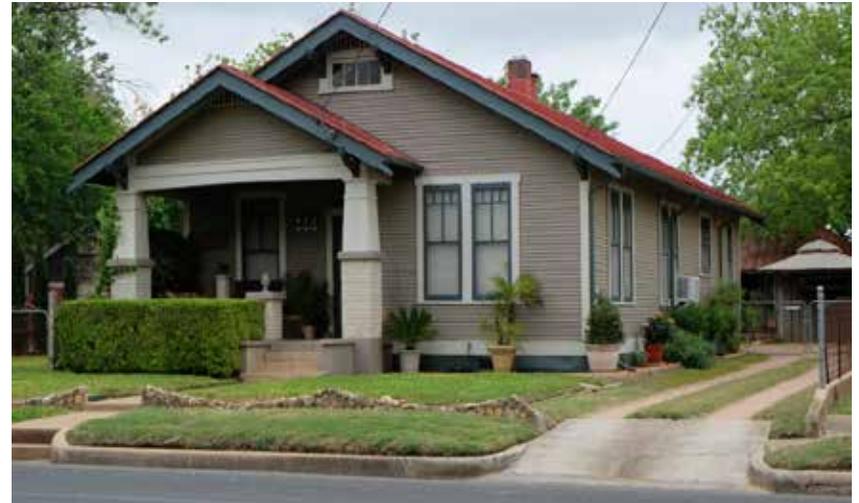
Figure 2-34. Photo of a Craftsman bungalow at 412 S. Milam Street. Note the broad eaves, tapered porch supports, and paired windows with screens with geometric detail. Source: CMEC 2019 Historic Resources Survey.

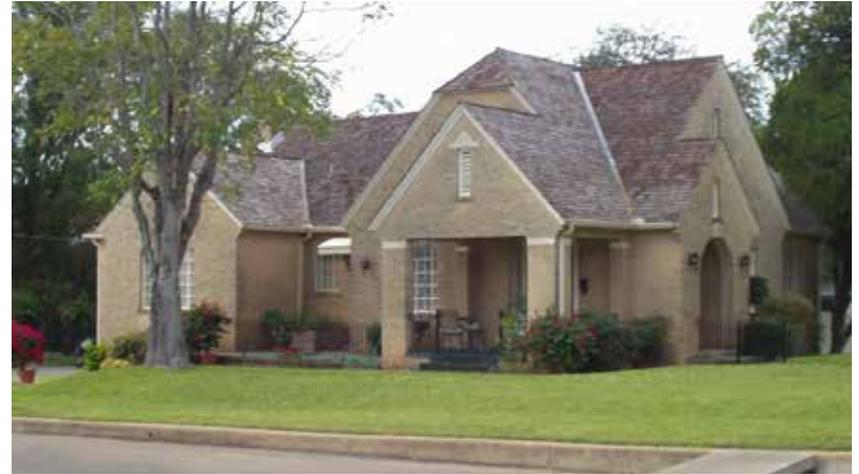
Figure 2-35. Tudor Revival house at 401 W. San Antonio Street. Note the round-arched door opening and heavy wrought-iron lighting and hardware. Source: HHM 2003 Historic Resources Survey.

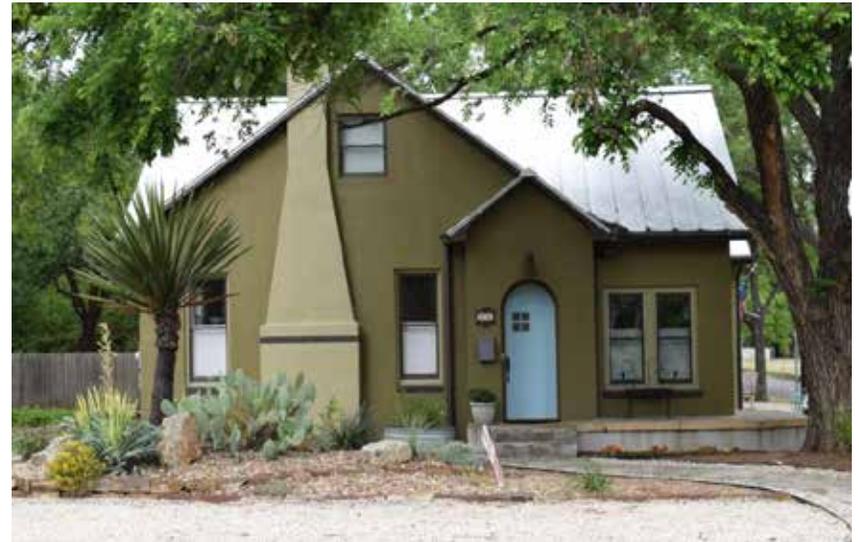
Figure 2-36. Example of a stucco Tudor Revival house at 306 E. Orchard Street. Note the use of the bungalow form with Tudor Revival stylistic details like its round-arched door and broad, tapered chimney. Source: CMEC 2019 Historic Resources Survey.

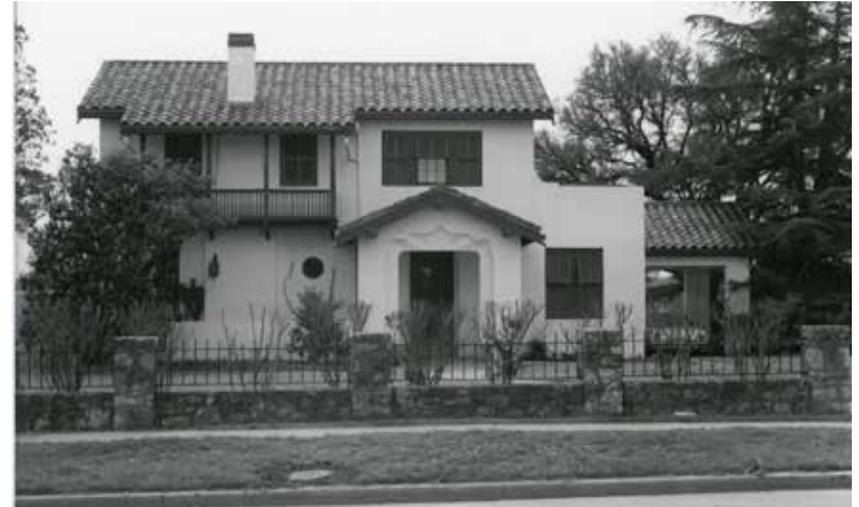
Figure 2-37. Residential example of the Spanish Colonial Revival style at 403 E. Main Street. Note the stucco surface, balcony with turned wood balusters, clay tile roof, and broad stucco chimney with tile caps. Source: Fredericksburg Local Historic District Designation, 1985.

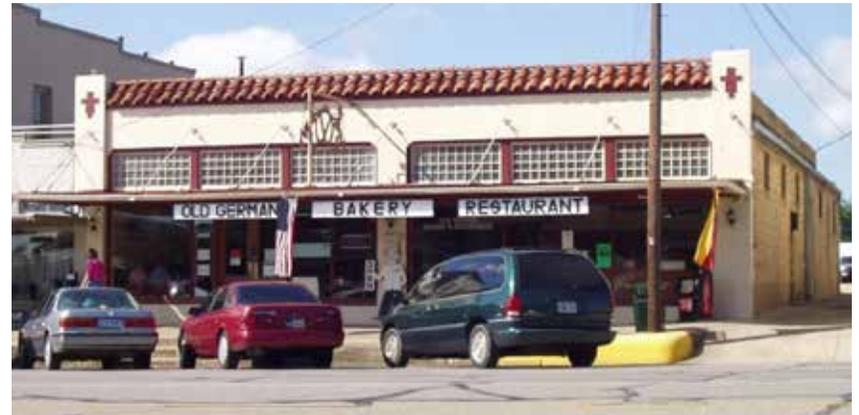
Figure 2-38. One-part commercial block at 225 W. Main Street with Spanish Colonial Revival stylistic influences. Note the stucco façade surface, tile inlay detailing, and clay tile at the parapet. Source: HHM 2003 Historic Resources Survey.
