# City of Fredericksburg Historic District Design Guidelines & Standards

Fredericksburg, Gillespie County, Texas  
Final Draft Adopted July 19, 2021

Prepared for  
The City of Fredericksburg

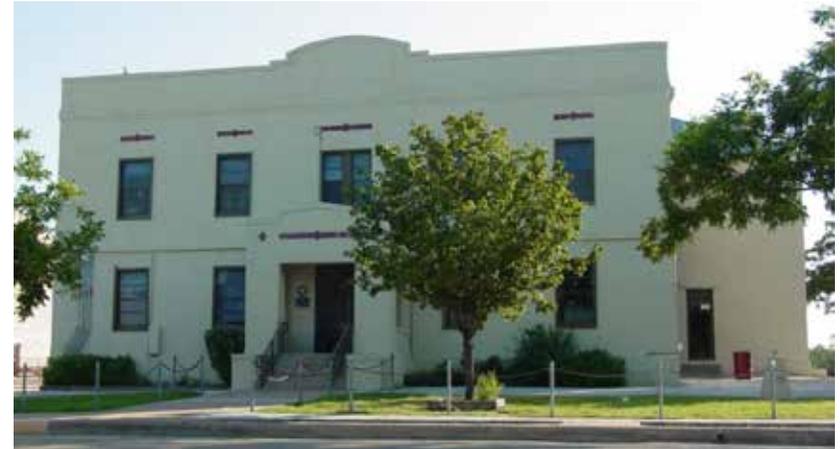
Figure 2-39. Example of a Mission Revival school at 110 E. Travis Street. Note stucco wall surfaces, tile inlay, and molded parapets. Source: HHM 2003 Historic Resources Survey.

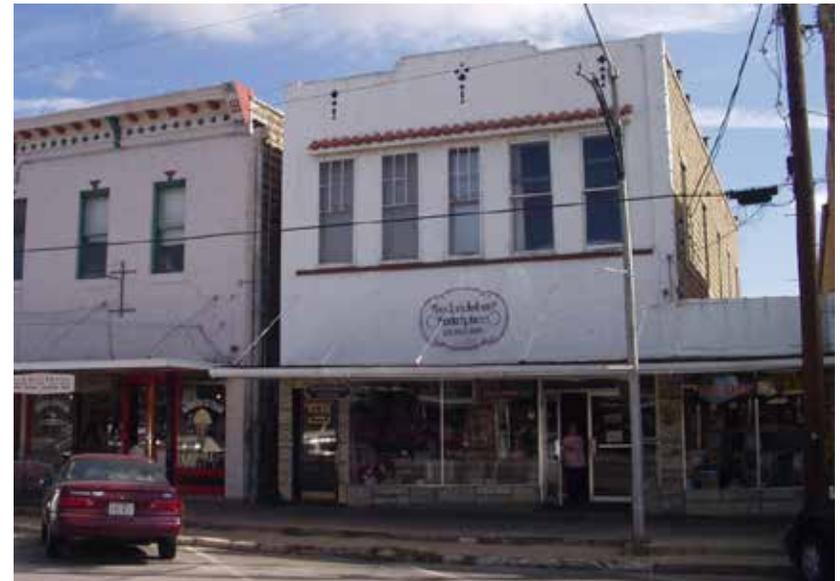
Figure 2-40. Mission Revival commercial building at 142 E. Main Street. Note the stucco wall surface, tile inlay, clay tile awning, and molded parapet. Source: HHM 2003 Historic Resources Survey.

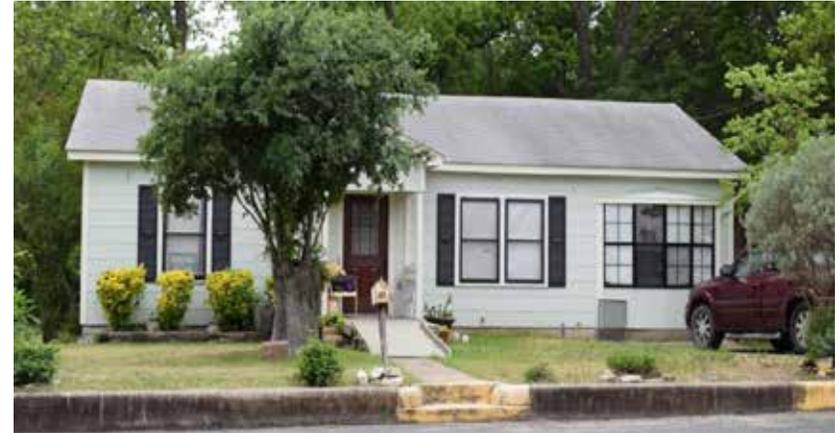
Figure 2-41. Minimal Traditional house at 308 E. Austin Street featuring asbestos shingle siding, a minimal porch, and shutters. Note enclosed attached garage at the right. Source: CMEC 2019 Historic Resources Survey.

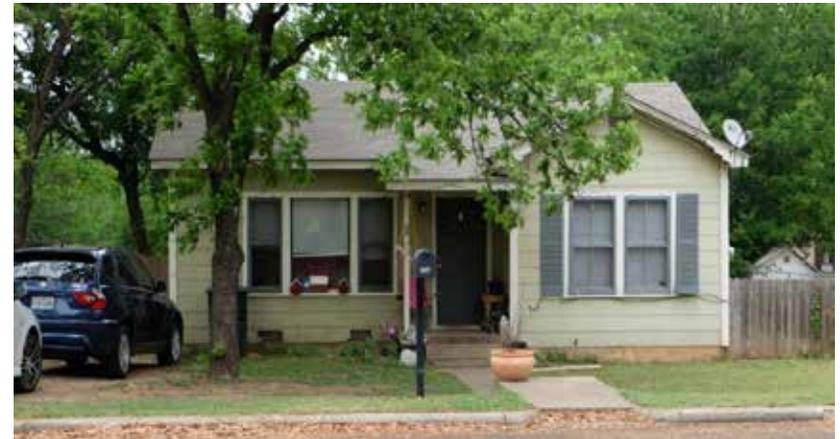
Figure 2-42. Minimal Traditional house at 104 W. Park Street with bungalow form, as well as asbestos shingle siding, wood shutters, and a minimal porch. Source: CMEC 2019 Historic Resources Survey.

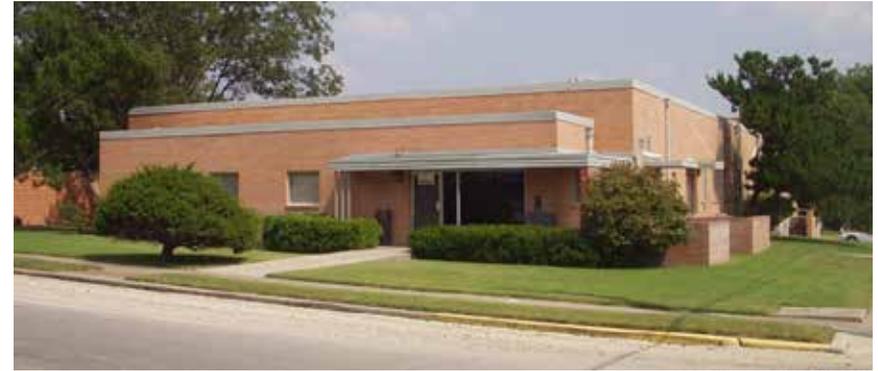
Figure 2-43. Midcentury Modern building at 109 S. Llano Street. Note the unadorned wall surface, flat roof, and flat-roofed porch supported by slender metal columns. Source: HHM 2003 Historic Resources Survey.

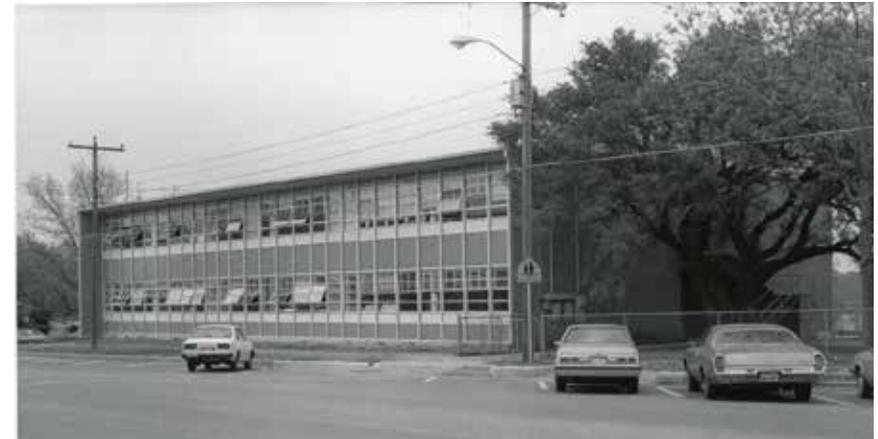
Figure 2-44. Midcentury Modern school at 2020 S. Orange Street. Note the flat roof, unadorned wall surfaces, and horizontal ribbons of metal hopper windows. Source: National Register Nomination, Fredericksburg Historic District, 1983.

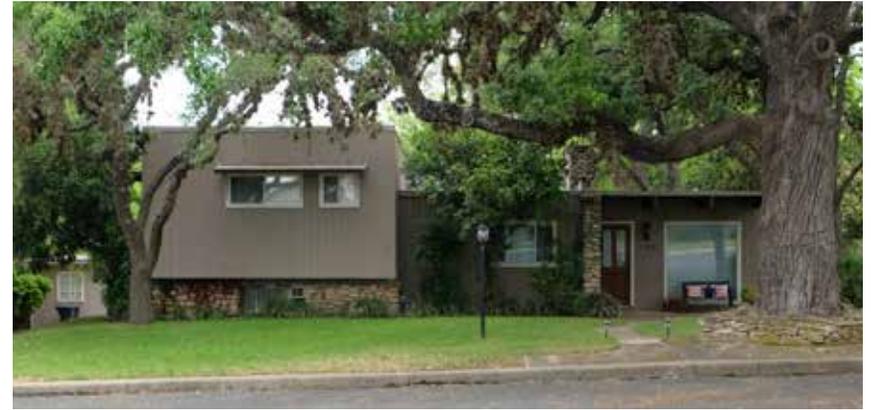
Figure 2-45. Contemporary house at 709 W. San Antonio Street. Note the deep overhanging eaves and bold, broad chimney. Source: CMEC 2019 Historic Resources Survey.

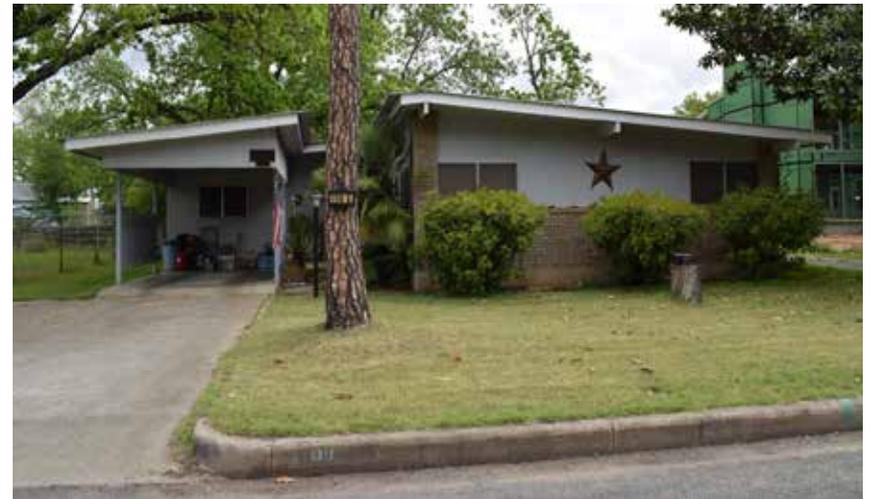
Figure 2-46. Contemporary house at 110 E. Centre Street. Note the bold asymmetrical roof form, deep eaves, and integrated carport. Source: CMEC 2019 Historic Resources Survey.

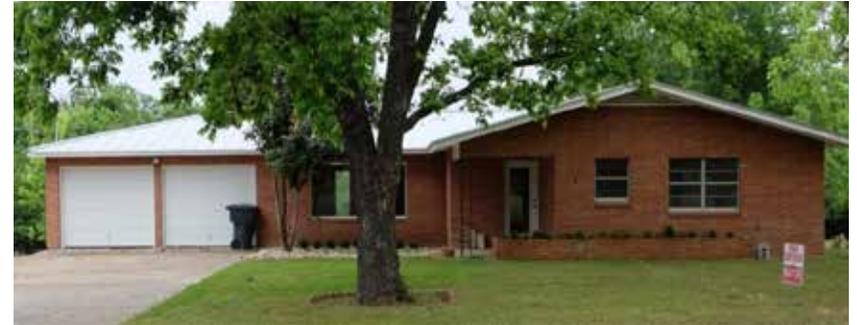
Figure 2-47. Ranch residence at 413 S. Orange Street. Note the broad eaves, integrated planter, wrought-iron porch supports, and attached garage. Source: CMEC 2019 Historic Resources Survey.

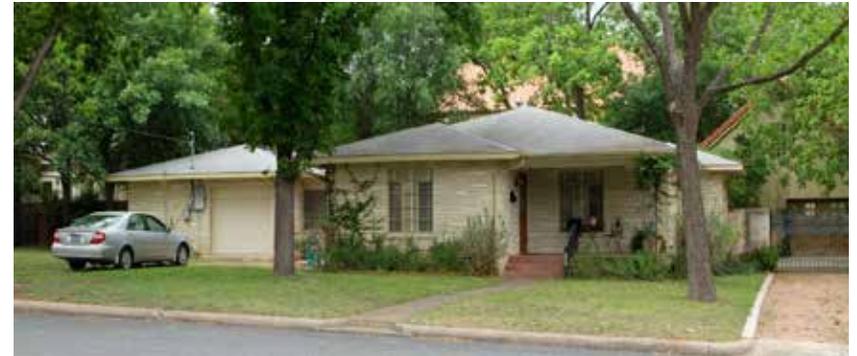
Figure 2-48. House with Ranch stylistic influences at 708 W. Schubert Street. Note the narrow flagstone emphasizing horizontality, the wrought-iron porch support, the metal casement windows, and the attached garage. Source: CMEC 2019 Historic Resources Survey.

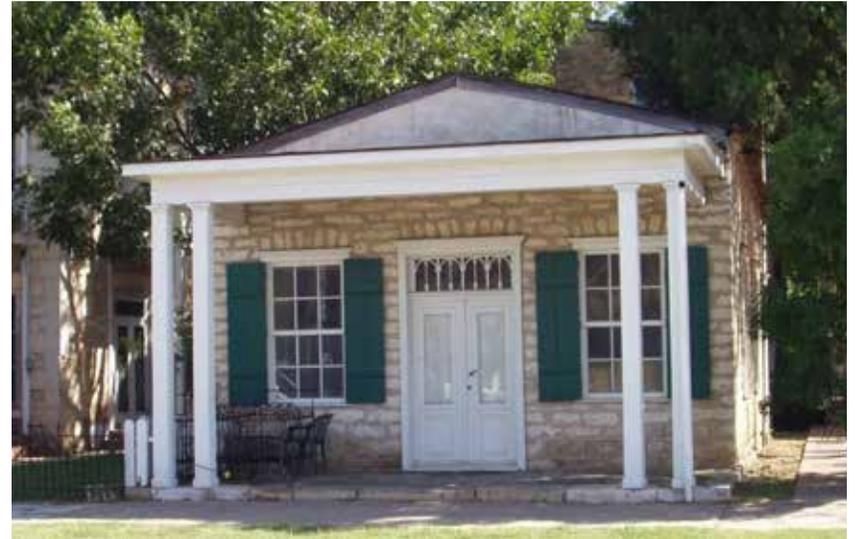
Figure 2-49. Example of a single-room-width house at 254 E. Main Street. Source: HHM 2003 Historic Resources Survey.

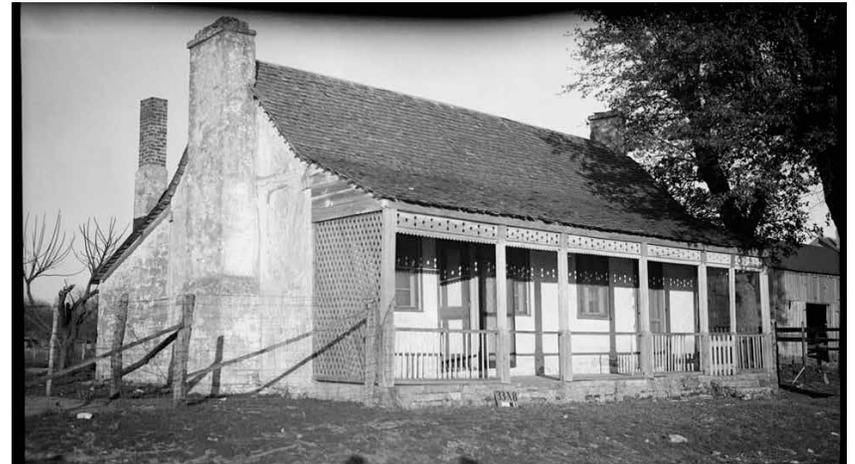
Figure 2-50. Example of a reported “Sunday House” not following the standard single-room width, documented by HABS ca. 1933, located at 512 W. Creek Street. Source: Library of Congress, <https://www.loc.gov/item/tx0333/>.

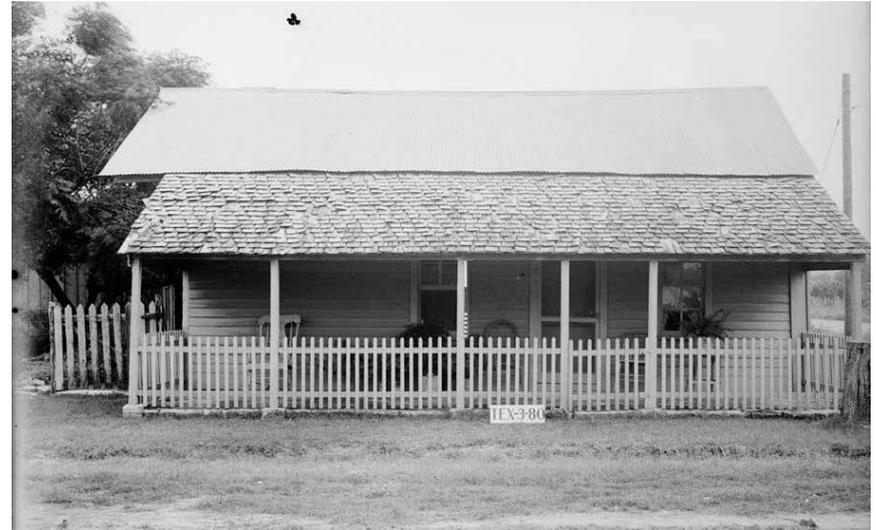
Figure 2-51. HABS photograph of a hall-and-parlor form house at Creek & Bowie Streets, ca. 1933. Source: Library of Congress, <https://www.loc.gov/item/tx0337/>.

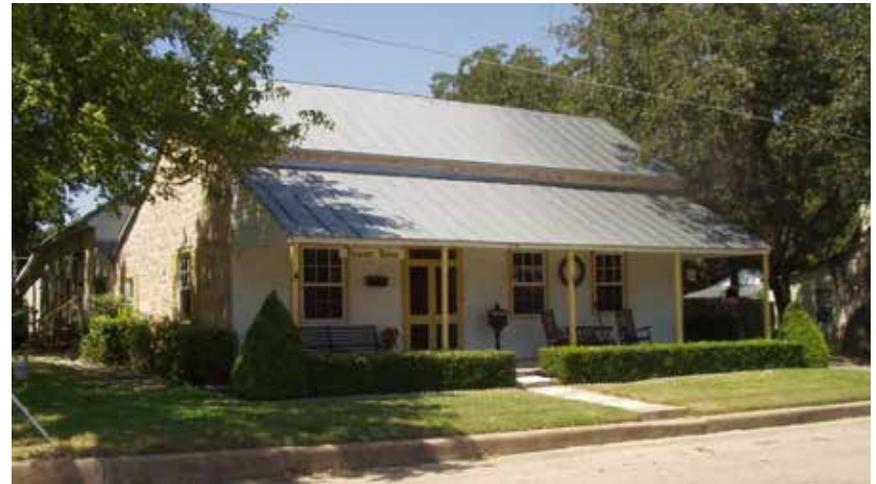
Figure 2-52. A one-and-a-half story variation of the hall-and-parlor form at 108 N. Acorn Street. Note the front porch and rear addition. Source: HHM 2003 Historic Resources Survey.

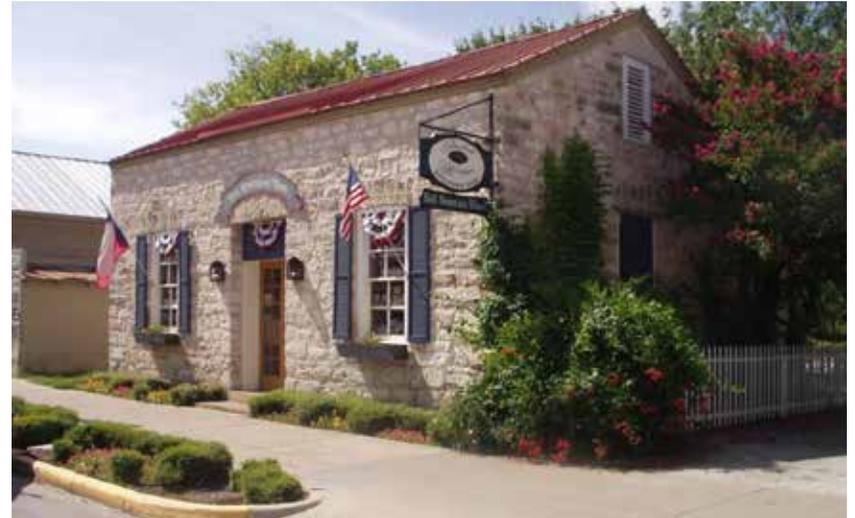
Figure 2-53. Example of a center-passage house at 315 E. Main Street.  
Source: HHM 2003 Historic Resources Survey.

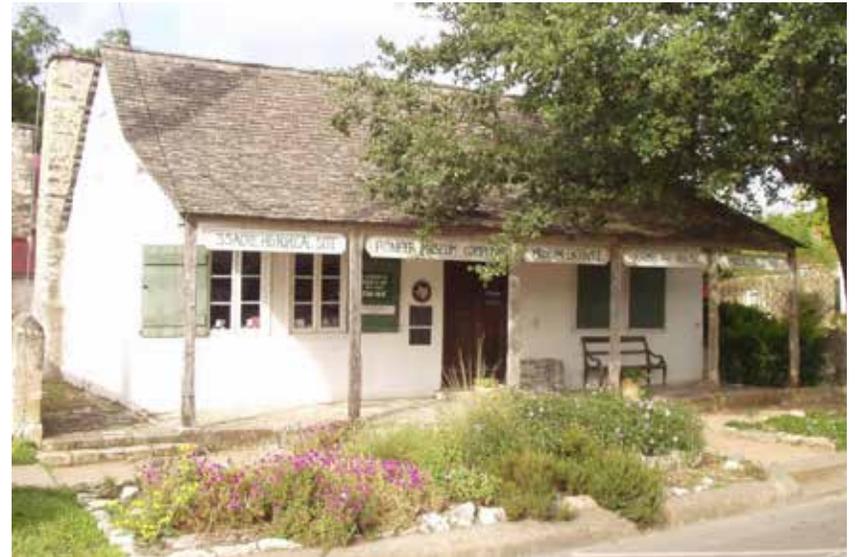
Figure 2-54. Example of a center-passage house at 309 W. Main Street.  
Source: HHM 2003 Historic Resources Survey.

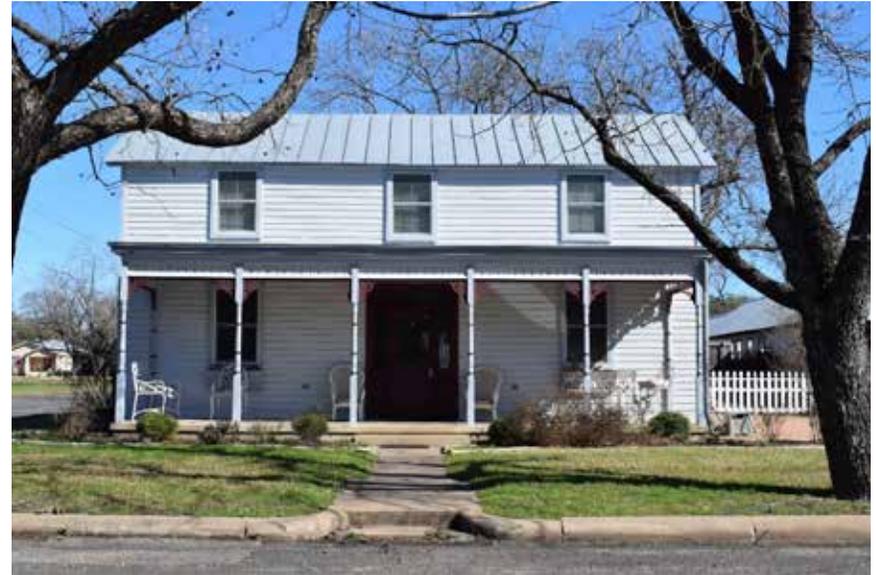
Figure 2-55. Example of a wood-frame I-house. Source: HHM, 2020.

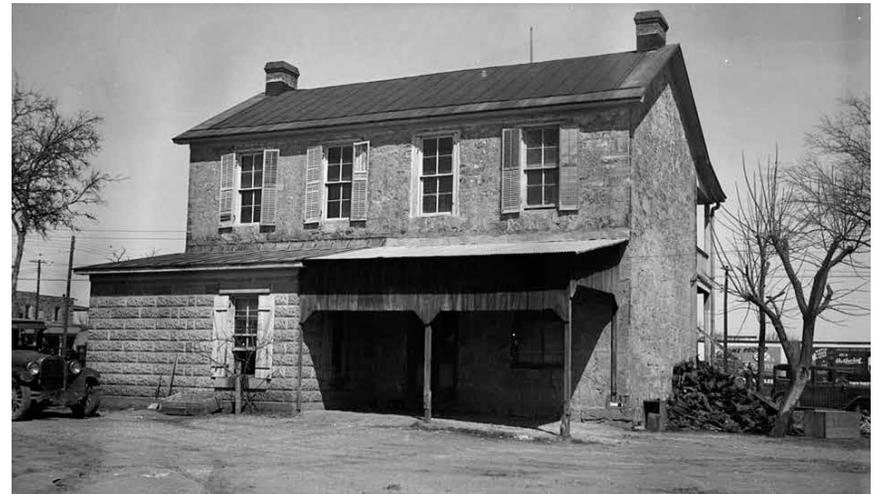
Figure 2-56. Example of a masonry I-house with stucco veneer at Main and Crockett Streets, documented by HABS ca. 1933. Source: Library of Congress, <https://www.loc.gov/item/tx0332/>.

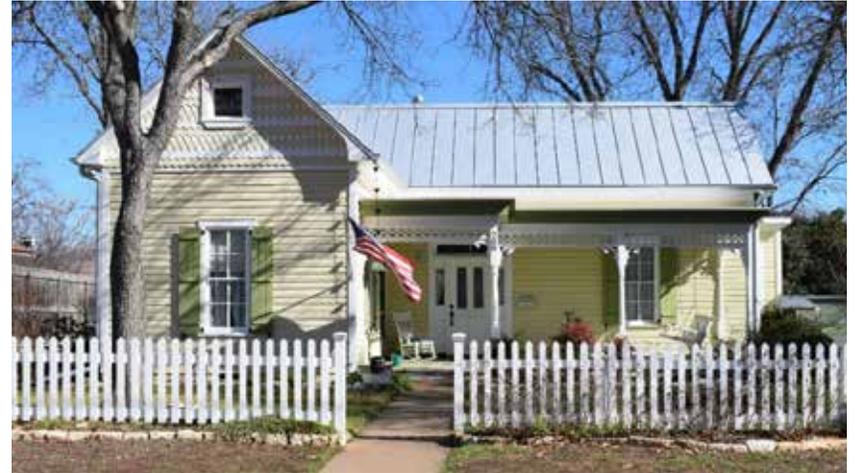
Figure 2-57. Example of a one-story L-plan house. Source: HHM, 2020.

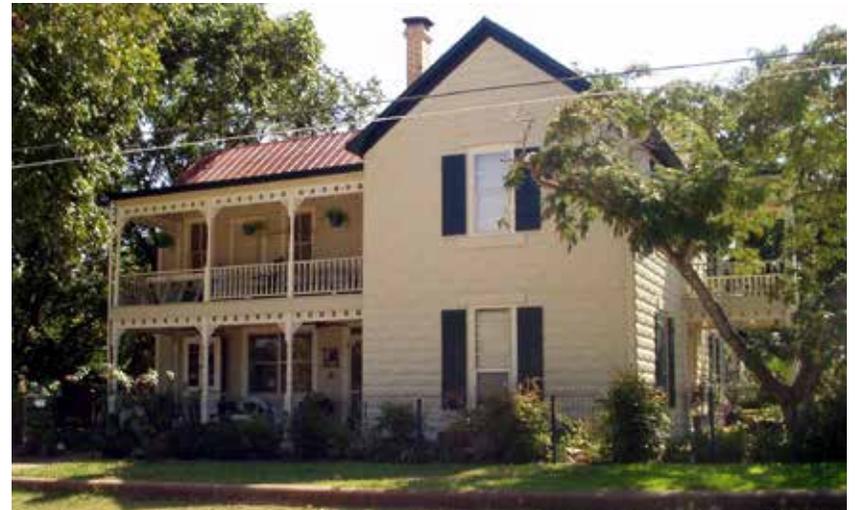
Figure 2-58. Example of a two-story L-plan house at 209 N. Bowie Street. Source: HHM 2003 Historic Resources Survey.

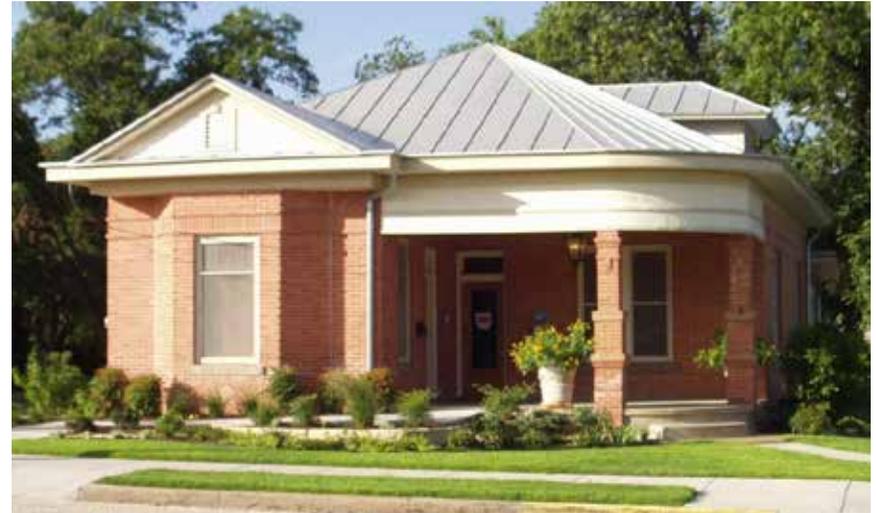
Figure 2-59. Brick modified L-plan house at 116 E. Austin Street. Note the gable-on-hip roof form. Source: HHM 2003 Historic Resources Survey.

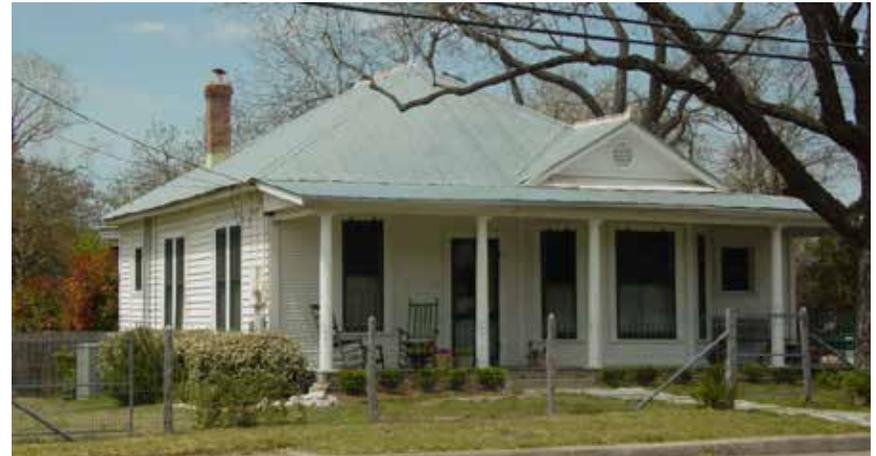
Figure 2-60. Wood-frame modified L-plan house at 102 S. Cherry Street. Note the gable-on-hip roof form and the bay window. Source: HHM 2003 Historic Resources Survey.

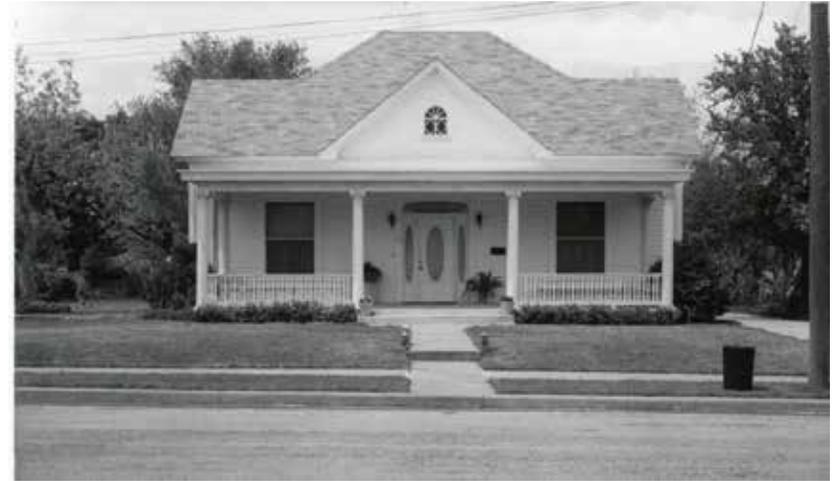
Figure 2-61. Example of a hipped-roof square-plan house at 206 N. Bowie Street. Note the high roof pitch and Classical Revival stylistic influences. Source: National Register Nomination, Fredericksburg Historic District, 1983.

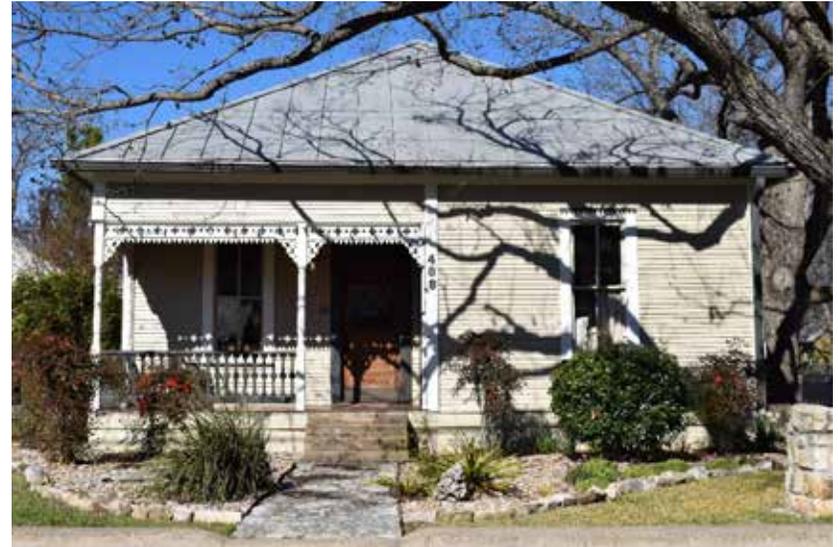
Figure 2-62. Example of a hipped-roof square-plan house. Note the porch recessed under the main roof form. Source: HHM, 2020.

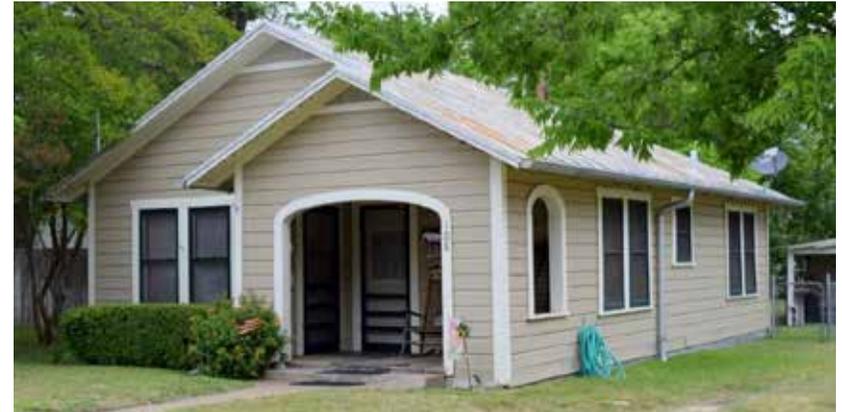
Figure 2-63. Example of a wood-frame bungalow with a front-gabled roof at 108 W. College Street. Note that the porch is both projecting *and* recessed, with the front wall leading into the living room set back slightly further than the main front wall. Source: CMEC 2019 Historic Resources Survey.

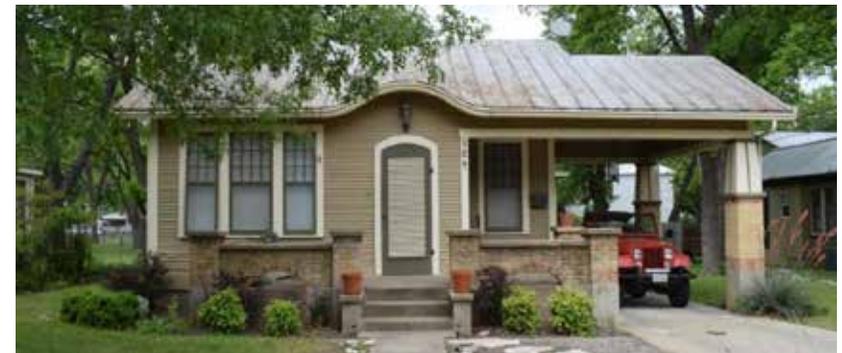
Figure 2-64. Example of a wood-frame bungalow with a side-gabled roof at 304 E. Orchard Street. Source: CMEC 2019 Historic Resources Survey.

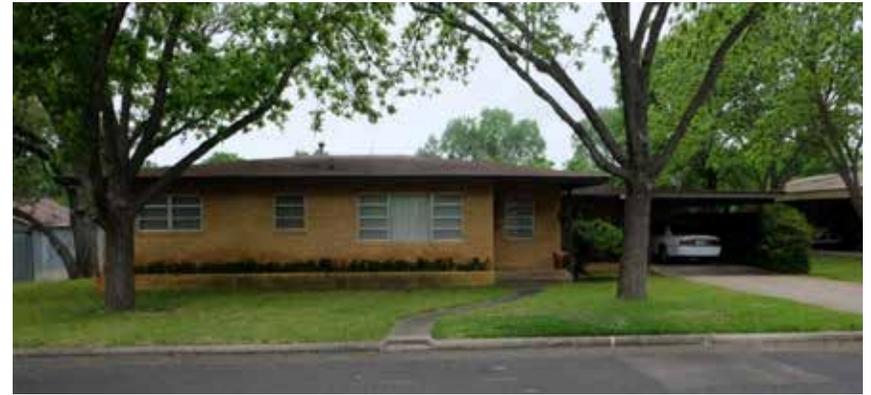
Figure 2-65. Ranch house at 303 Fulton Street. Note the horizontal orientation, minimal porch, and integrated carport. Source: CMEC 2019 Historic Resources Survey.

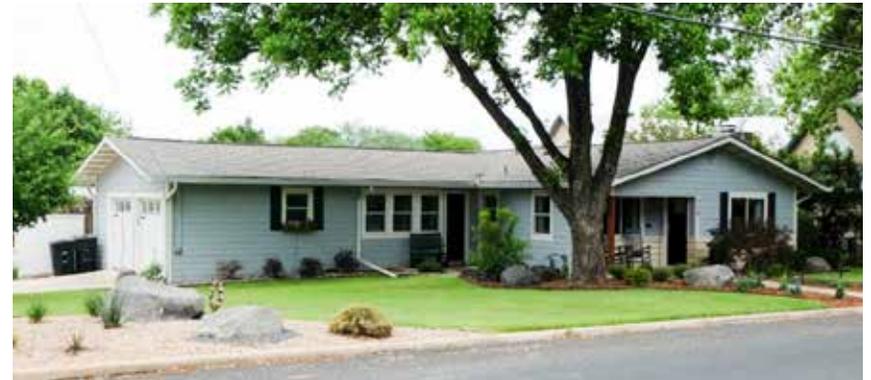
Figure 2-66. Example of the Ranch house form at 714 W. Travis Street. Note the attached garage. Source: CMEC 2019 Historic Resources Survey.

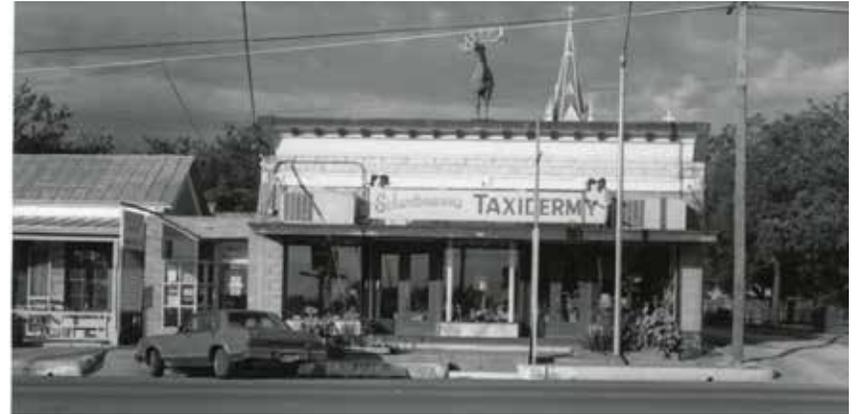
Figure 2-67. Example of a one-part commercial block at 303 W. Main Street. Source: National Register Nomination, Fredericksburg Historic District, 1983.

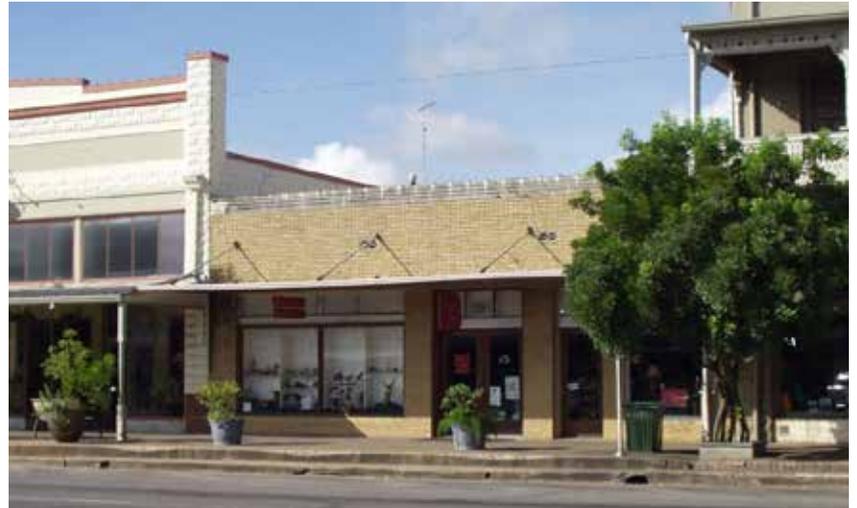
Figure 2-68. Example of a one-part commercial block at 113 E. Main Street. Source: HHM 2003 Historic Resources Survey.

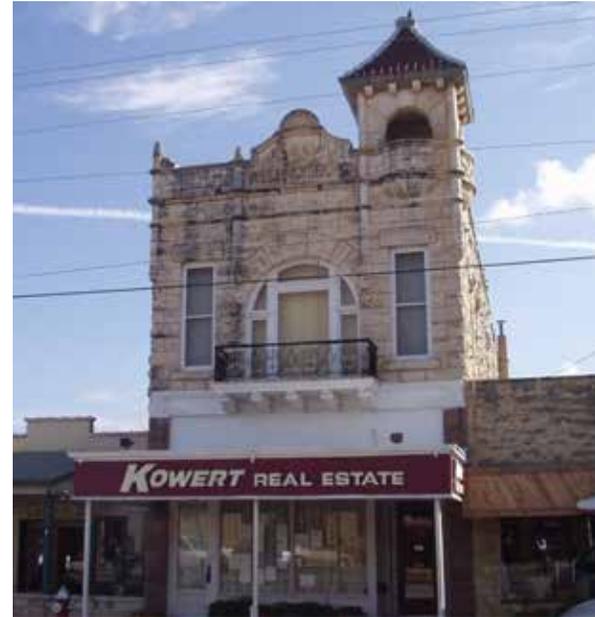
Figure 2-69. Two-part commercial block at 118–120 E. Main Street. Note the distinct fenestration pattern on the upper floor. Source: HHM 2003 Historic Resources Survey.

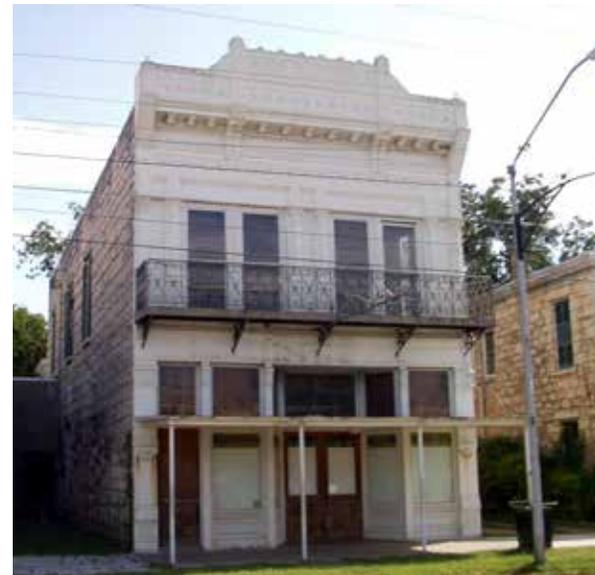
Figure 2-70. Two-part commercial block at 248 E. Main Street. Note the single-door entrance at the far left, leading to the separate office space on the upper floor. Source: HHM 2003 Historic Resources Survey.

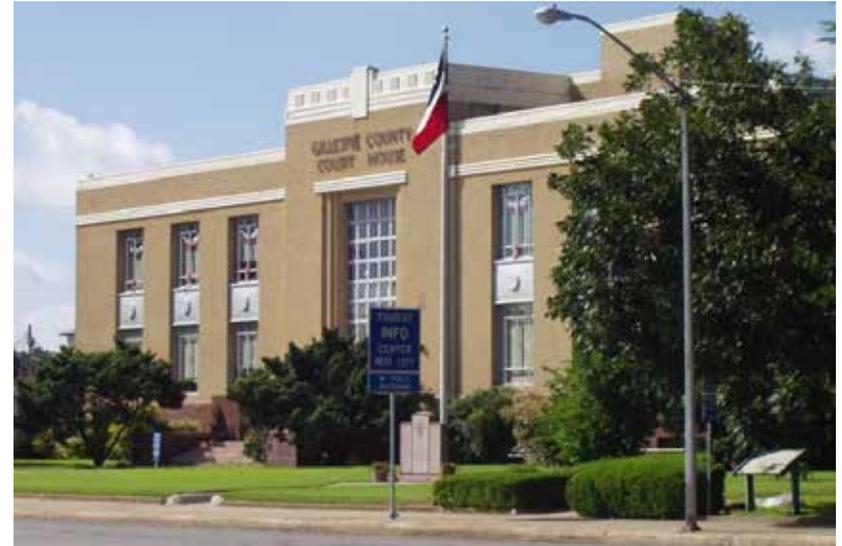
Figure 2-71. County courthouse at 101 W. Main Street, exemplifying the central-block-with-wings form. Note that the central wing is slightly taller, with bold ornamentation at the central door surround. Also note the division of the façade into three horizontal bands. Source: HHM 2003 Historic Resources Survey.

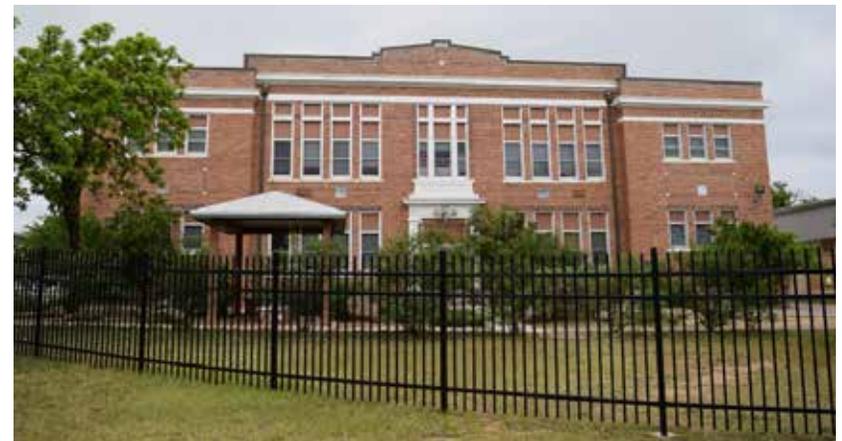
Figure 2-72. Fredericksburg High School at 110 W. Travis Street, also displaying the central-block-with-wings form, including a taller central mass, a central main entrance, and horizontal bands dividing the façade. Source: CMEC 2019 Historic Resources Survey.

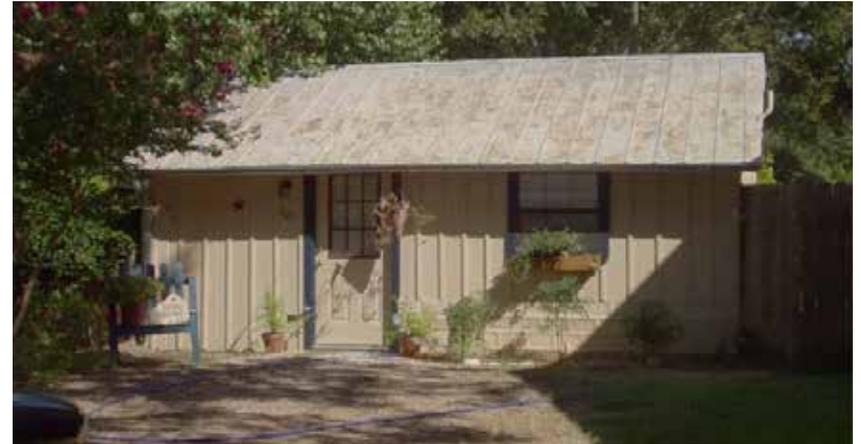
Figure 2-73. Example of a backhouse constructed around 1900 at 205 (rear) S. Bowie Street. Source: HHM 2003 Historic Resources Survey.

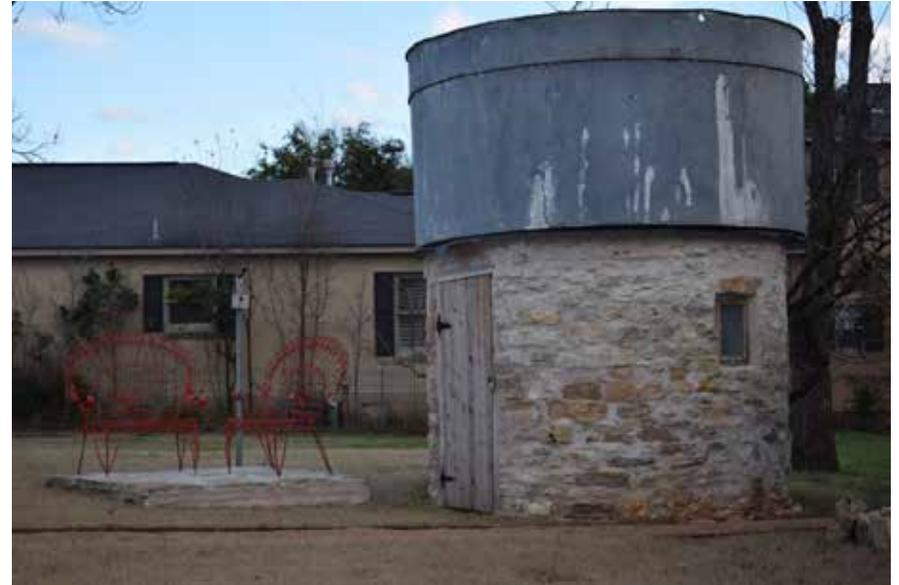
Figure 2-74. Example of an elevated cistern. Source: HHM, 2020.

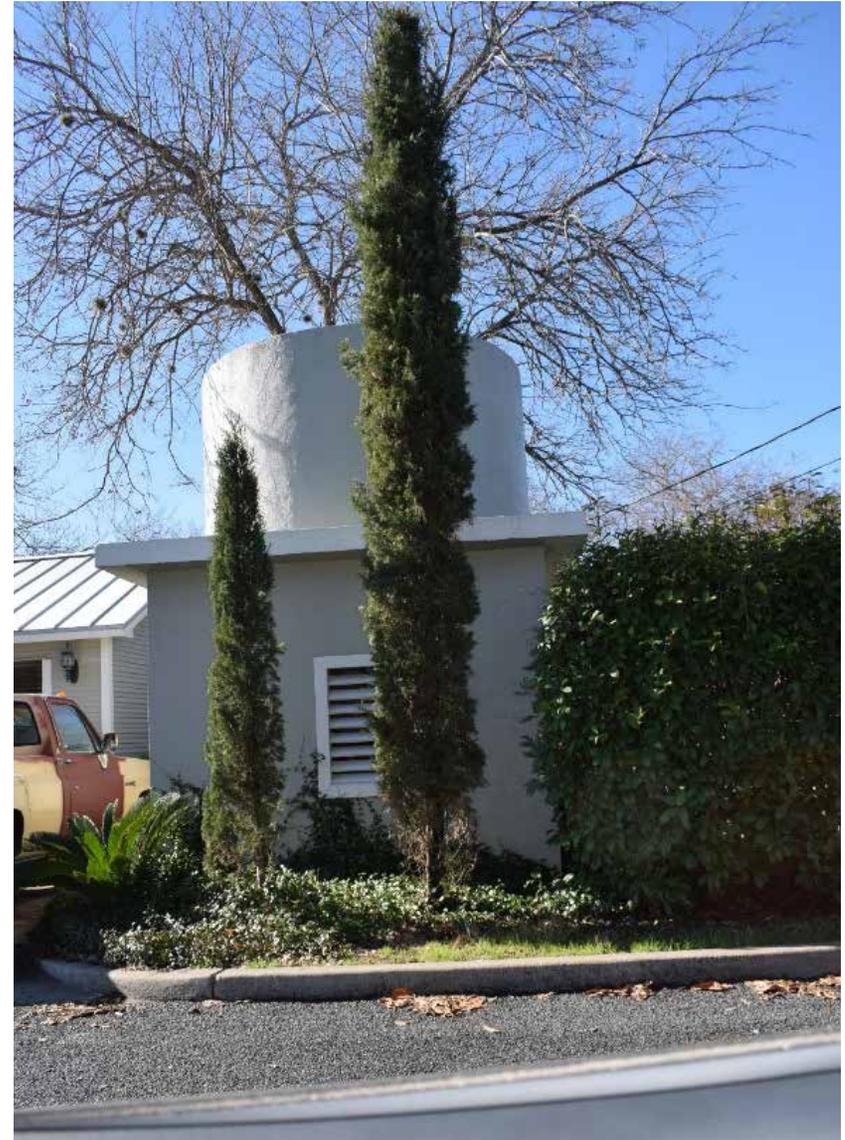
Figure 2-76. Example of a tank house. Source: HHM, 2020.

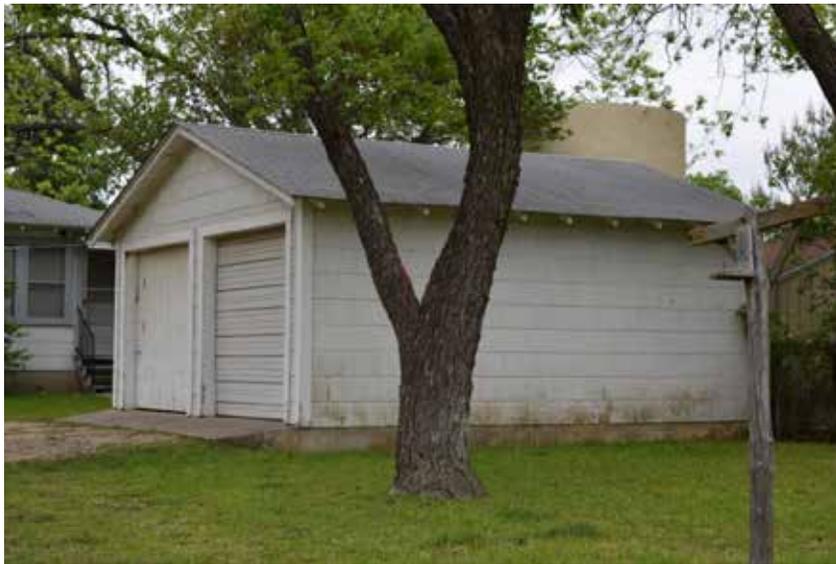
Figure 2-77. Example of a garage at 212 W. College Street. Source: CMEC 2019 Historic Resources Survey.

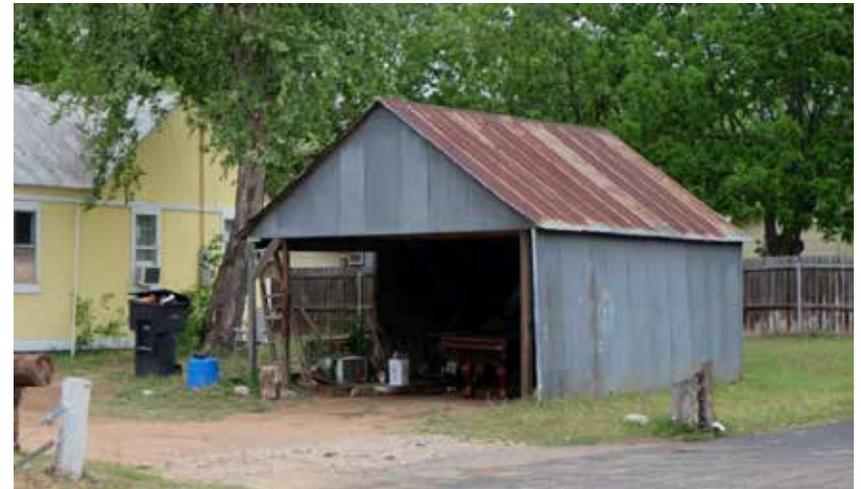
Figure 2-78. Example of a carport at 402 S. Orange Street. Source: CMEC 2019 Historic Resources Survey.

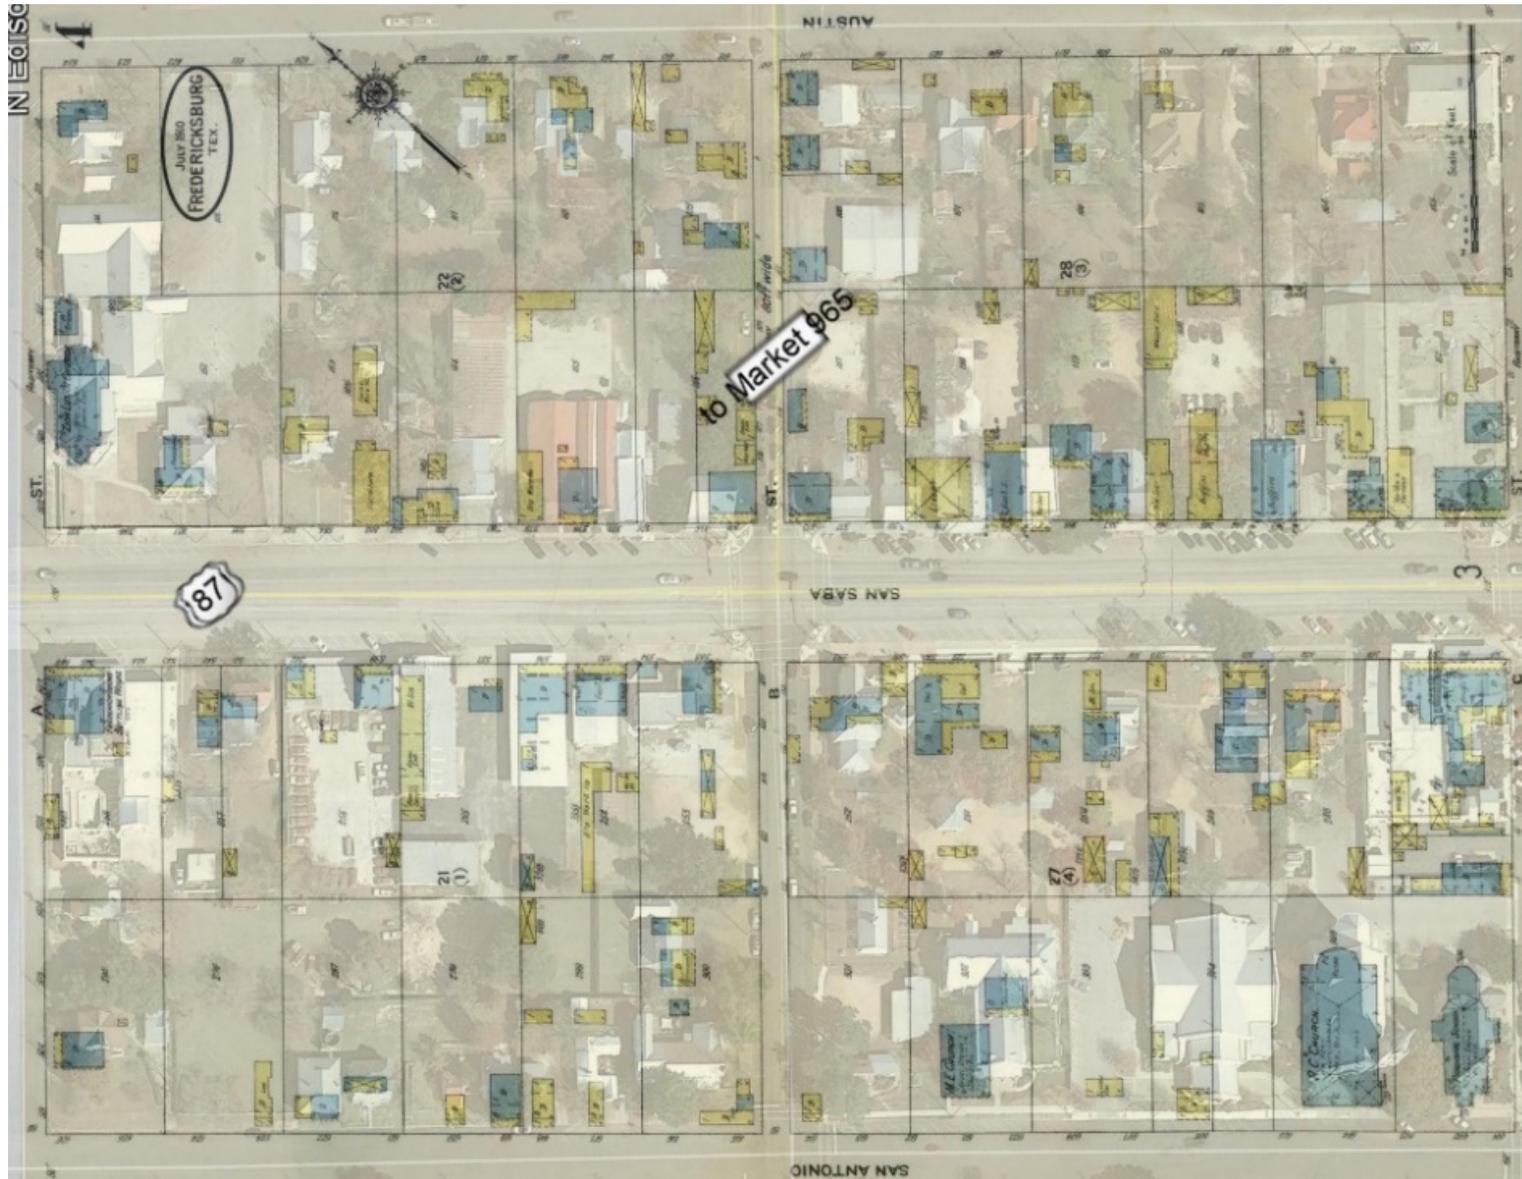
Figure 2-80. Overlay of a Sanborn Fire Insurance map from 1910 showing the relatively consistent lot size at the core of the town, near present-day Main Street. However, note the large scale of present-day building footprints compared to historic building footprints. Source: University of Texas Libraries, base aerial photo from Google Earth.

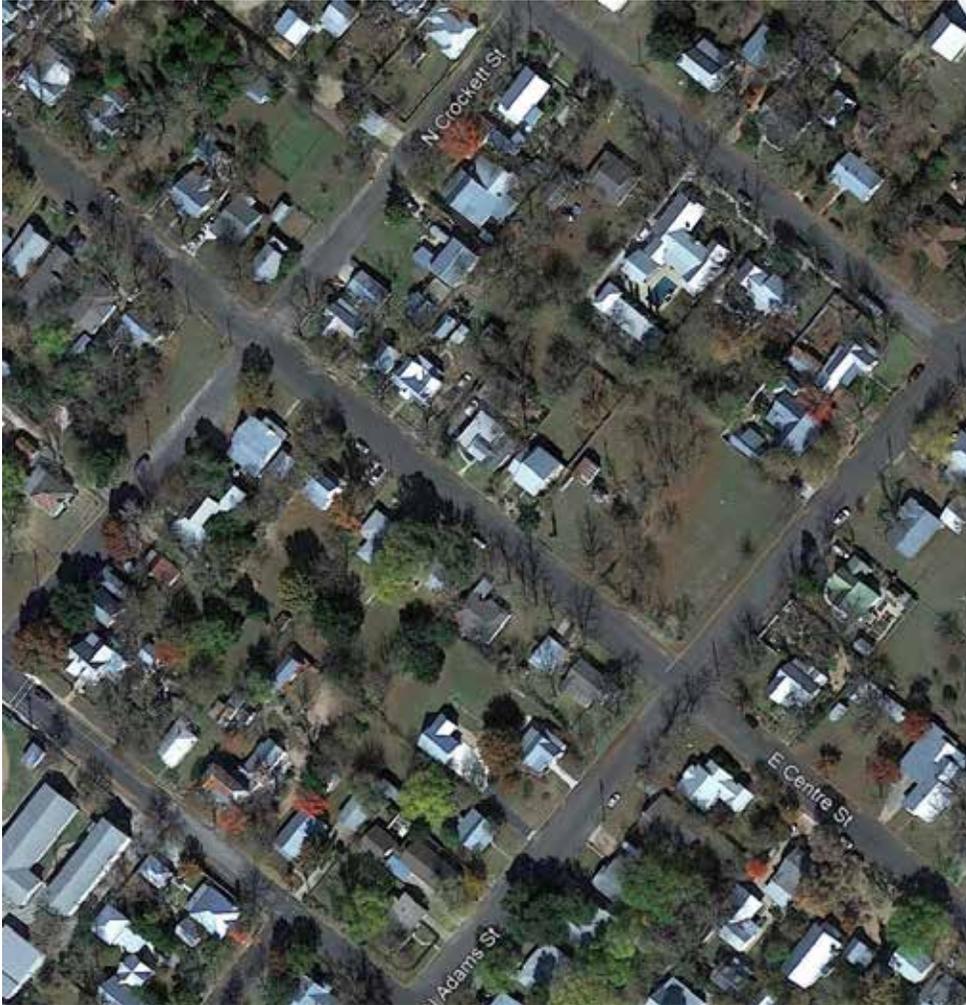
Figure 2-81. Aerial photo of the northern portion of the historic district, where lots historically measured 100 ft by 200 ft. Note the diversity of lot sizes today due to subdivision of large lots over time. Source: Google Earth.

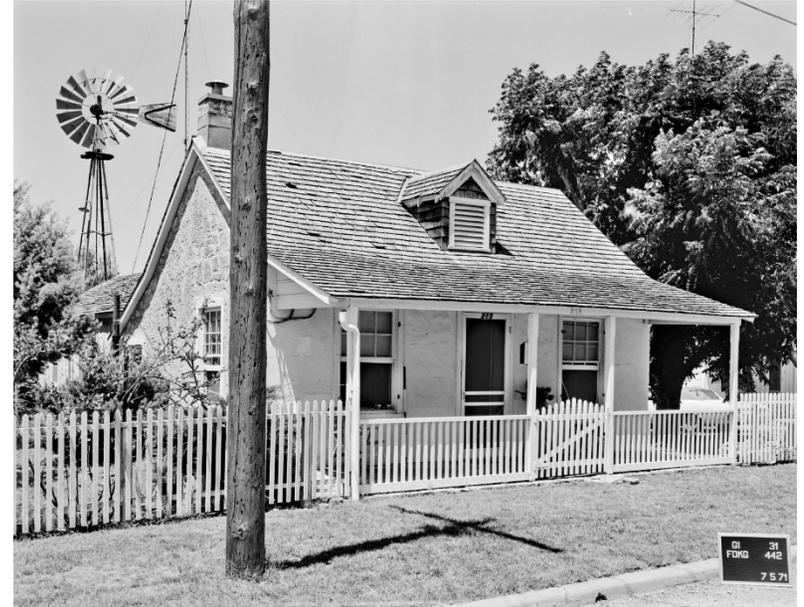
Figure 2-82. Photograph of 213 W. Creek Street illustrating a typical narrow front-yard setback for a pre-1920s house, with a fenced front yard and windmill set directly behind the house. Source: Texas Historical Commission. [Historic Property, Photograph THC\_15-0193], photograph, Portal to Texas History, crediting the THC, <https://texashistory.unt.edu/ark:/67531/metaph688051>.

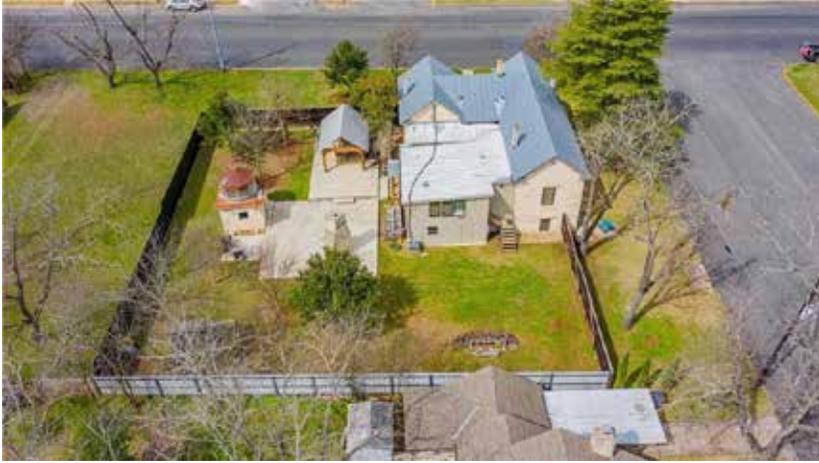
Figure 2-83. Bird's-eye view photograph of 211 N. Cherry Street showing the cistern and tank house situated directly behind the main house. Note that the fence does not date from the historic period. Source: Realtor.com.

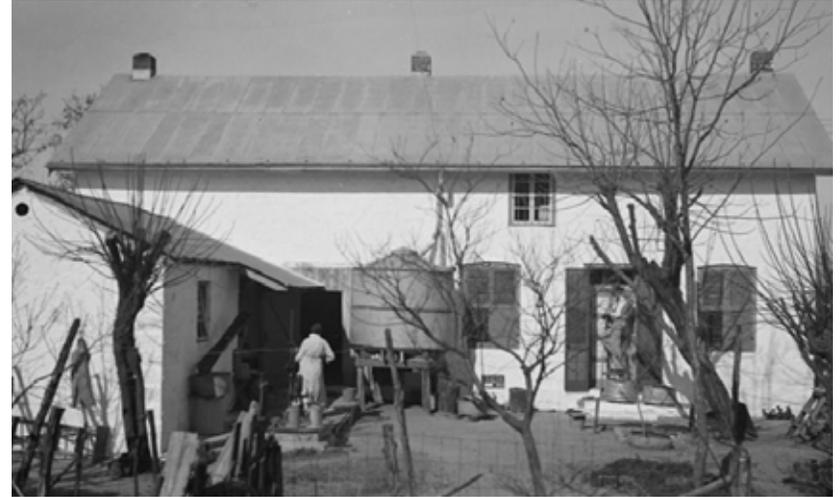
Figure 2-84. Photograph of the rear of 125 W. San Antonio Street showing the open space at the central core of the rear yard, used for domestic functions. Source: Library of Congress, <https://www.loc.gov/pictures/item/tx0335>.
