# City of Fredericksburg Historic District Design Guidelines & Standards

Fredericksburg, Gillespie County, Texas  
Final Draft Adopted July 19, 2021

Prepared for  
The City of Fredericksburg

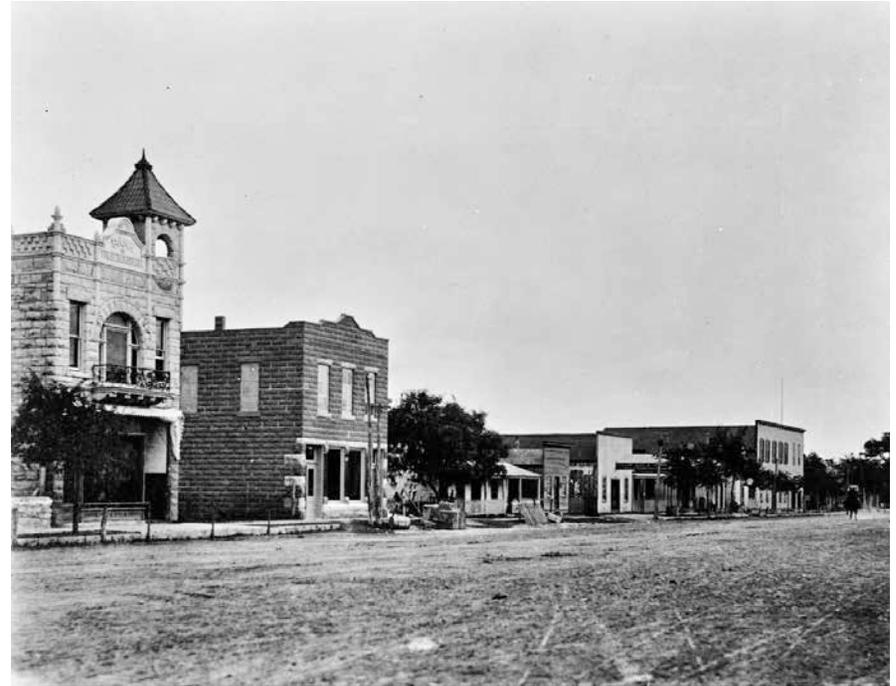
Figure 2-85. Historic photograph showing commercial construction extending fully to the lot line. Source: The Portal to Texas History, crediting Texas Historical Commission, <https://texashistory.unt.edu/ark:/67531/metaph683349/>.

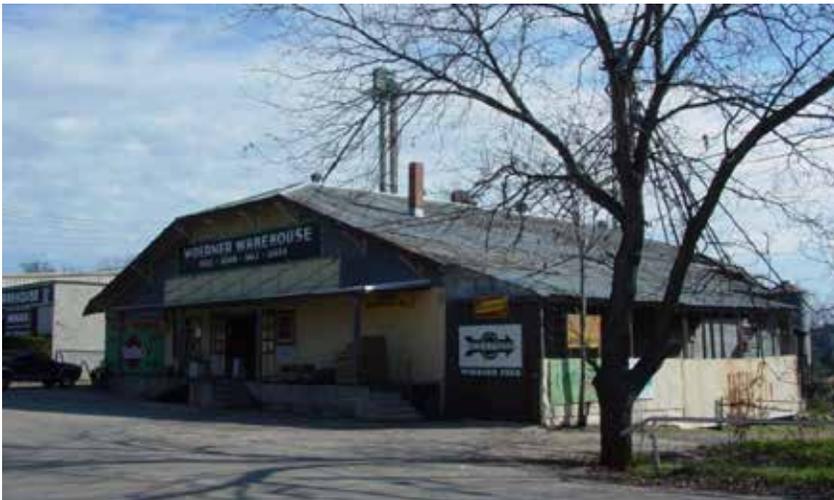
Figure 2-87. Woerner Warehouse at 305 S. Lincoln Street. Note the wide door openings at loading-dock height to allow truck transfers, as well as the grain silos and grain elevators dispersed in the background. Source: HHM 2003 Historic Resources Survey.

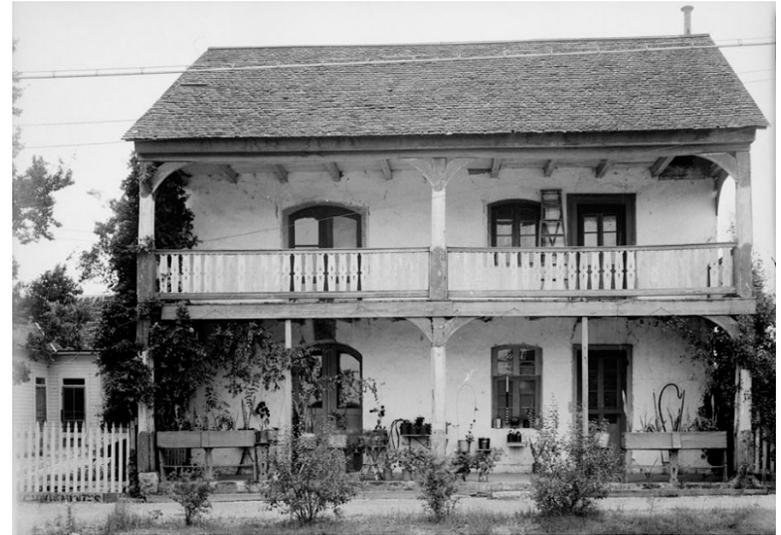
Figure 3-1. Photo of the Kiehne-Foerster House at 405 E. Main Street, showing load-bearing porch posts and structural beams visible at the balcony ceiling, which are visible character-defining features that should be preserved and maintained. Source: Library of Congress, <https://www.loc.gov/item/tx0338/>.

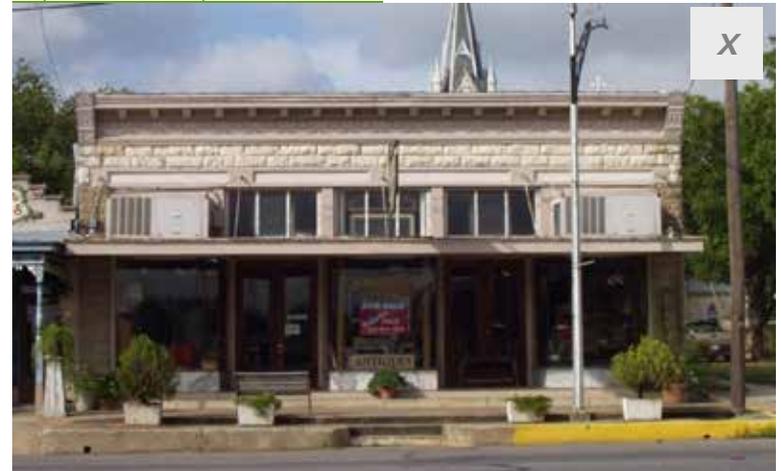
Figure 3-2. (**Inappropriate**) Photograph of 205 W. Main Street, showing air-conditioning units mounted on the front canopy at the time, inappropriately obscuring character-defining transoms. Source: CMEC 2019 Historic Resources Survey.

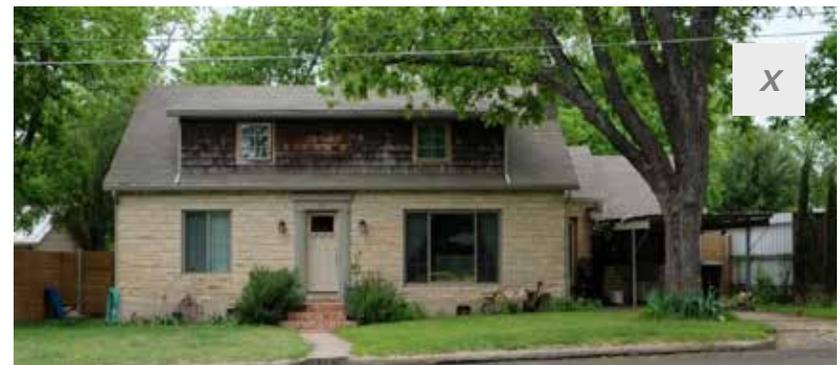
Figure 3-5. Example of a house with an **inappropriate** non-historic dormer altering the original roof form and compromising the integrity of the house. Source: CMEC 2019 Historic Resources Survey.

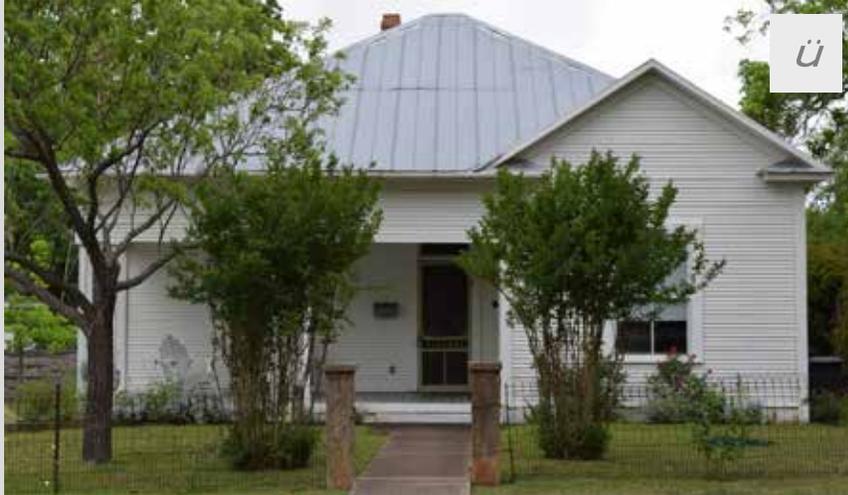
The example **above** at 303 W. College Street shows the **appropriate** use of a metal roof with folded joints. Given the house's National Folk style, a metal roof was likely original. Because the house was constructed ca. 1910, use of folded or crimped joints is required.

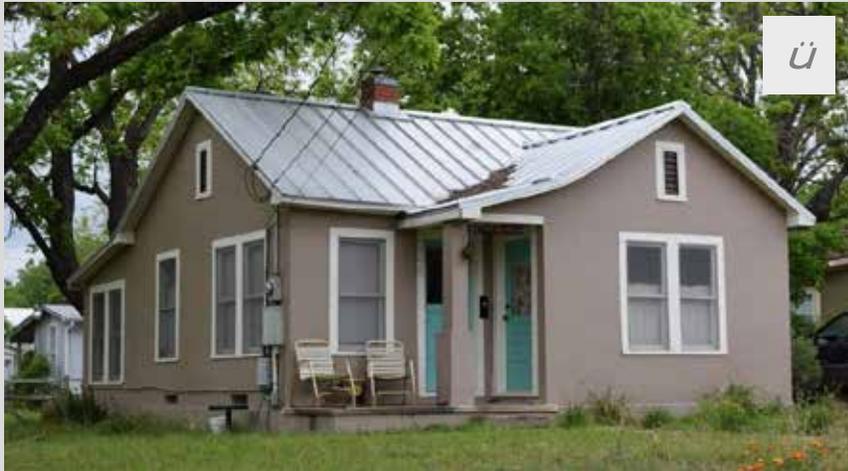
The **above** example of a new metal roof at 402 N. Milam Street is **appropriate in this case** because the house has no style, so the original roof materials were not character-defining. The ridge cap is appropriate given the ca. 1940 date.

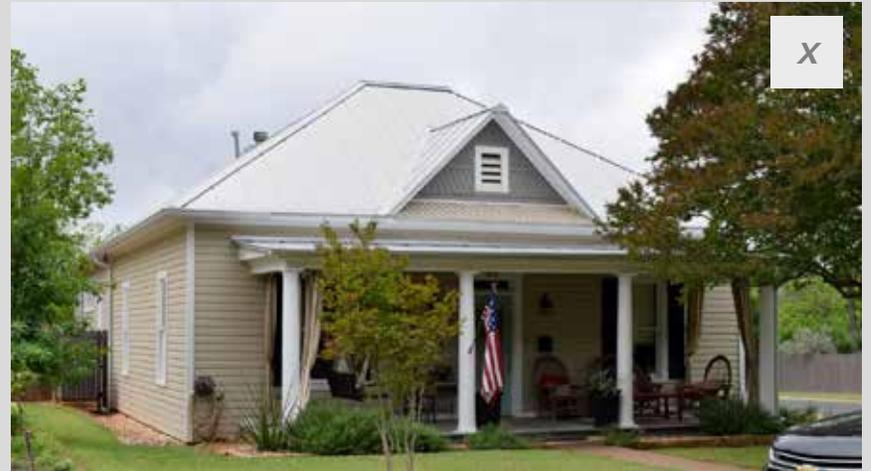
The example **above** at 313 W. College Street shows the **inappropriate** use of a ridge cap rather than folded or crimped joints given the house's construction date of ca. 1910.

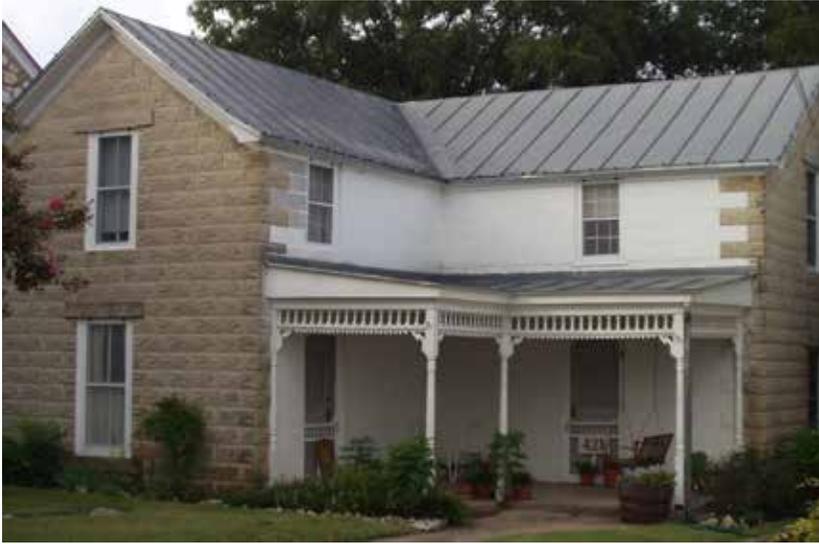
Figure 3-14. Example of original Folk Victorian porch detailing at 421 W. Main. Note how the turned porch posts are integrated into the masonry with attention to detail seldom replicated in non-historic examples. Source: HHM 2002 Survey.

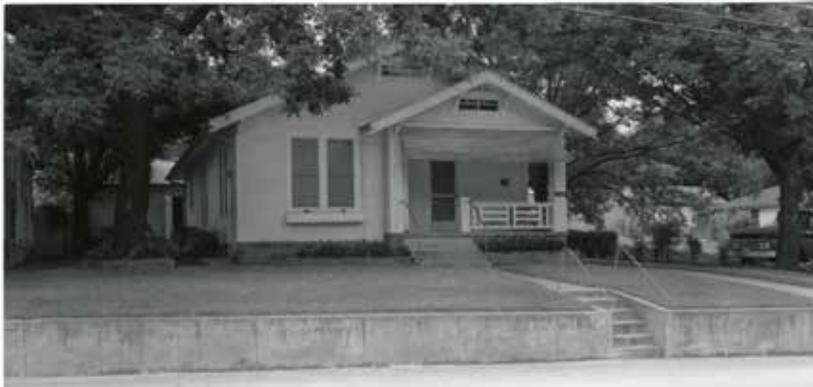
Figure 3-15. Example of original character-defining Craftsman-style porch detailing on a ca. 1920 bungalow at 308 E. San Antonio. Source: National Register Nomination, Fredericksburg Historic District, 1983.

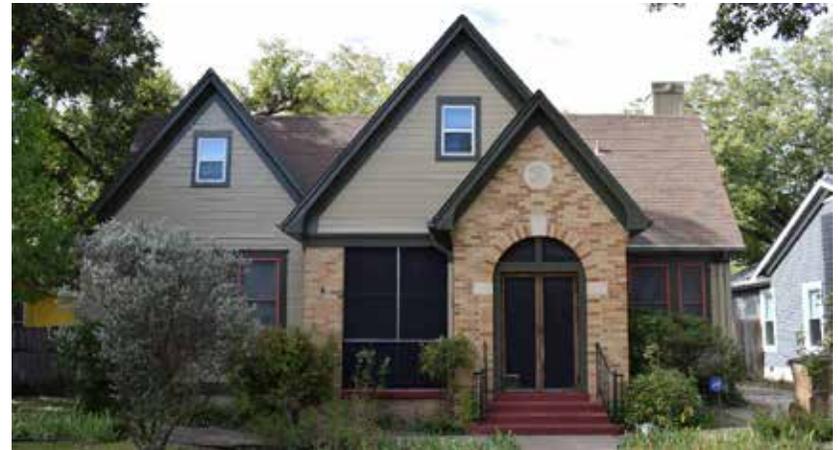
Figure 3-17. Example of a reversible porch screening that does not damage or obscure historic character-defining features, **appropriate for Low or Medium priorities only**. Source: HHM archives.

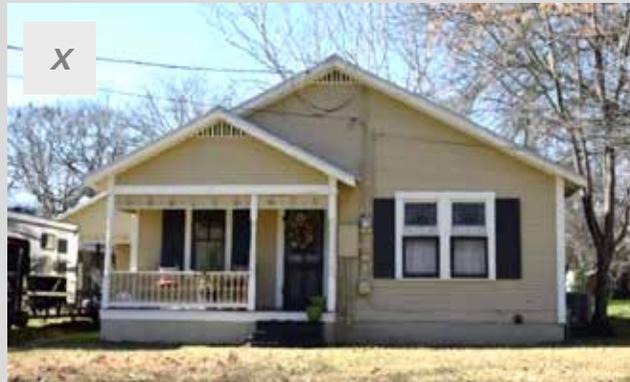
Example of **inappropriate** non-historic "gingerbread" detailing added to a bungalow that likely originally had Craftsman porch styling.

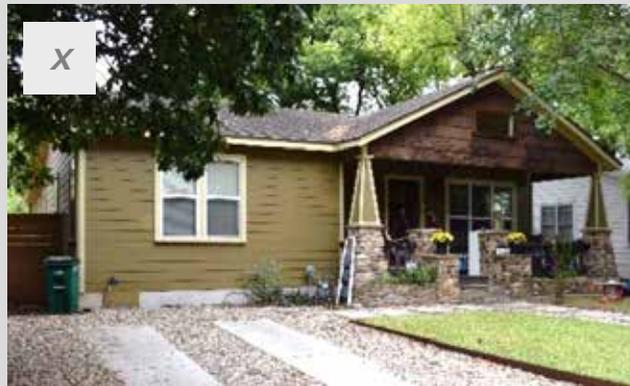
Example of **inappropriate** faux-Craftsman columns added to a 1957 Minimal Traditional house that originally had no porch.

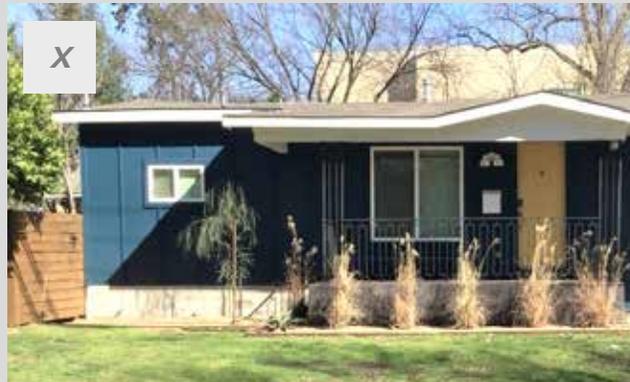
Example of **inappropriate** replacement of original organic wrought-iron porch posts with non-historic geometric porch posts on a simple ca. 1950 house.

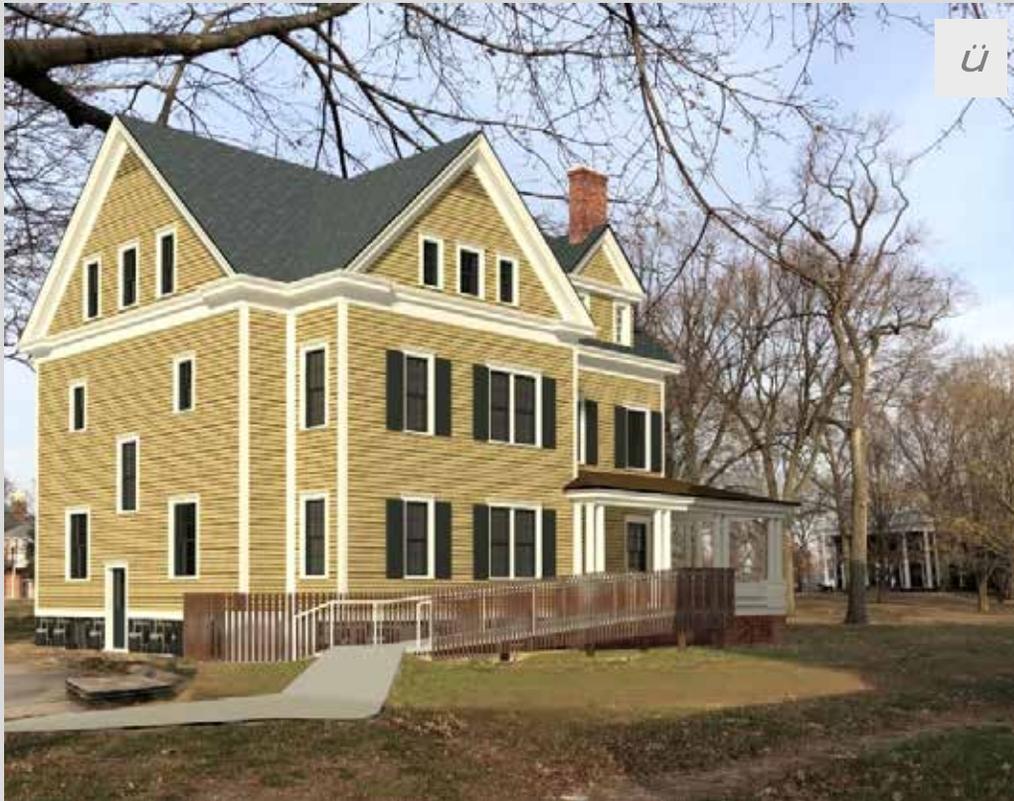
The **above** rendering shows a proposed ramp added to a less-visible side elevation of a historic house at Governor’s Island in New York City.

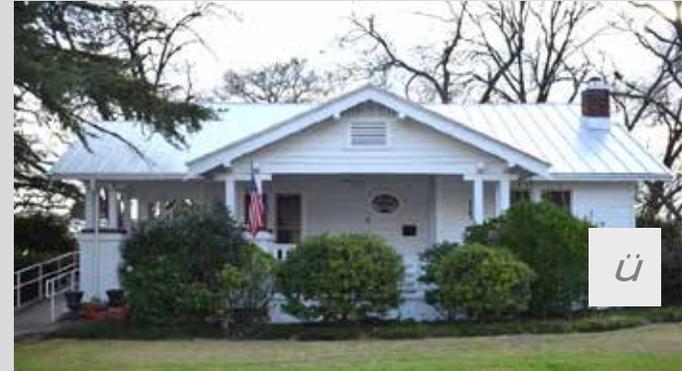
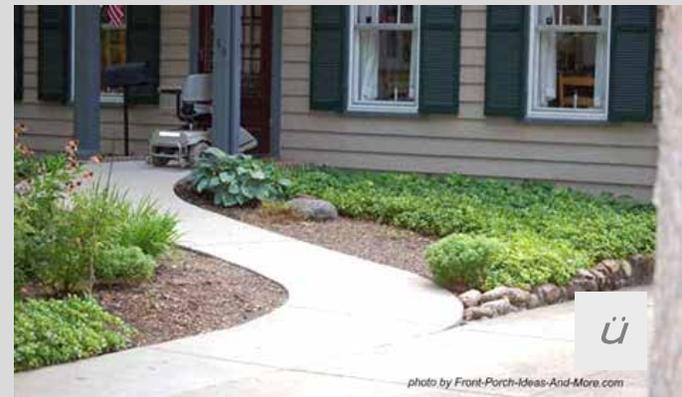
The **top** photo shows a reversible ramp added at the side of a historic porch, keeping the historic porch steps intact and minimizing removal of historic porch railings. The **bottom** photo shows a subtle increase in the yard grade leading to the front porch, avoiding the need for a standard railing.

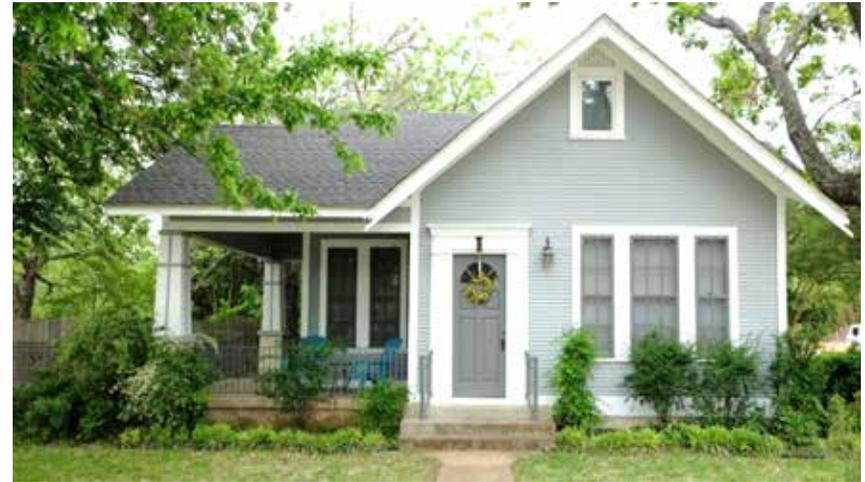
Figure 3-20. Example of a Craftsman bungalow at 707 W. Main Street. Note that the 2-inch horizontal wood siding and relationship of wall to window are character-defining features to be preserved. Source: CMEC Historic Resources Survey, 2019.

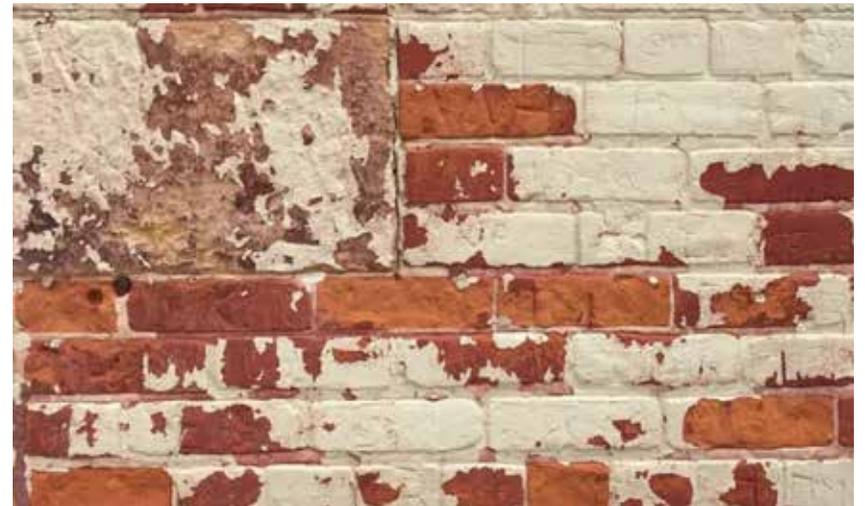
Figure 3-21. Example of damage to brick surface caused by paint. Paint can allow moisture to become trapped within the brick, resulting in flaking off the brick’s hard outer crust along with the paint, leaving the softer inner brick exposed and susceptible to weatherization. Source: “Please, Don’t Paint Your Mid-Century Brick,” MidMod Midwest, accessed January 8, 2021, <https://midmod-midwest.com/mid-century-brick/>.

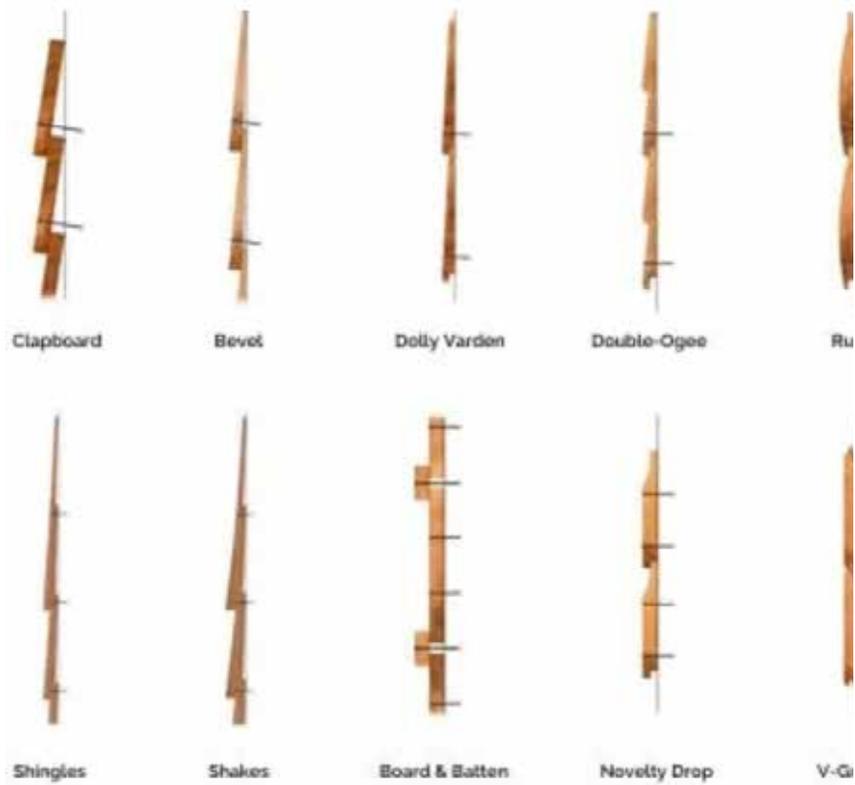
Figure 3-23. Examples of common siding profiles, to be matched as closely as possible. Source: Scott Sidler, "The Ultimate Guide to Wood Siding," The Craftsman Blog, updated June 1, 2020, <https://thecraftsmanblog.com/the-ultimate-guide-to-wood-siding/>.

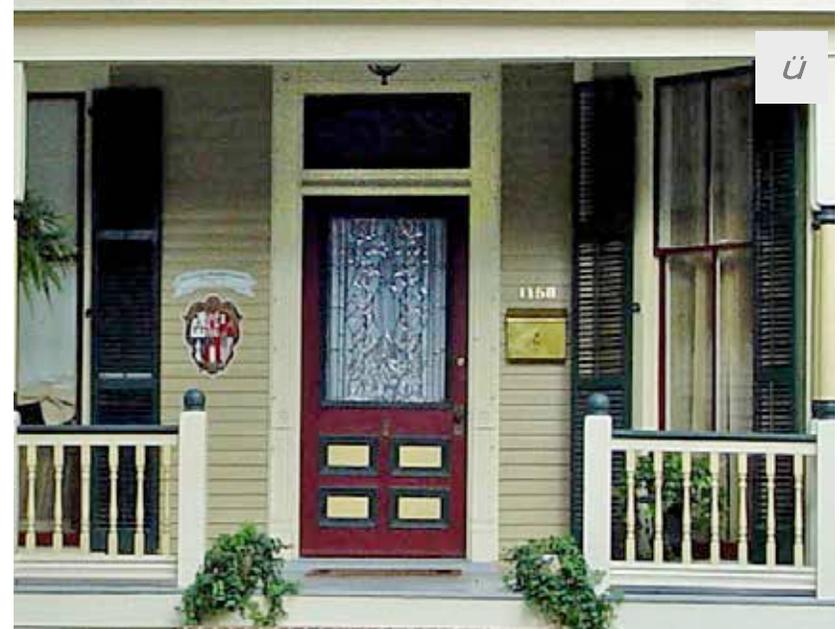
Figure 3-28. Example of an **appropriate** door, consistent with the style and time period of construction. Source: Winter & Company.

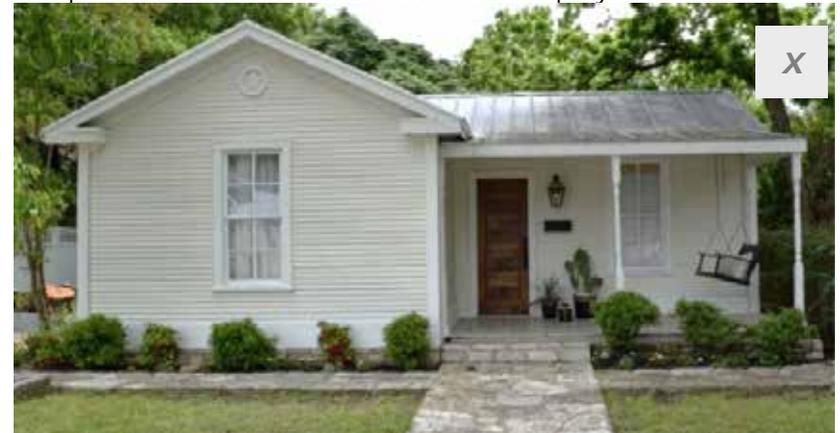
Figure 3-29. Example of a Folk Victorian House at 505 N. Milam Street with an **inappropriate** Contemporary door detracting from the overall style and character of the house. Source: CMEC 2019 Historic Resources Survey.

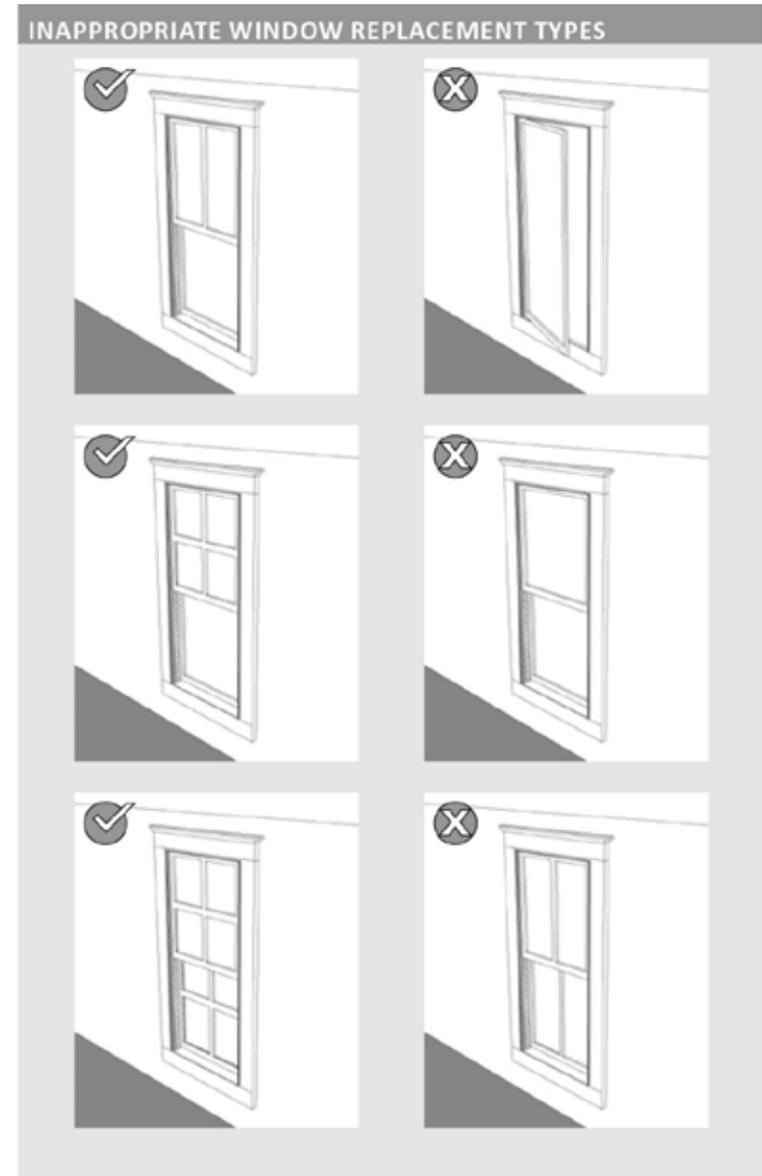
Figure 3-31. Illustrations depicting **inappropriate** types of window replacements, not matching the historic configuration or pattern of lites. Source: Winter & Company archives.

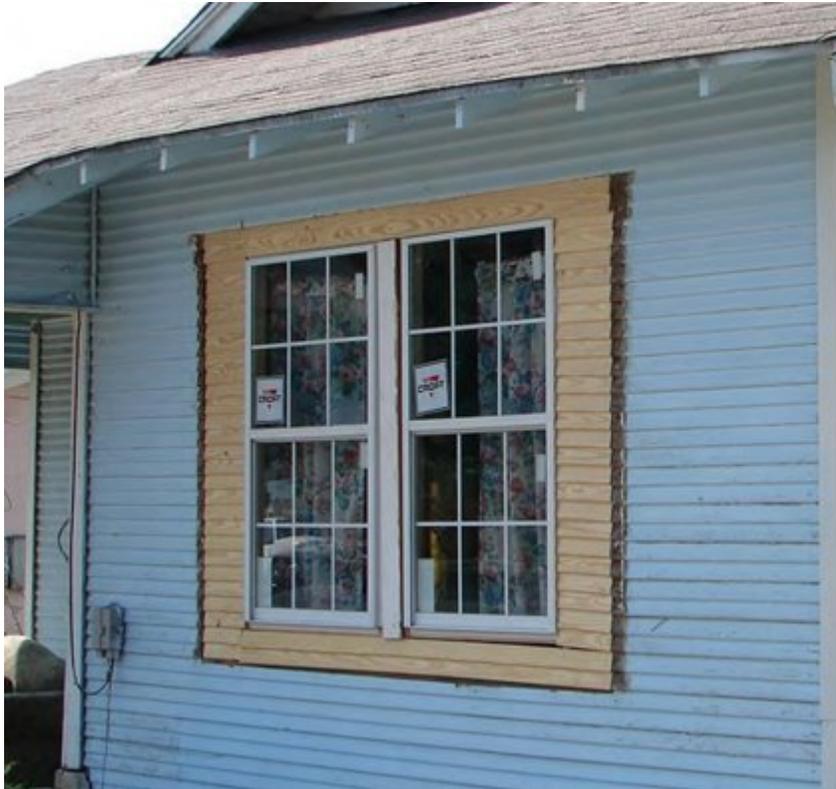
Figure 3-32. Example of **inappropriate** installation of replacement windows. Source: City of San Antonio Office of Historic Preservation.

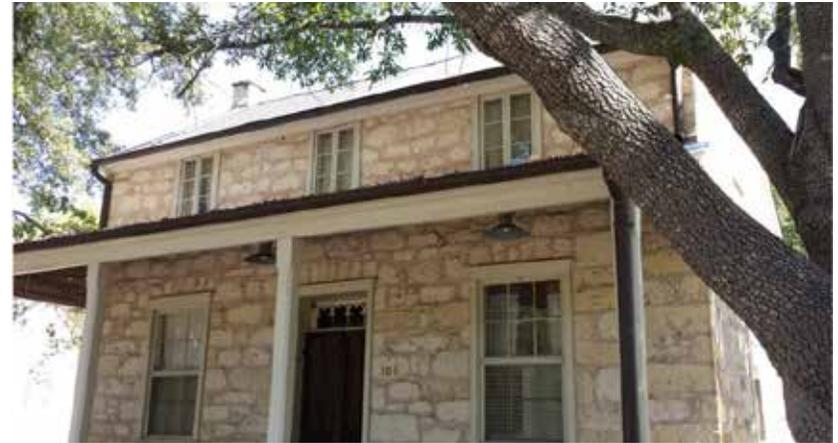
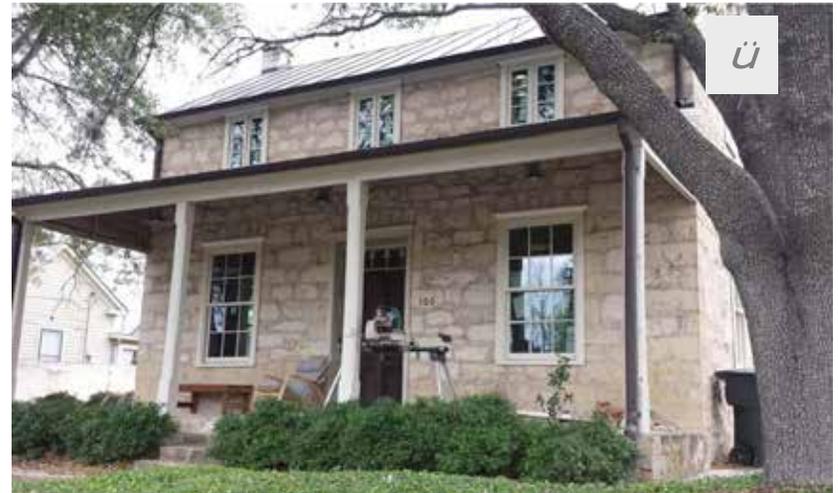
Figure 3-33. Example of **appropriate** replacement windows at 106 E. Schubert Street. The new aluminum clad wood windows match the original in size, configuration, profile, and depth. Source: City of Fredericksburg Historic Preservation Office.

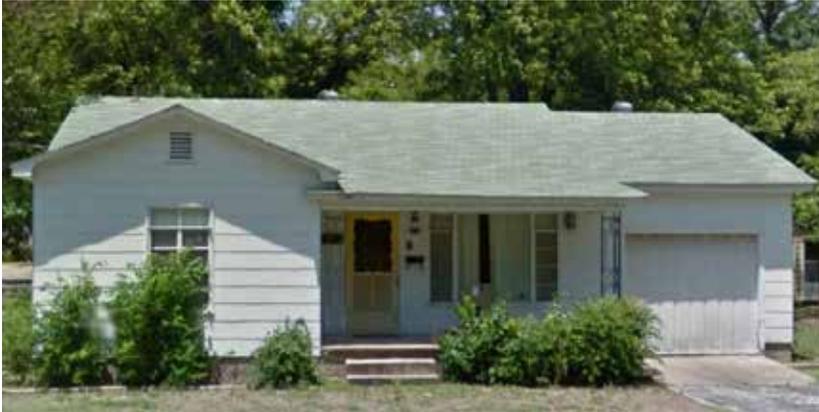
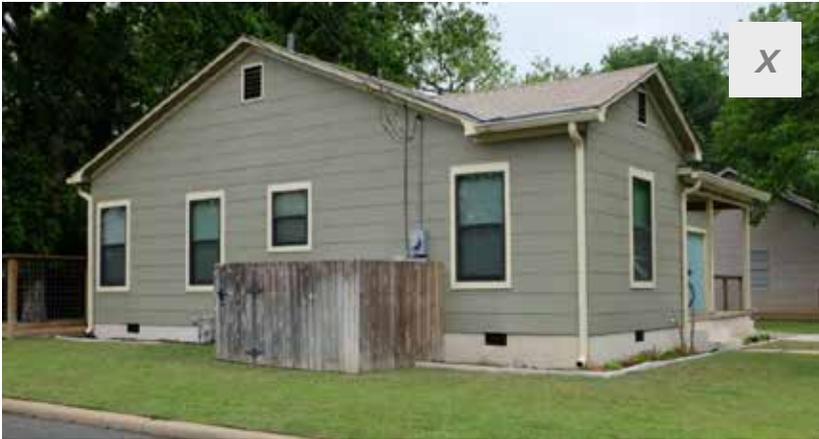
Figure 3-34. Matching the dimension, profile, configuration, and spatial relationships for midcentury windows is just as important as older windows for Medium or High priorities. These **inappropriate** vinyl windows at 312 S. Crockett Street replaced historic metal casement windows. Sources: Google Street View, City of Fredericksburg Historic Preservation Office.

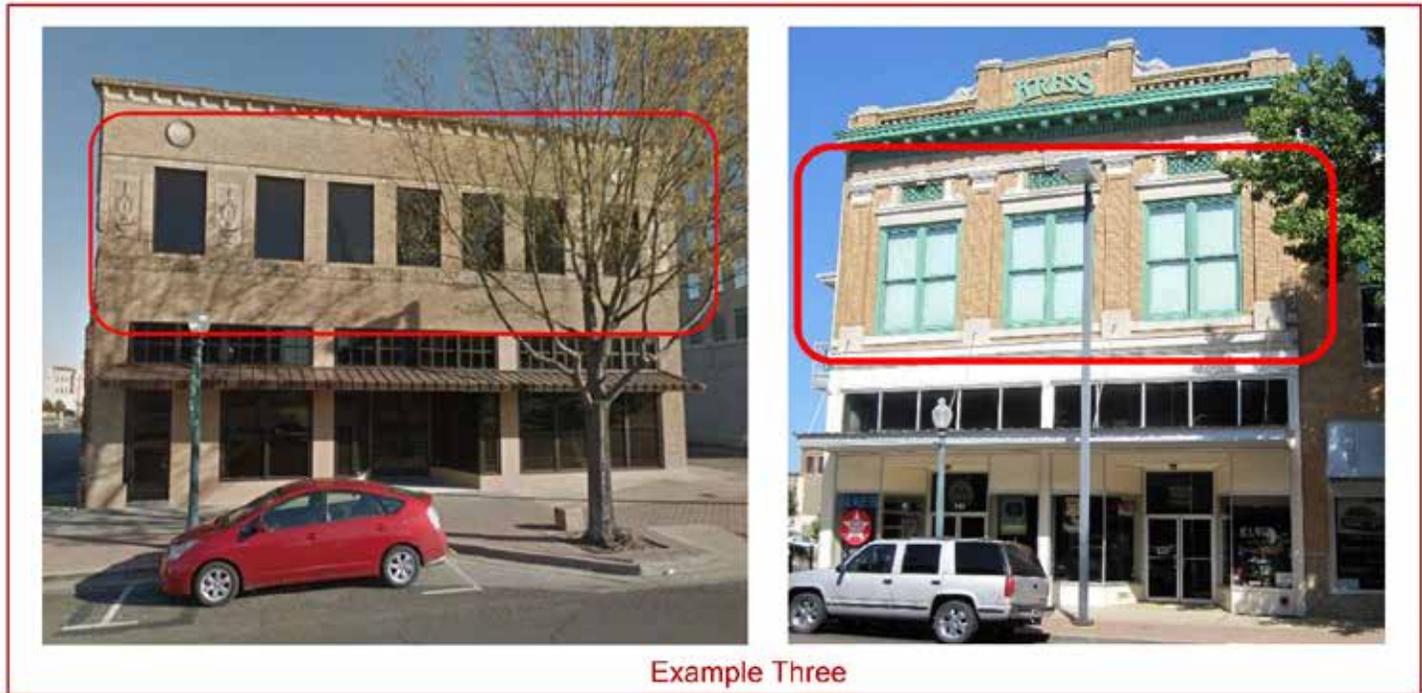
Figure 3-36. Examples of **inappropriate** new shutters improperly sized to fit the original window openings. Source: Scott Sidler, "All About Wood Shutters," The Craftsman Blog, published October 8, 2020, <https://thecraftsmanblog.com/all-about-wood-shutters/>.

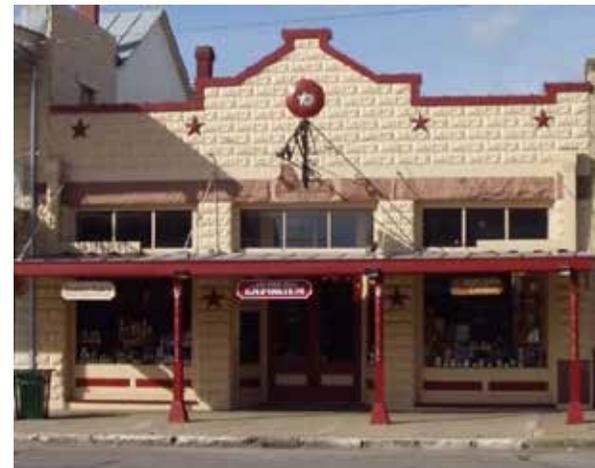
Figure 3-37. Example of an **appropriate** canopy on a historic building at 121 E. Main Street. Note how the canopy is mounted so that it does not obscure the transom windows above. Also note the metal tie rods anchored into the façade. Source: HHM 2003 Historic Resources Survey.

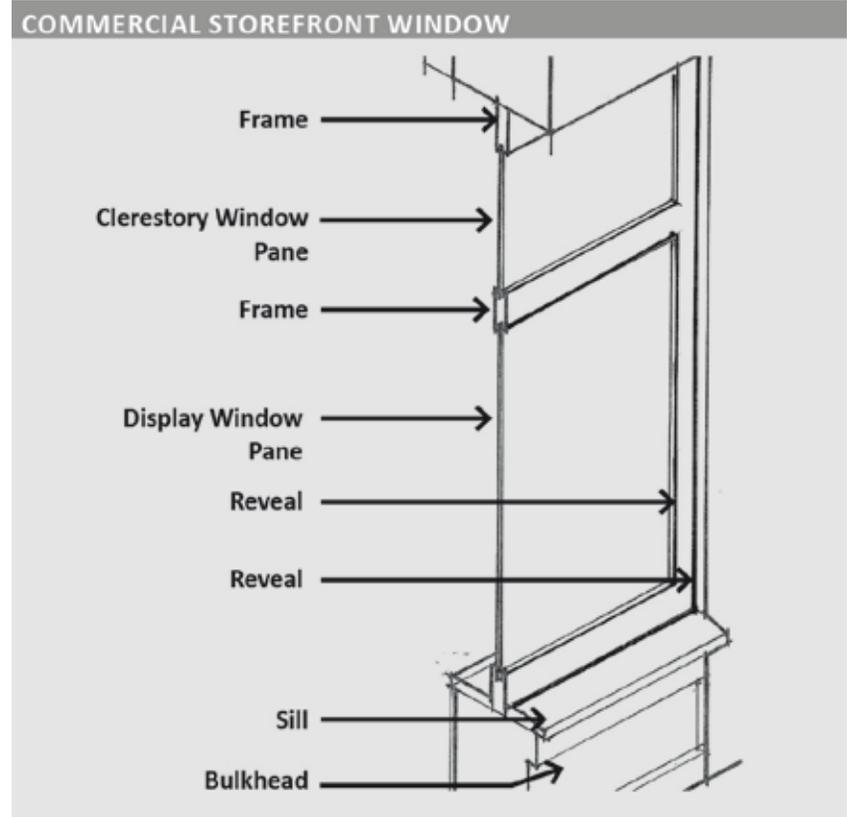
Figure 3-39. Diagram showing the elements of a commercial storefront window – all of which should be matched in dimension, profile, and finish if replacing a storefront. Source: Winter & Company archives.

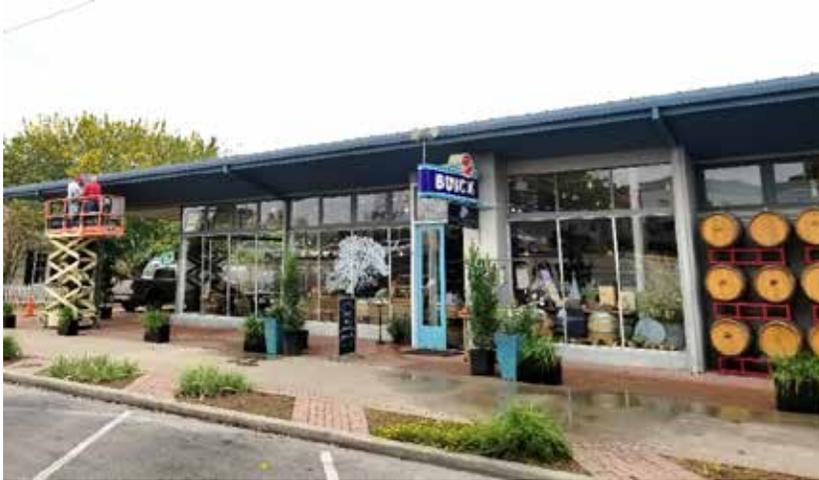
Figure 3-41. Examples of pedestrian-oriented signage under canopy.

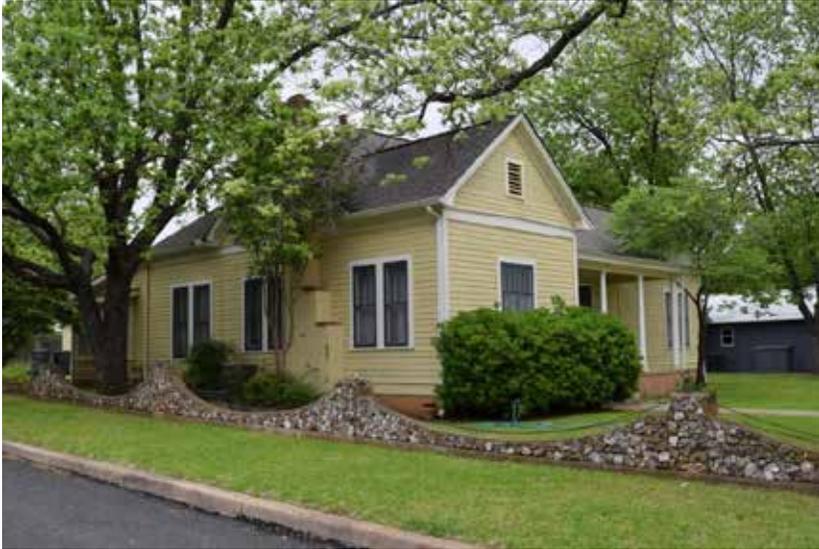
Figure 3-42. Example of a character-defining historic stone wall at 212 W Orchard Street, which should be preserved and maintained. Source: CMEC 2019 Historic Resources Survey.

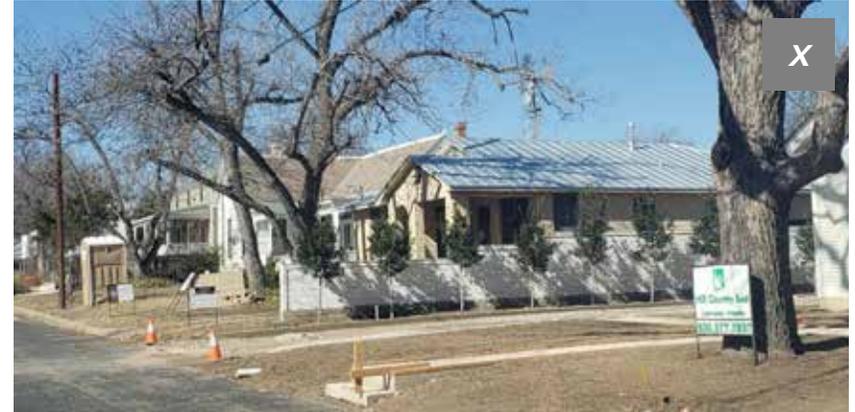
Figure 3-43. Example of an **inappropriate** side-yard fence at 606 W. Creek Street. The fence should not protrude forward from the front façade unless given special approval due to safety issues or noxious adjacent uses. If approved, the front-yard fence should be partially transparent and no more than 3 feet tall. Source: City of Fredericksburg Historic Preservation Office.

For the purpose of these standards, a “front-yard fence” is any fence that extends forward from the front façade of the main building toward the primary public street. A “back-yard fence” is any fence that recedes behind the front façade of a main building. A side fence extending forward from the front façade of the main building toward the public street must follow the standards for a front-yard fence. (See fig. 3-42).

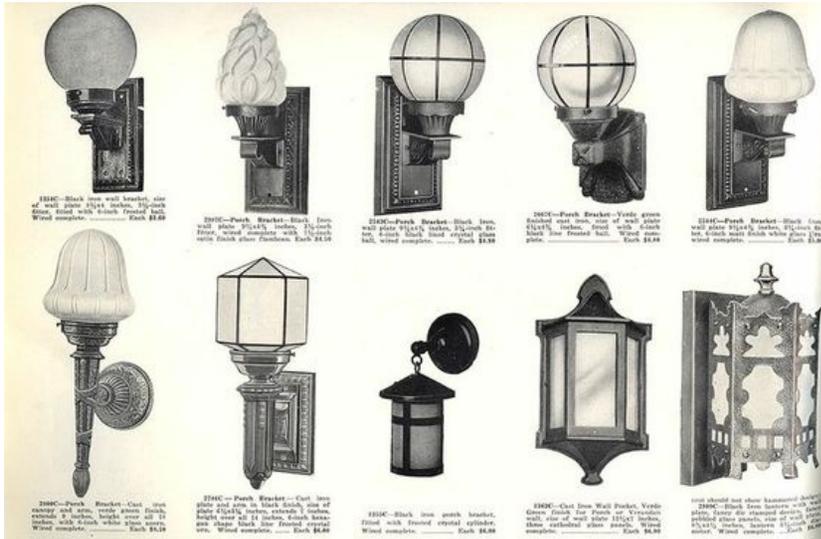
Figure 3-44. Example of period-appropriate porch bracket fixtures for late-nineteenth or early-twentieth century buildings. Source: Pinterest, accessed January 10, 2021, <https://www.pinterest.com/pin/290834088430267824/>.

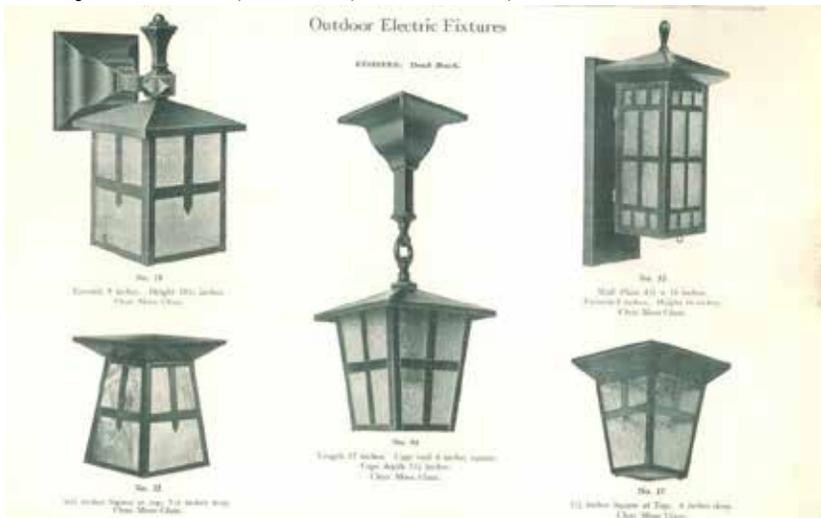
Figure 3-45. Example of period-appropriate porch bracket fixtures Prairie Style or Craftsman resources, dating from ca. 1910 through ca. 1940. Especially note the ceiling-mounted options. Source: Pinterest, accessed January 25, 2021, <https://www.pinterest.de/pin/93660867237805123/>.

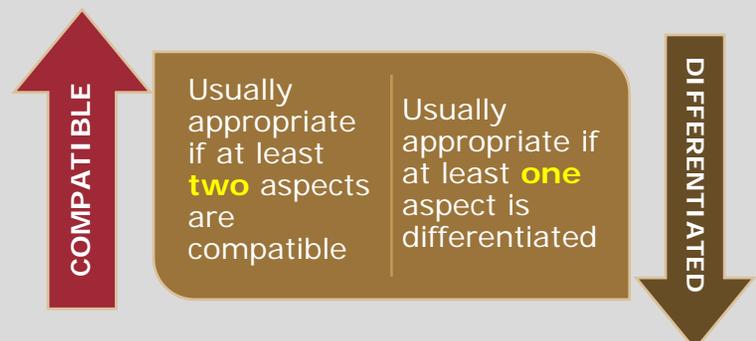
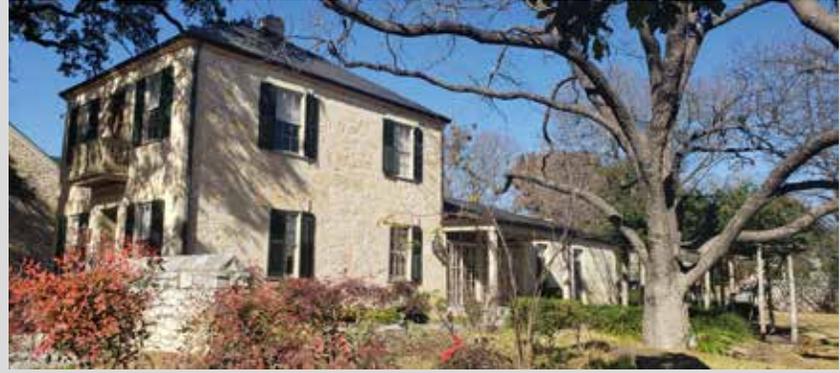
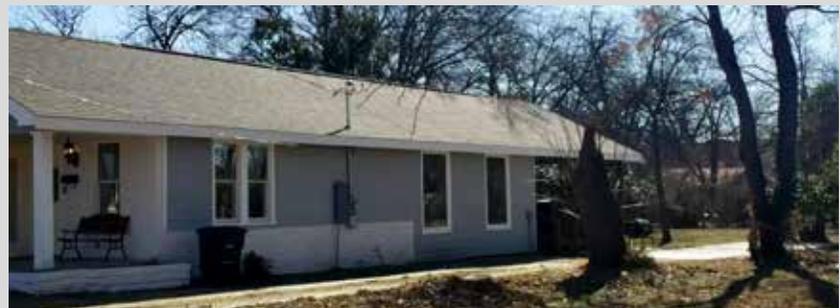
Examples of **appropriate** additions on 106 E. Schubert Street (top) and 303 W. San Antonio Street (bottom). Both examples above create slight differentiation using only one aspect of design—fenestration—while maintaining compatibility with materials and color. Source: City of Fredericksburg Historic Preservation Office.

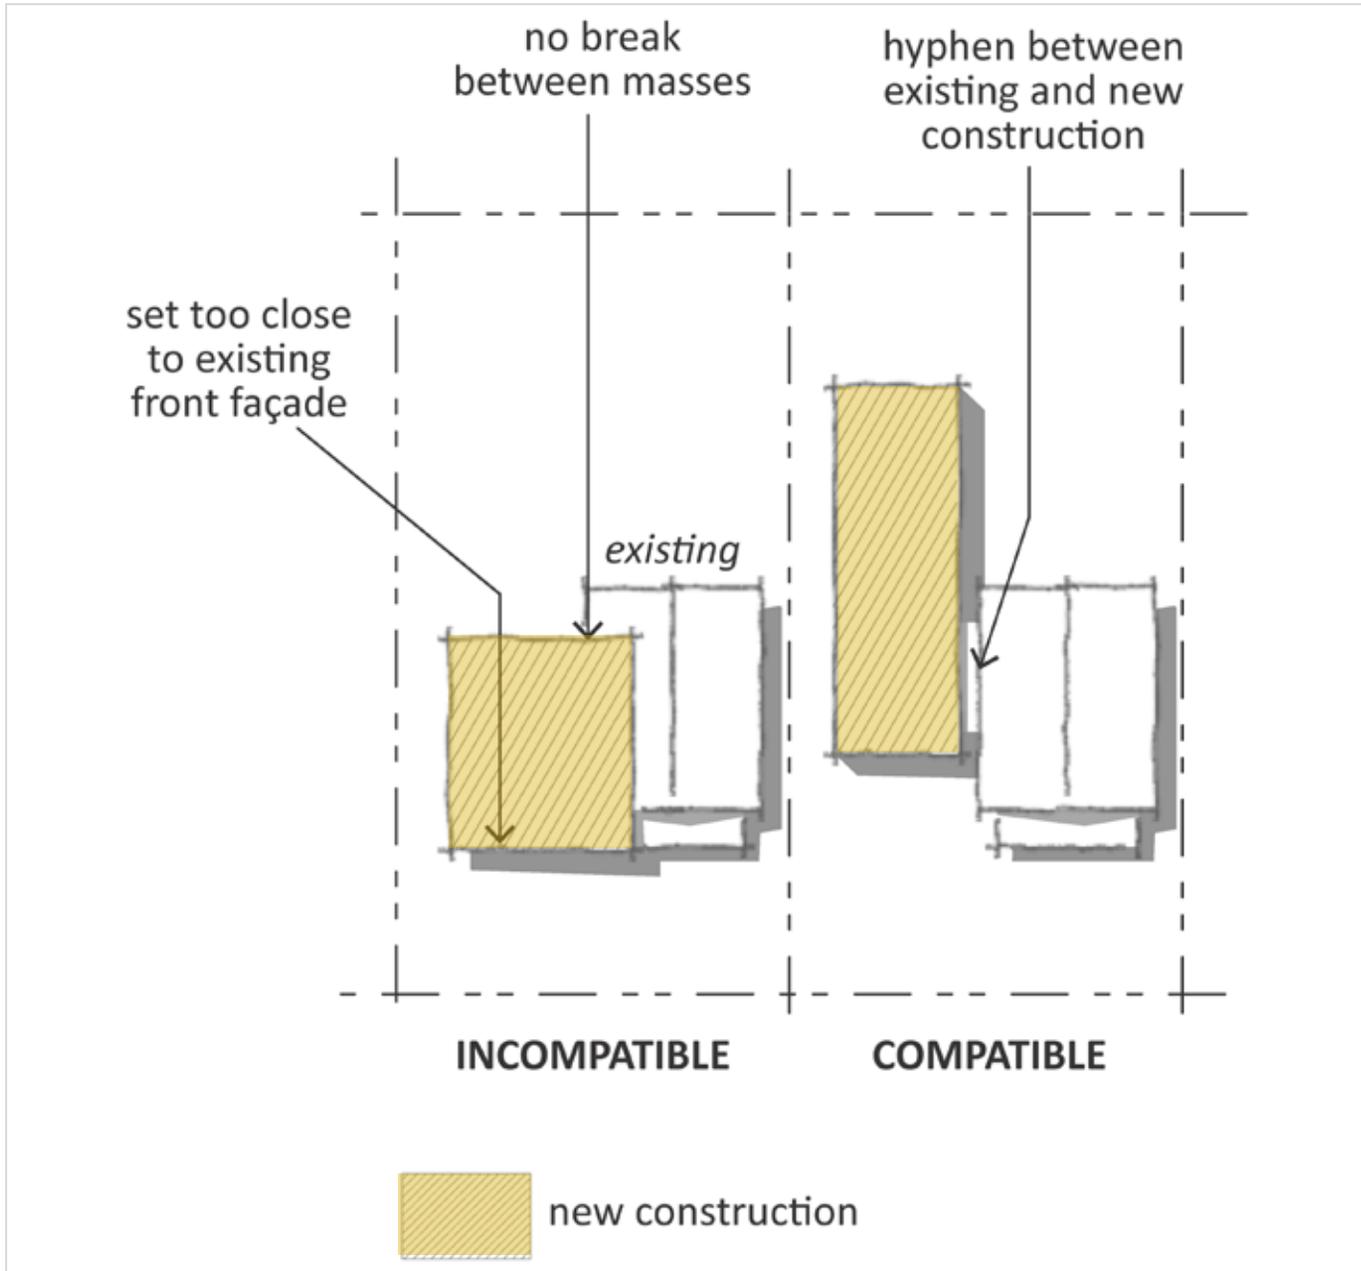
Figure 3-48. Examples of side additions, showing how the compatible side addition uses a hyphen and setback to separate it from the original building (medium or low). Source: HHM archives.

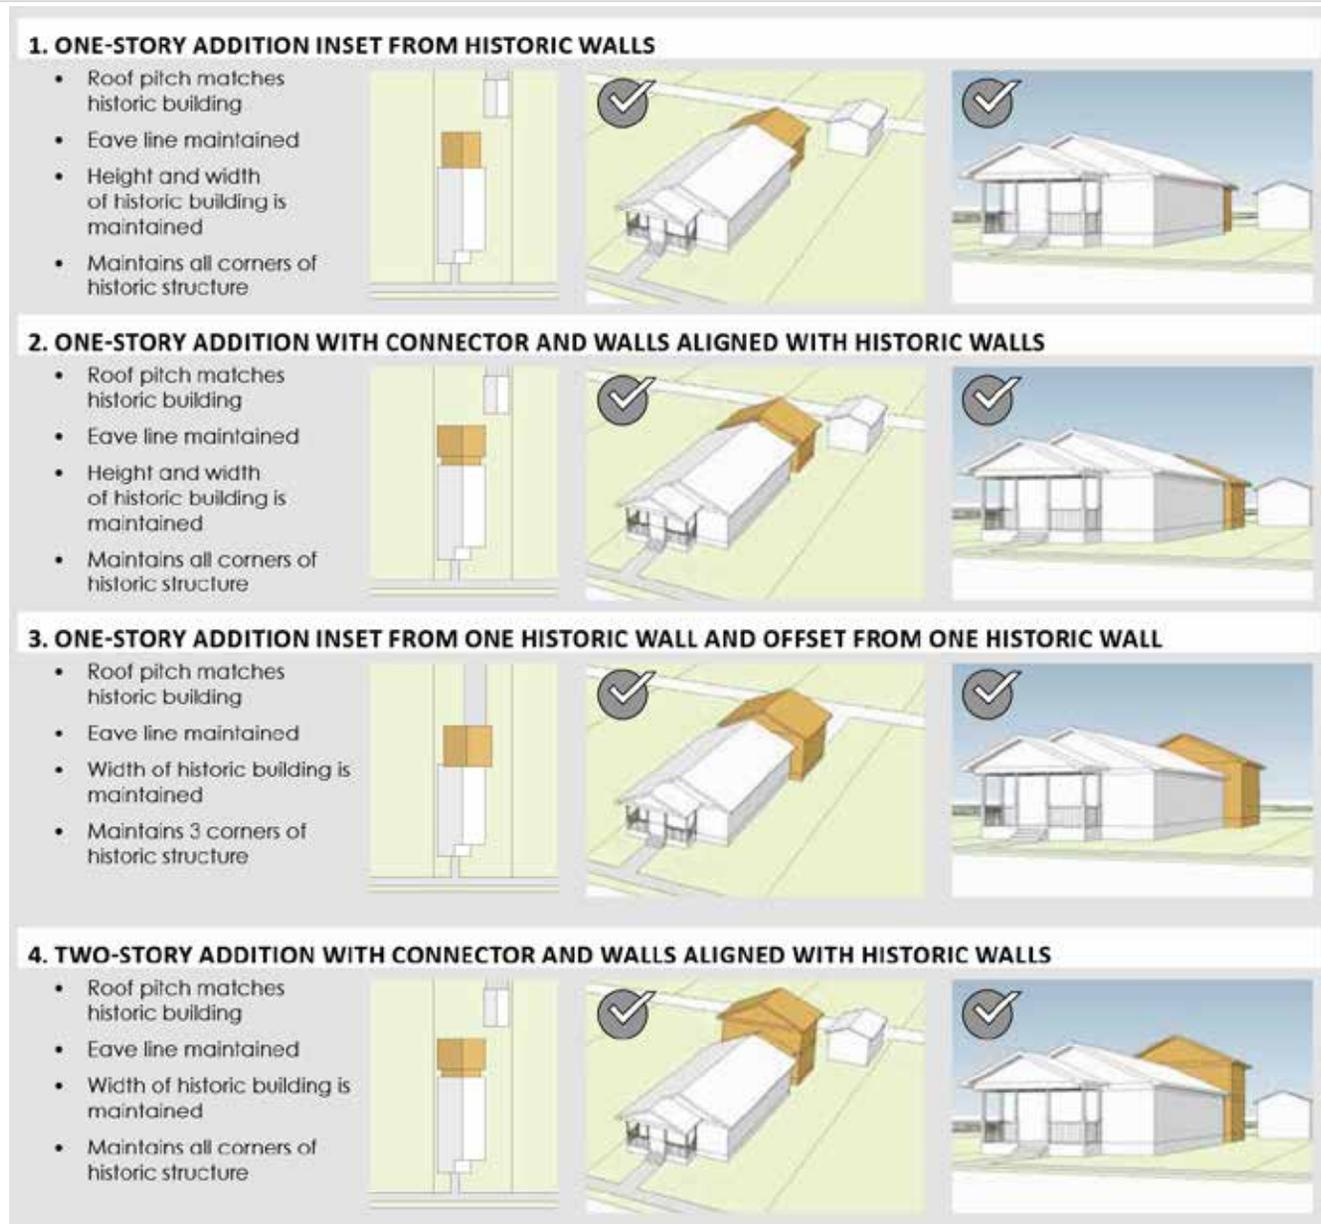
Figure 3-49. Examples of potential **appropriate** massing for hyphens, breezeways, insets, or offsets to differentiate a main original house from an addition. For High- or Medium-priority buildings, use of hyphens, breezeways, insets, or offsets is recommended for rear additions of the same height. They may be required for rear additions that rise taller than a historic High- or Medium-priority building. Source: Winter & Company archives.
