# City of Fredericksburg Historic District Design Guidelines & Standards

Fredericksburg, Gillespie County, Texas  
Final Draft Adopted July 19, 2021

Prepared for  
The City of Fredericksburg

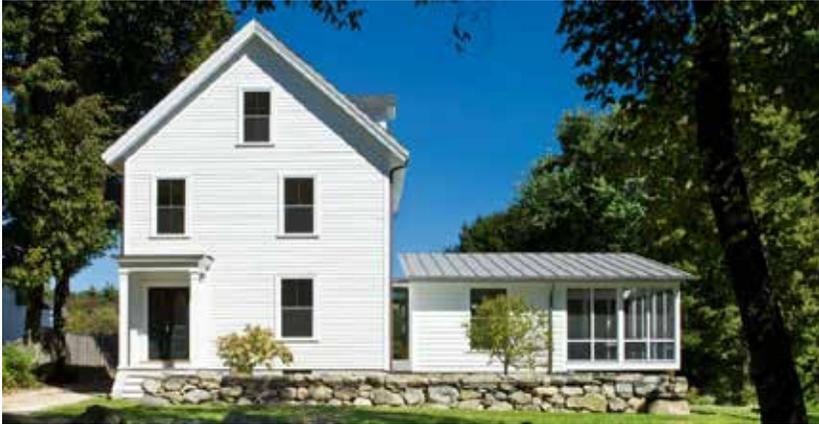
Figure 3-50. Photo of an **appropriate** side addition connected to a historic house by a glass hyphen in Concord Massachusetts, designed by Estes/Twombly Architects. These standards require use of a similar hyphen for side additions on High- or Medium-priority buildings. Note that the addition is compatible with the historic house in terms of its materials and color, but differentiated by its fenestration pattern and roof form. Source: Kristin Dispenza, "House of the Month: Redesign of a Historic 1890s-era House," Buildipedia, accessed May 16, 2020, <http://buildipedia.com/at-home/design-remodeling/house-of-the-month-redesign-of-a-historic-1890s-era-house?print=1&tmpl=component>.

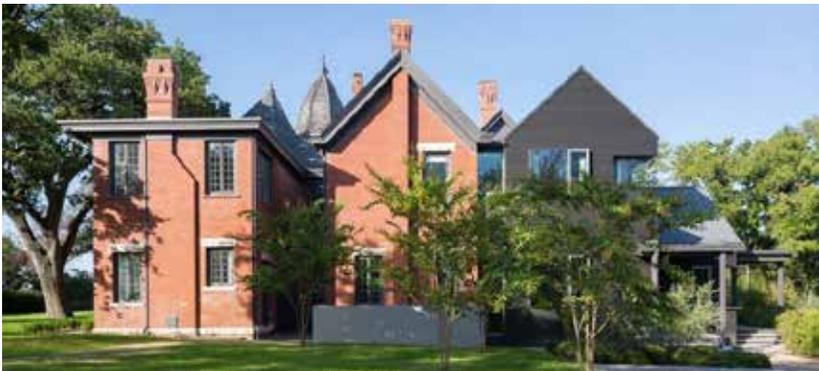
Figure 3-51. **Appropriate** rear addition in Austin, designed by Clayton Little Architects. Note that a glass hyphen separates the addition from the main house. The addition is compatible in terms of height, roof form, and footprint shape, but differentiated by its color, materials, and fenestration pattern. Source: "Clarksville Residence," Clayton Little Architects, accessed January 10, 2020, <https://claytonlittle.com/work/clarksville-residence/>.

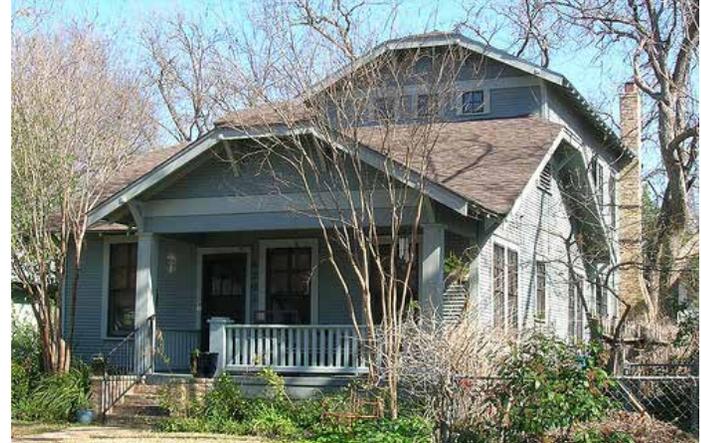
Figure 3-52. Example of a two-story rear addition set back behind the ridgeline of a one-story bungalow. This addition would be inappropriate for a High- or Medium-priority house, but appropriate for a Low-priority house. Source: HHM archives.

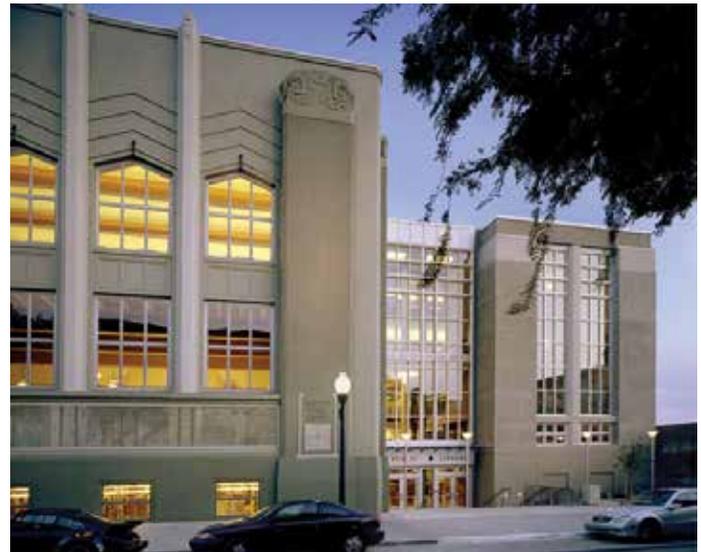
Figure 3-53. Example of an **appropriate** historic stone building that connects to a new side addition on the right through a glass hyphen, minimizing impact to the historic building. Note that the materials, roof form, and color are compatible, while the fenestration is differentiated. Source: National Park Service.

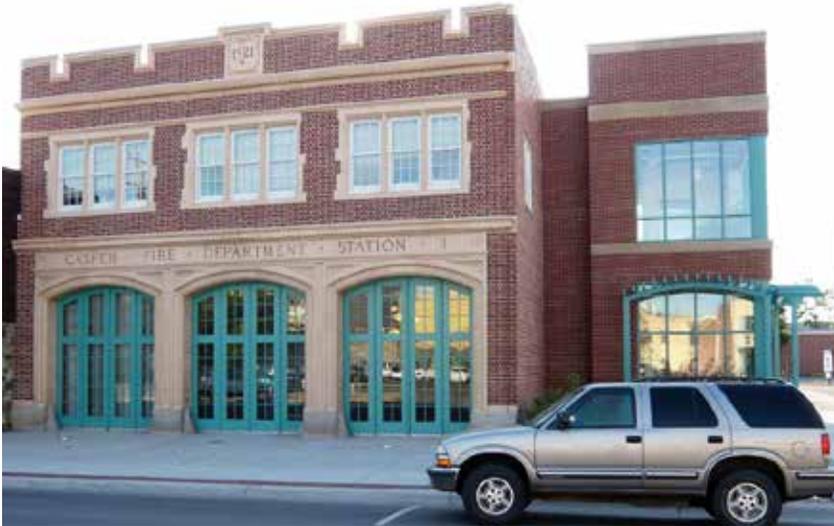
Figure 3-54. Photo of a contemporary addition to a historic fire station via an offset brick hyphen. Note that the roof form, materials, and color are compatible, while the fenestration pattern is differentiated. Source: Winter & Company archives.

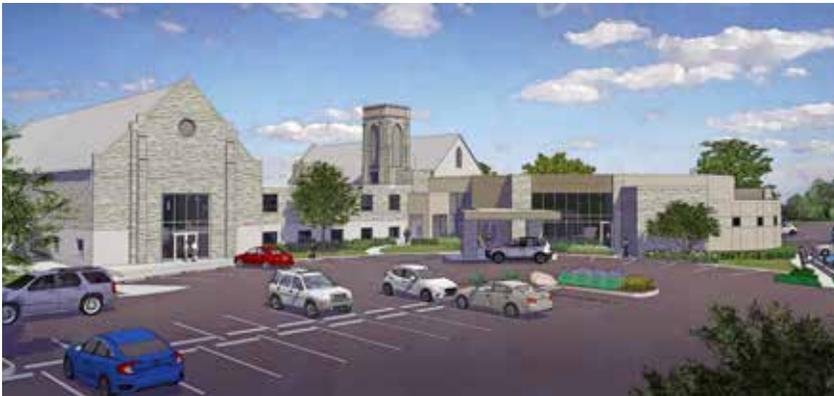
Figure 3-55. Rendering of a rear addition to a historic church that uses a hyphen to minimize impact on the adjacent historic fabric. Note that the addition uses a contemporary footprint, roof form, and fenestration pattern, but the height is subordinate to the historic building and the materials and color palette are compatible. Source: SKT Architects.

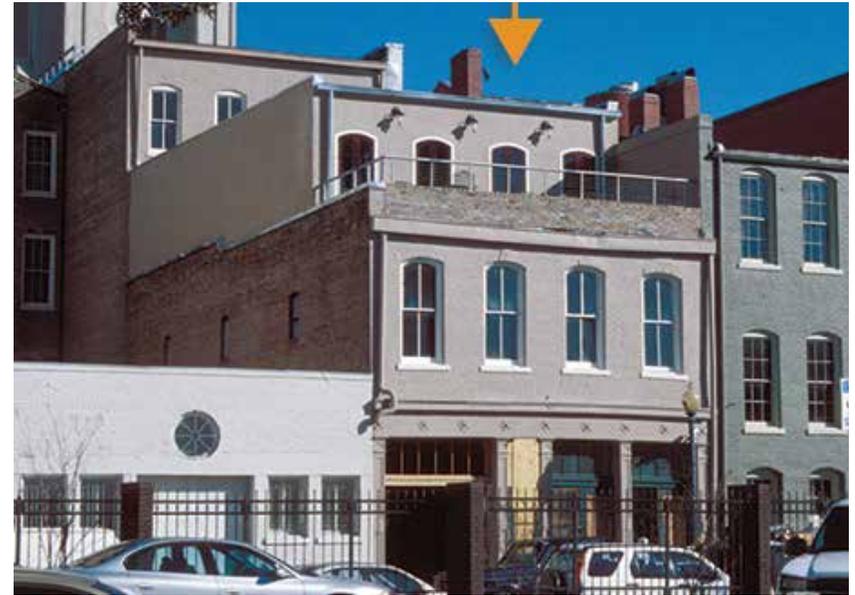
Figure 3-56. Example of a rooftop addition on a commercial building. In Fredericksburg, a similar rooftop addition would be appropriate only on a Low priority building, and only if set back 15 feet behind the original front wall per standard 3.3(f) above. Source: Anne E. Grimmer and Kay D. Weeks, *Preservation Brief 14: New Exterior Additions to Historic Buildings: Preservation Concerns*, National Park Service, updated August 2010, <https://www.nps.gov/tps/how-to-preserve/briefs/14-exterior-additions.htm>.

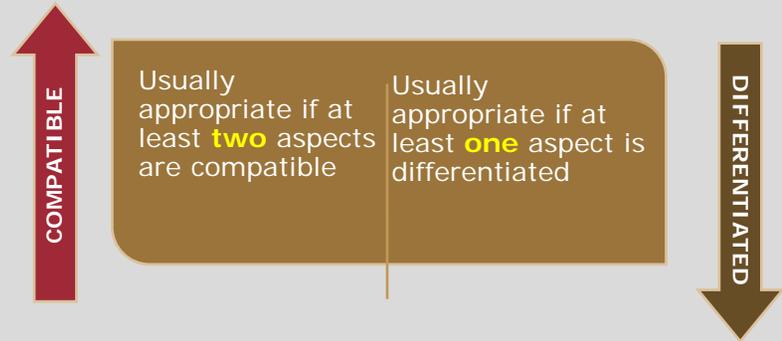
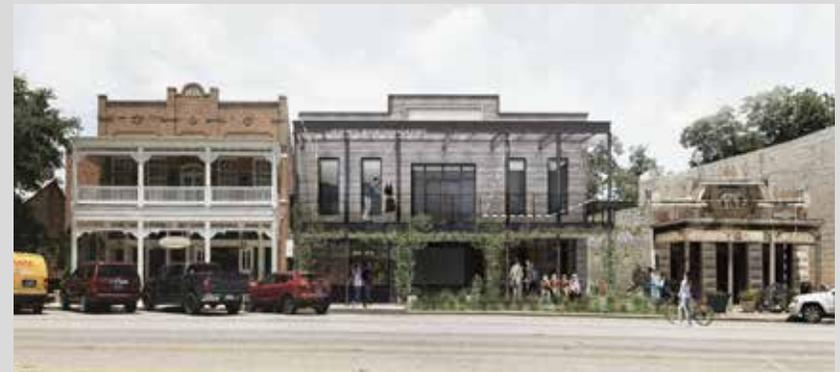
Rendering of the **appropriate** proposed new Albert Hotel on Main Street, designed by Clayton Little Architects. The new building shown at the center is compatible with its neighbors in terms of height, roof form, footprint, and the stylistic detailing of the parapet, but differentiated by its color, materials, and fenestration pattern. Also note the consistent setbacks and inclusion of a canopy. Source: Clayton Korte Architects.

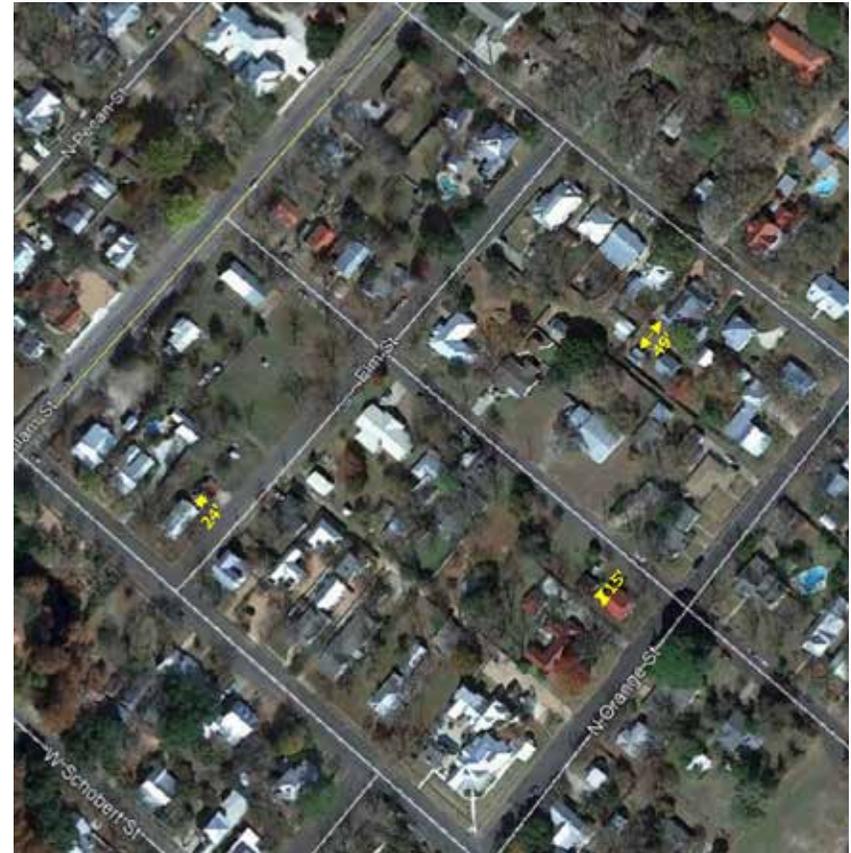
Figure 3-57. Aerial photograph showing a sampling of setback measurements between historic main houses and historic accessory buildings within the Fredericksburg Historic District. Note a range of setbacks between 15 feet and 66 feet. Source: Basemap and measurements from Google Earth Pro.

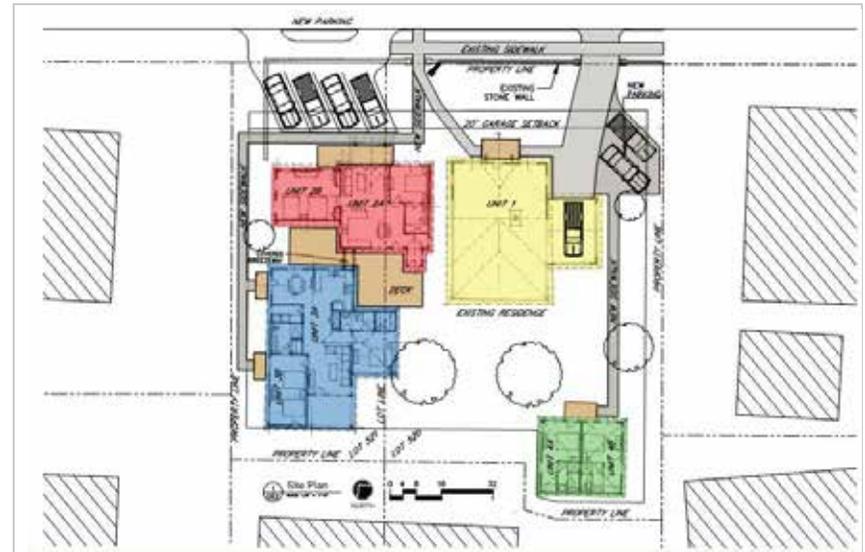
Figure 3-59. Example of an **inappropriate** site plan on E. Travis Street that proposes lot coverage far denser than the surrounding neighborhood. Note the contrast in setbacks between the proposed buildings and the surrounding historic buildings. Note also the proposed inappropriate parking location on the main street, with no buffering or landscaping. Source: City of Fredericksburg Historic Preservation Office.

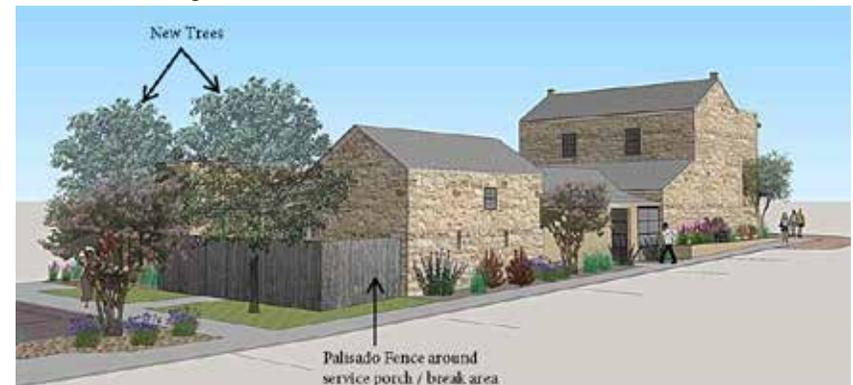
Figure 3-60. Example of locating parking at the side and using new fencing and landscaping to screen a new service area at 342 W. Main Street. Source: SKT Architects.

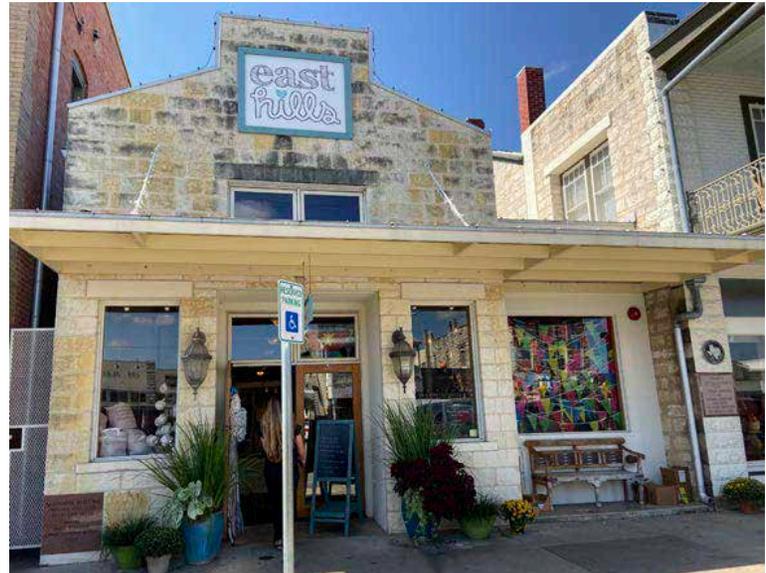
Figure 3-64. Example of an **appropriate** new commercial infill building at 127 E. Main Street, constructed with the front wall flush to the sidewalk – consistent with the adjacent historic buildings on Main Street east of Milam Street. Source: City of Fredericksburg Historic Preservation Office.

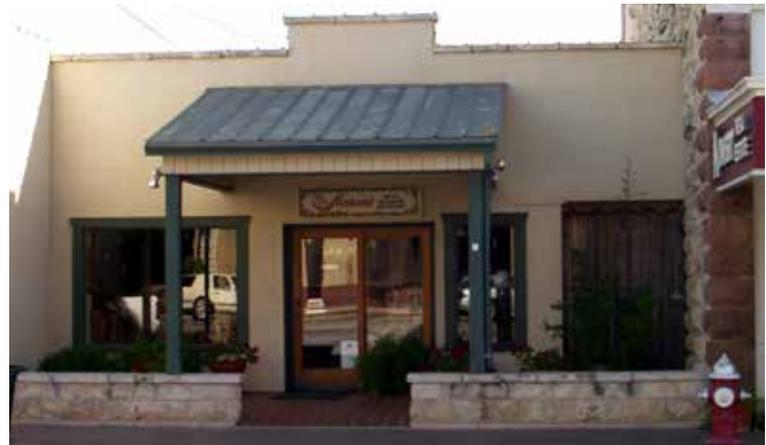
Figure 3-65. Example of an **inappropriate** ca. 1980 commercial building at 116 E. Main Street; its setback from the sidewalk interrupts the consistent line of storefronts. Source: HHM 2002 survey.

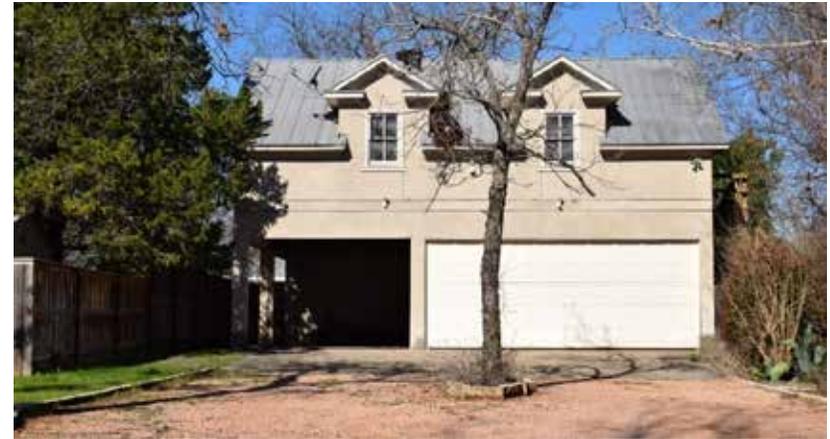
Figure 3-66. Example of an **appropriate** new accessory building—a garage apartment—with no applied ornament and minimal stylistic detailing, taking a visually subordinate role compared to the adjacent historic buildings (not shown). Since this building meets the definition of an ADU, it may be the only ADU on the lot. Source: HHM, 2020.

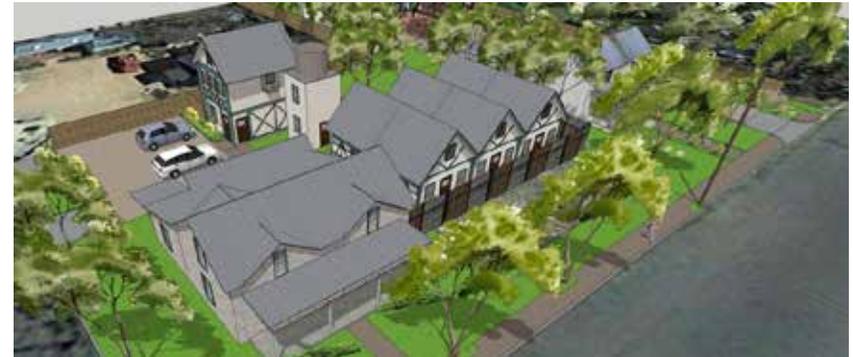
Figure 3-67. Rendering of an **inappropriate** site plan with insufficient setbacks between the historic primary building and the new ADUs to the right. The design of the ADUs also is inappropriate, with one of the ADUs designed to look like multiple cottages rather than a single building, plus inappropriate false structural detailing and applied ornament. Source: City of Fredericksburg Historic Preservation Office.

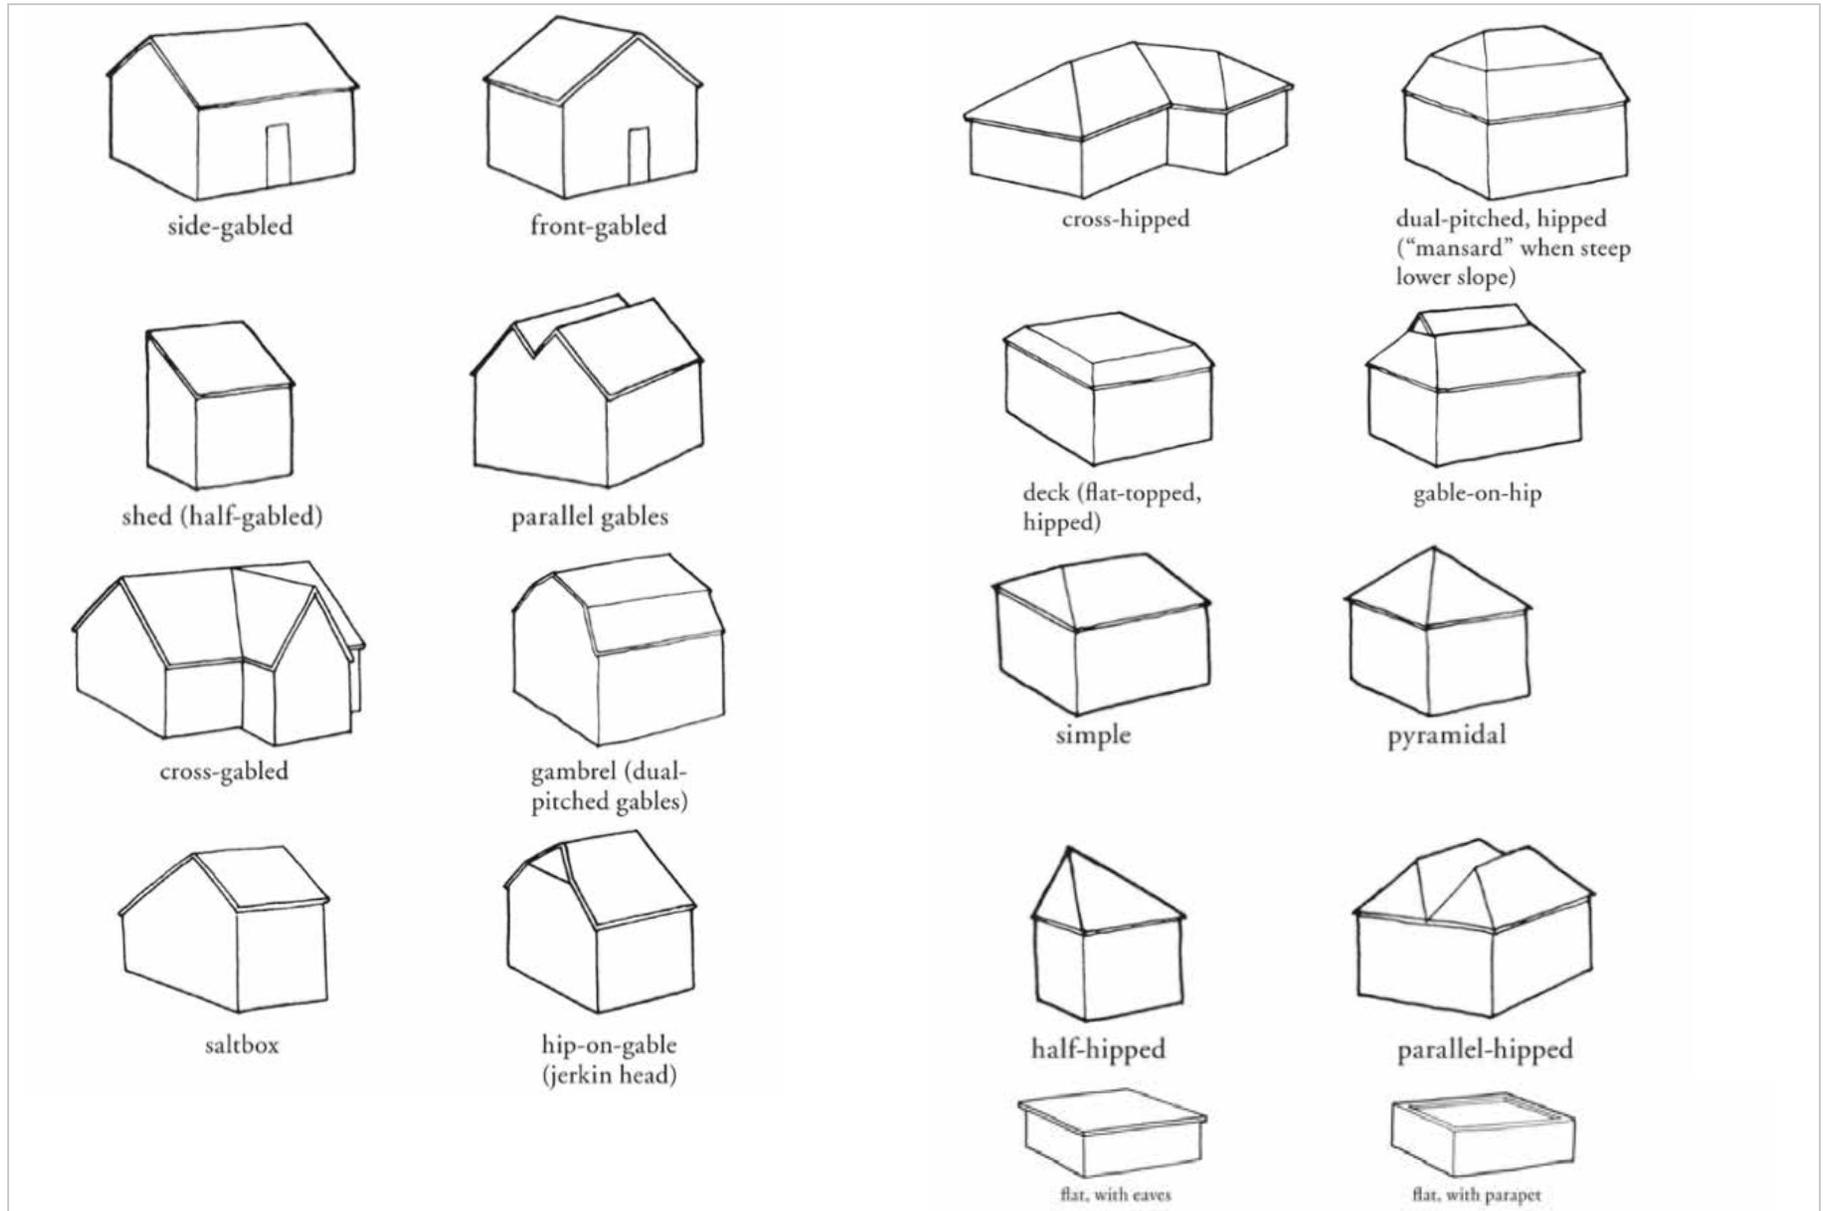
Figure A-1. Diagrams depicting types of roofs commonly found on historic houses. Source: McAlester, *Field Guide to American Houses*.

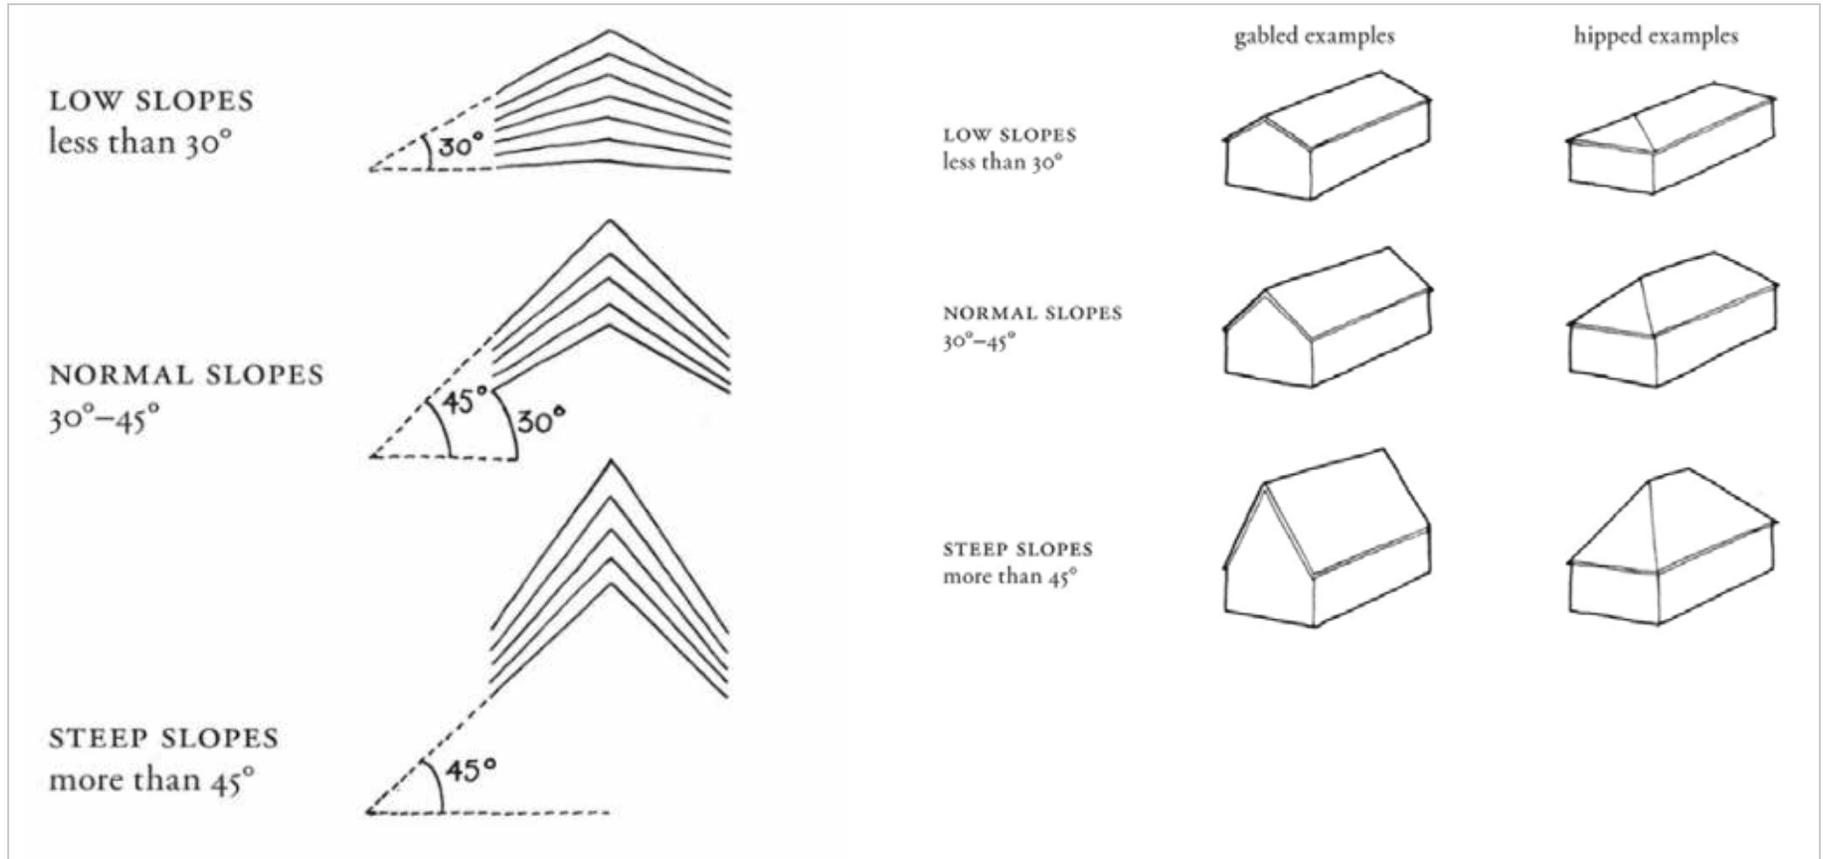
**Figure A-2.** Diagram depicting roof slopes (or roof pitches) commonly found on historic houses. Source: McAlester, *Field Guide to American Houses*.
