3. STANDARDS & GUIDELINES FOR HISTORIC PROPERTIES

3.1. INTRODUCTION

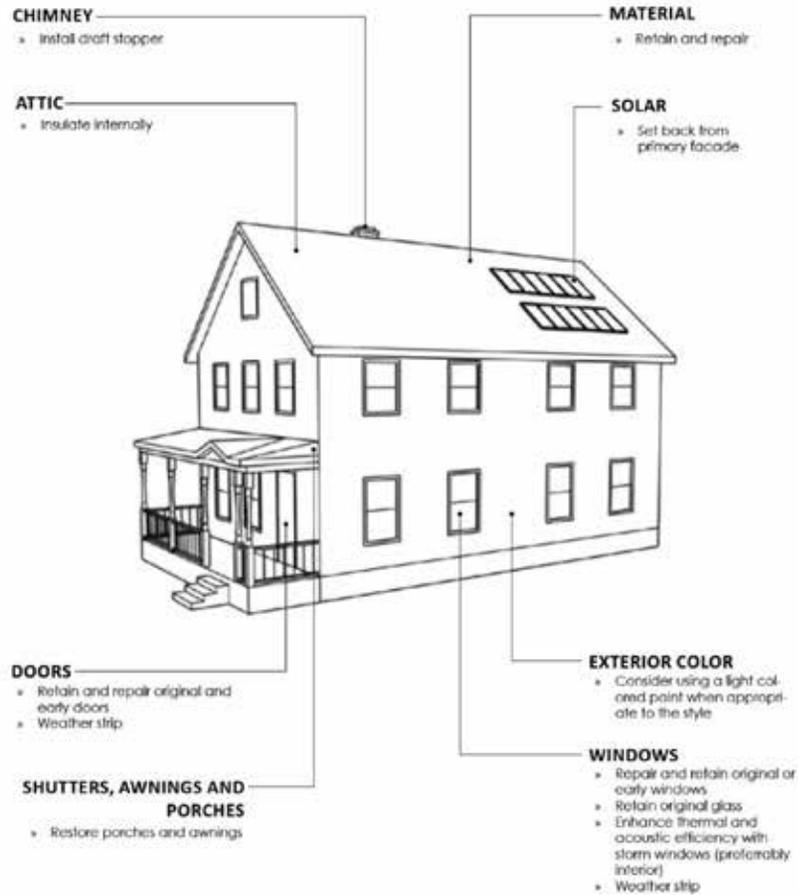
This diagram summarizes the principal guidelines for a rehabilitation project for energy efficiency on a residential building. These measures can enhance energy efficiency while retaining the integrity of the historic structure.

Figure 3-3. Diagram of **appropriate** residential energy-efficiency measures. Source: Winter & Company archives.

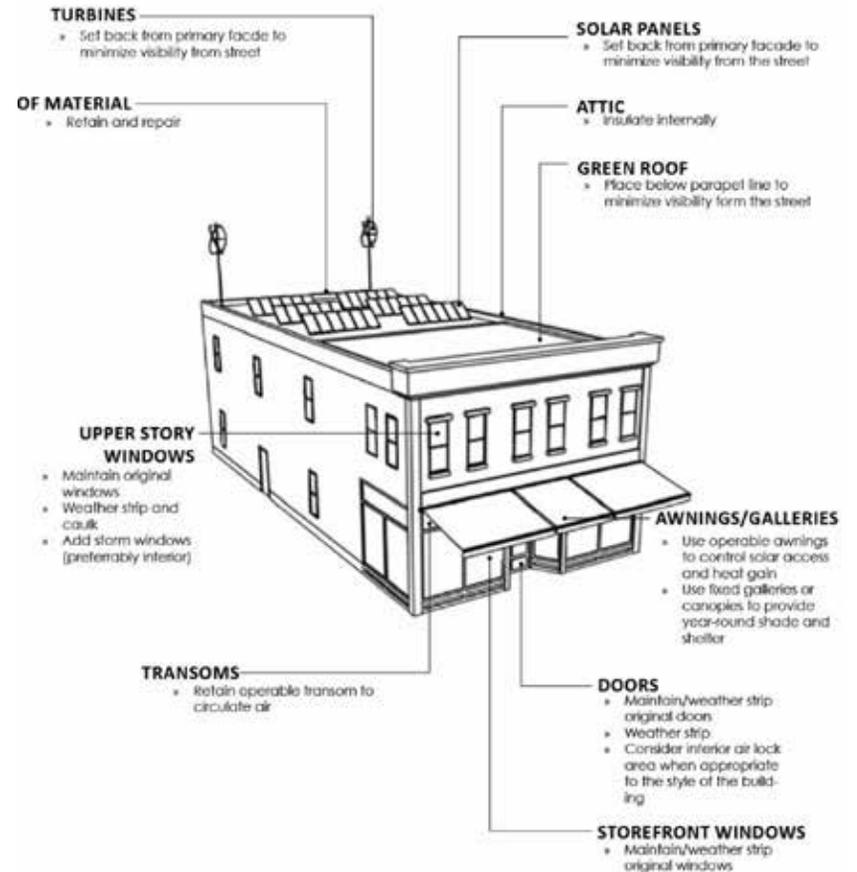
This diagram summarizes the principal guidelines for a rehabilitation project for energy efficiency on a commercial building. These measures can enhance energy efficiency while retaining the integrity of the historic structure.

Figure 3-4. Diagram of **appropriate** commercial energy-efficiency measures. Source: Winter & Company archives.

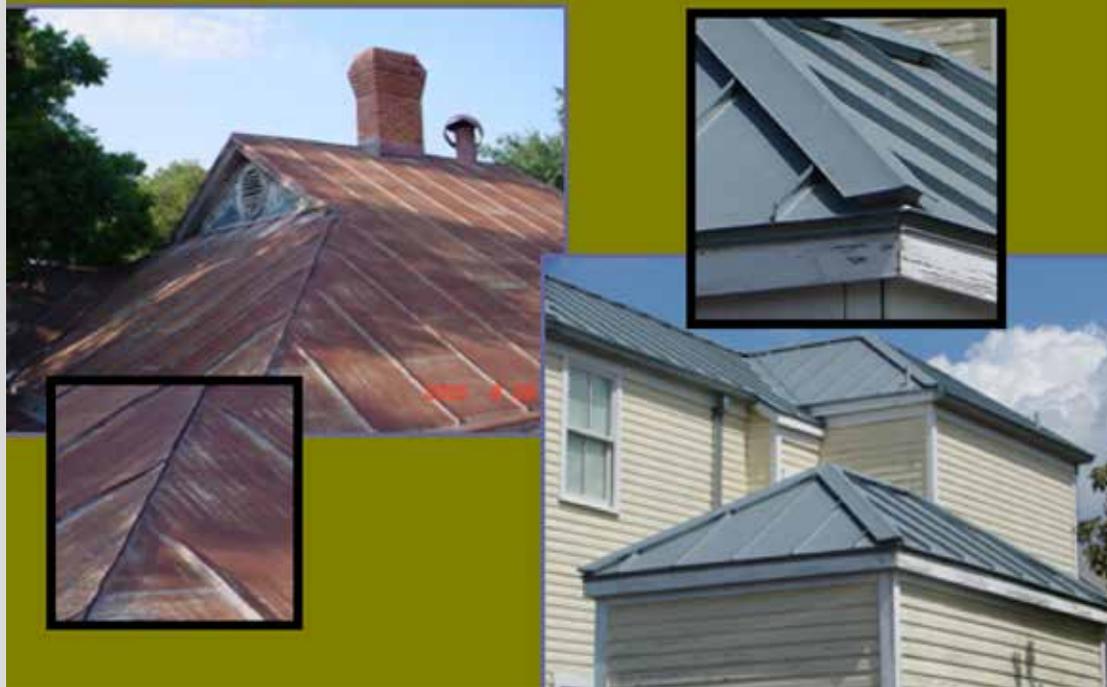
Figure 3-6. Examples of appropriate details for metal roofs. Sources: City of Fredericksburg Historic Preservation Office, SMANCA Architectural Sheet Metal Manual.

The **above** photographs compare details of metal roofs. The example of the reddish roof at the far left uses crimped joints, required for houses built before ca. 1915. The gray roof in the middle example uses a ridge cap, which is not appropriate for this pre-1915 house, but might be appropriate for a post-1915 house.

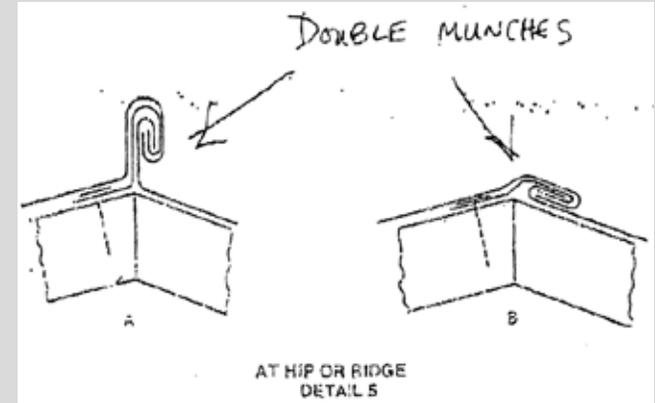
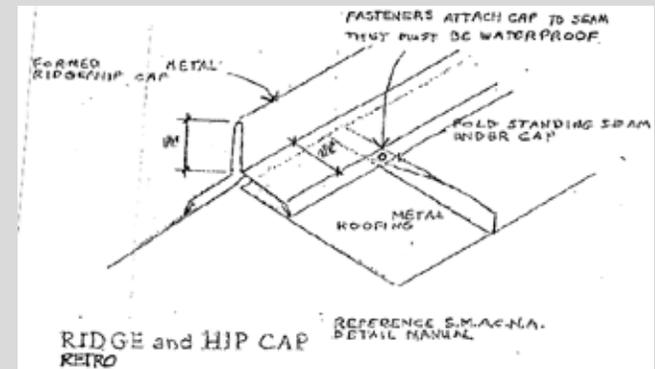
The **top** detail shows a type of folding known as “double munch” appropriate for joints on pre-1915 buildings; the **bottom** detail shows use of a ridge cap, which is acceptable on post-1915 buildings.

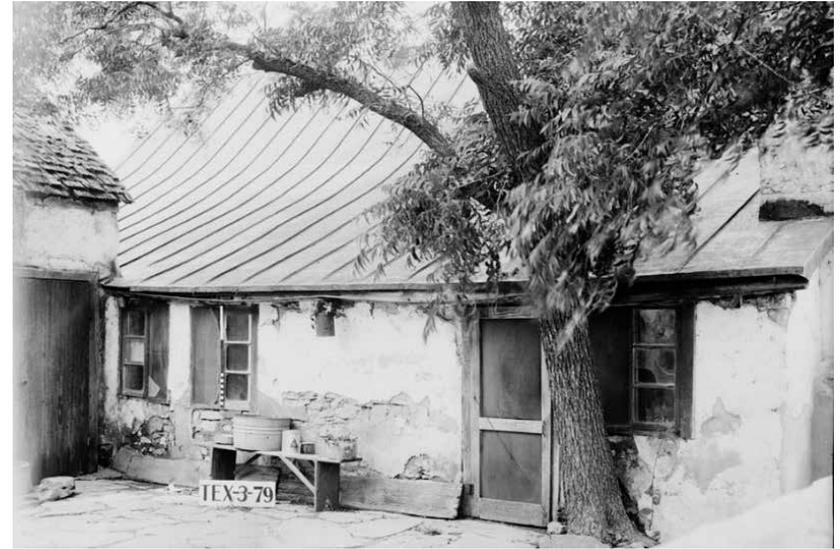
Figure 3-12. Photo of the Heinrich Kammlah House, 309 W. Main Street, showing wood shingles on the older portion of the house (seen on the left), juxtaposed to standing-seam metal roofing on a historic-age addition. Source: Library of Congress, HABS, ca. 1930, <https://www.loc.gov/item/tx0336/>. Find additional HABS photos showing a combination of metal and wood shingle roofs at <https://www.loc.gov/pictures/search/?q=fredericksburg>.

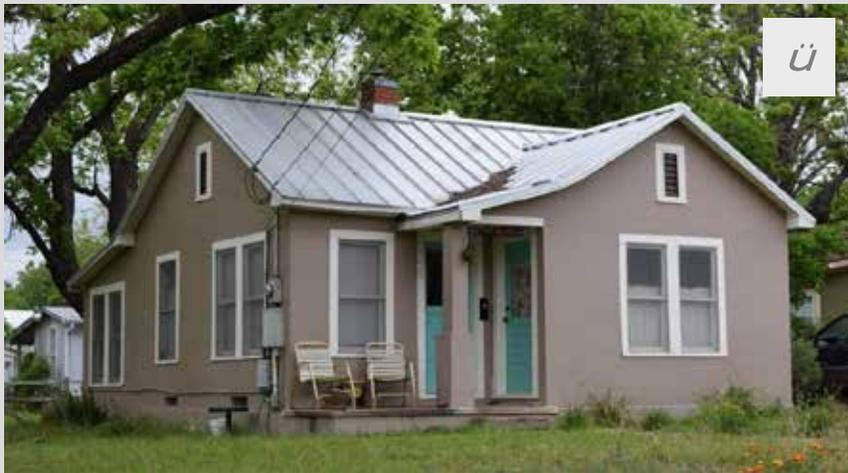
The **above** example of a new metal roof at 402 N. Milam Street is **appropriate in this case** because the house has no style, so the original roof materials were not character-defining. The ridge cap is appropriate given the ca. 1940 date.

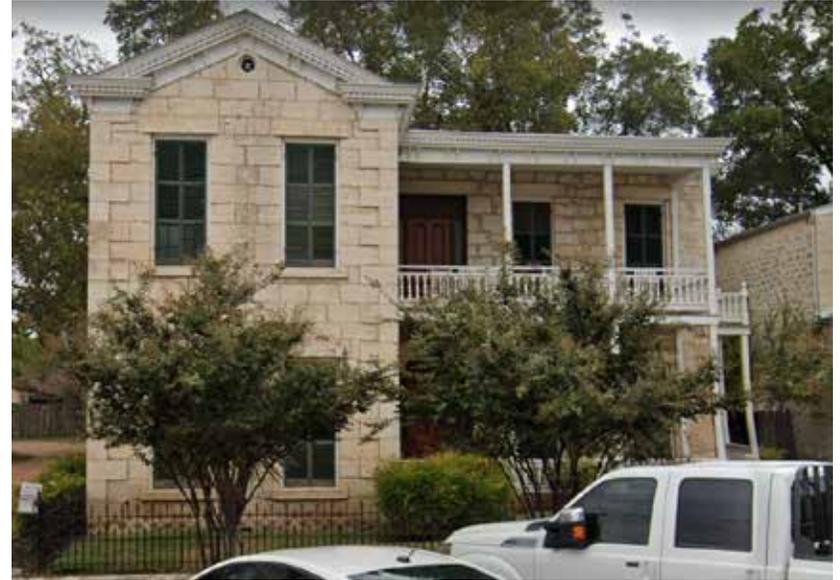
Figure 3-16. Example of an **appropriate** supplemental railing added above a historic balcony railing at 252 E. Main Street. Source: Google Street View.

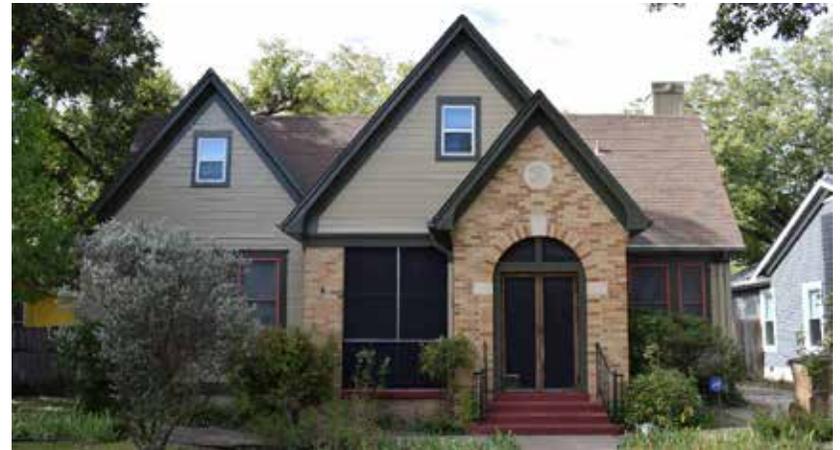
Figure 3-17. Example of a reversible porch screening that does not damage or obscure historic character-defining features, **appropriate for Low or Medium priorities only**. Source: HHM archives.

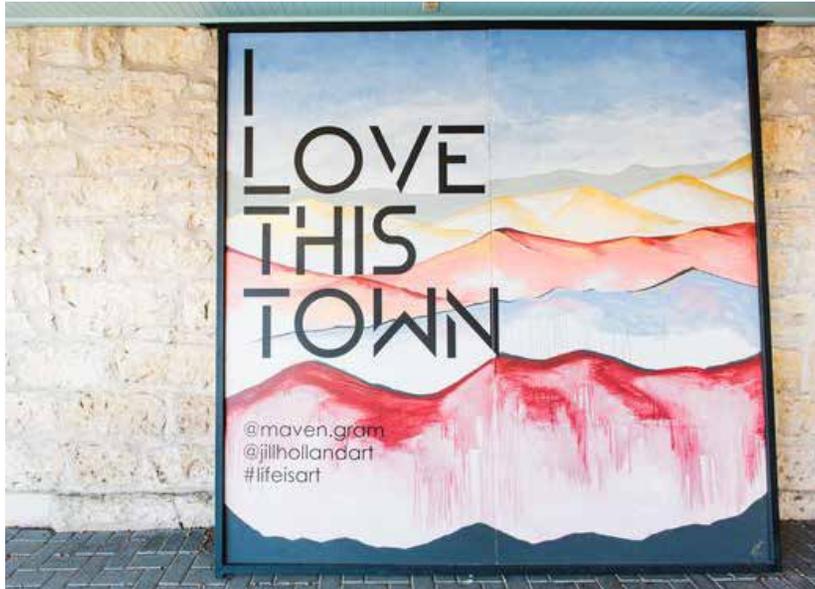
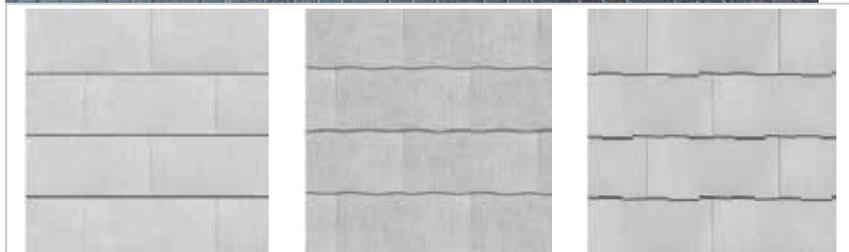
Figure 3-25. Matching replacement siding is just as important for midcentury buildings as older buildings. Fiber-cement shingles may be used to replace asbestos shingles. Although available options for fiber-cement—like these—may not match the original profile and dimension of the asbestos shingles exactly, the closest match available should be selected. Source: “Purity Fiber-Cement Siding,” GAF, accessed January 24, 2021, <https://www.gaf.com/en-us/roofing-products/residential-roofing-products/fiber-cement-siding/siding-shingles/weatherside-purity-fiber-cement-siding>.

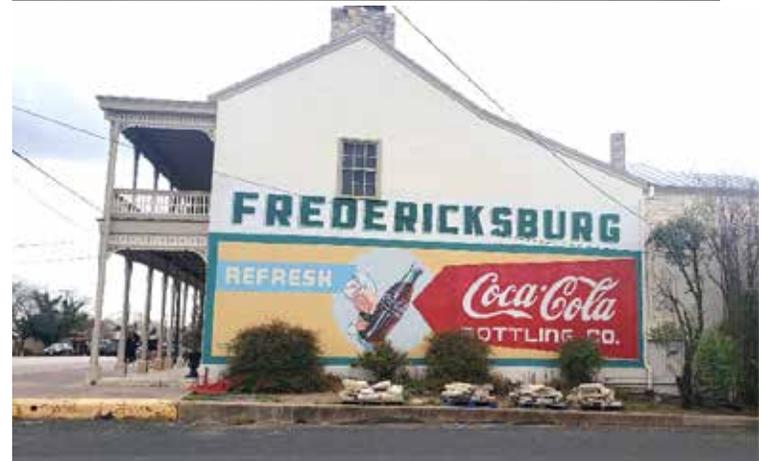
Figure 3-26. Example of a historic mural that has been restored by a local artist. Source: Shannon Yarbrough, “A Coca Cola sign in Fredericksburg” [top photo], from “Fredericksburg, Texas,” Texas Escapes, accessed January 8, 2021, <http://www.texasescapes.com/TexasHillCountryTowns/Fredericksburg-Texas.htm>.

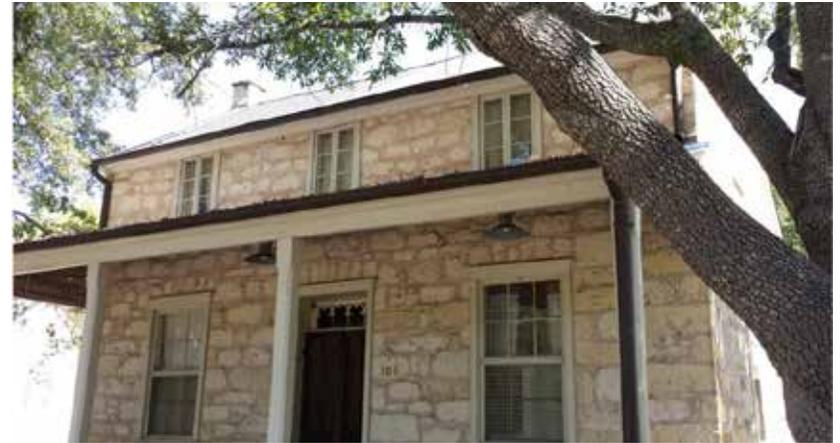
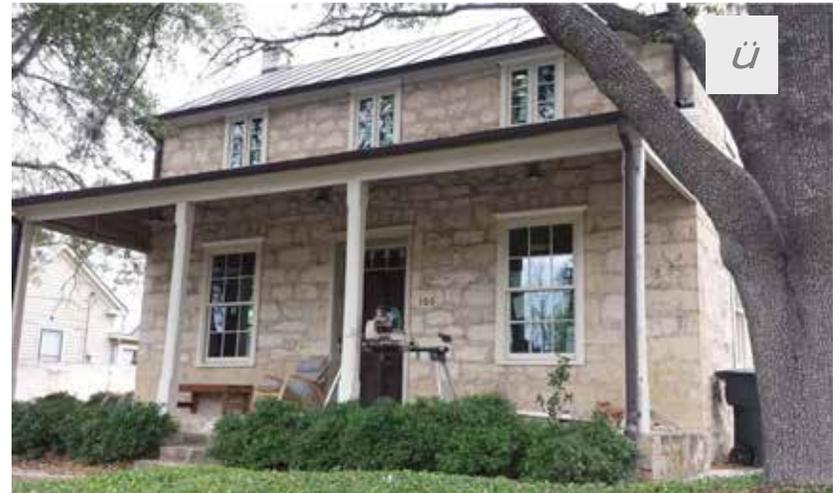
BEFORE

Figure 3-33. Example of **appropriate** replacement windows at 106 E. Schubert Street. The new aluminum clad wood windows match the original in size, configuration, profile, and depth. Source: City of Fredericksburg Historic Preservation Office.

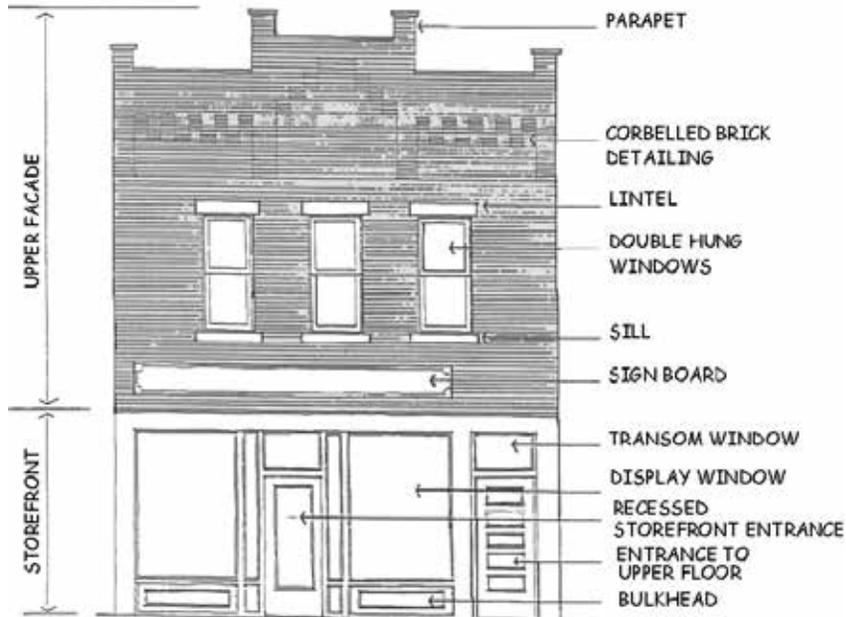
Figure 3-38. Typical storefront design with common features found along Main Street. Source: Zanesville, OH code of ordinances

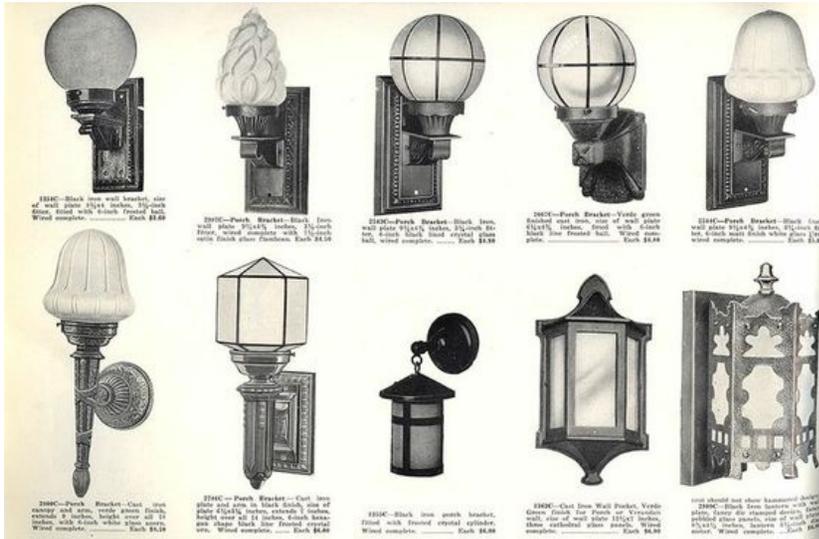
Figure 3-44. Example of period-appropriate porch bracket fixtures for late-nineteenth or early-twentieth century buildings. Source: Pinterest, accessed January 10, 2021, <https://www.pinterest.com/pin/290834088430267824/>.

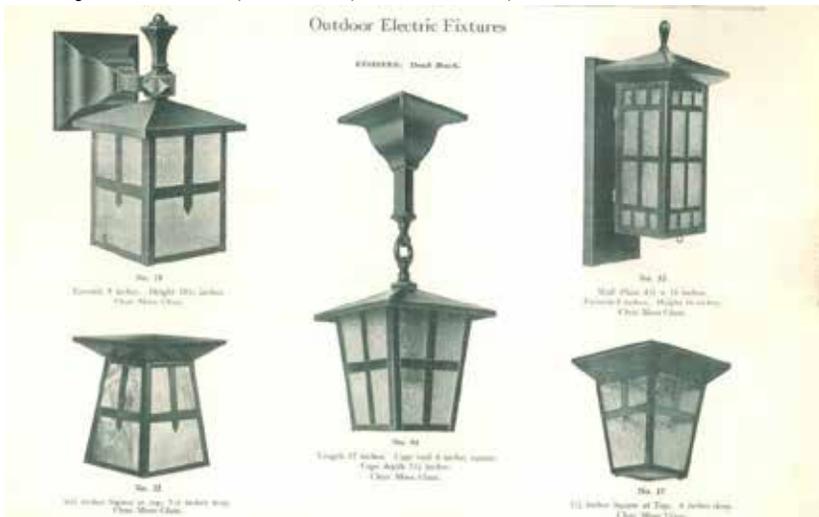
Figure 3-45. Example of period-appropriate porch bracket fixtures Prairie Style or Craftsman resources, dating from ca. 1910 through ca. 1940. Especially note the ceiling-mounted options. Source: Pinterest, accessed January 25, 2021, <https://www.pinterest.de/pin/93660867237805123/>.

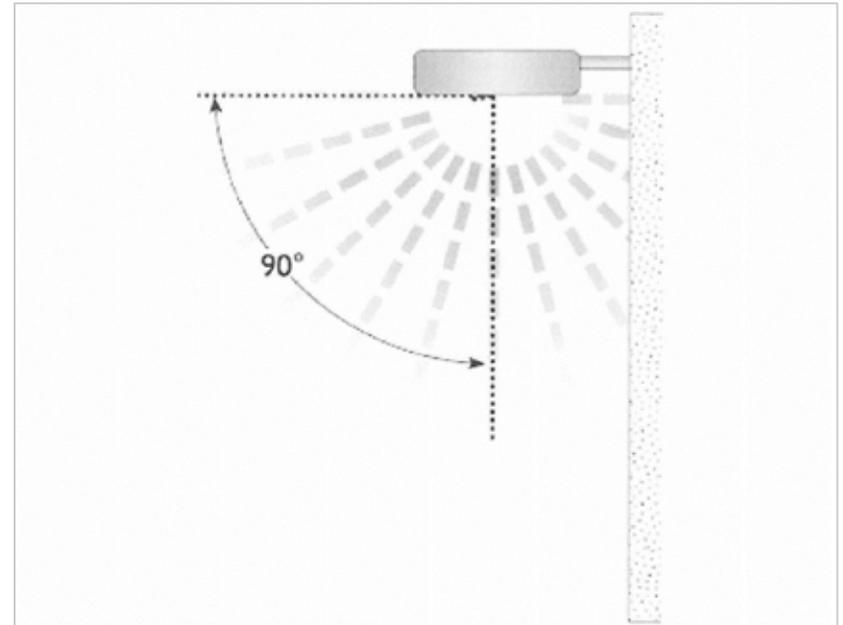
Figure 3-46. Profile of a lighting fixture meeting Fredericksburg’s Outdoor Lighting Ordinance. Note how the light does not shine upward, allowing the sky to remain dark. Source: “Ordinance No. 2019-16,” City of Fredericksburg, <https://www.fbgtx.org/DocumentCenter/View/2869/Ordinance-2019-16--Outdoor-Lighting>.

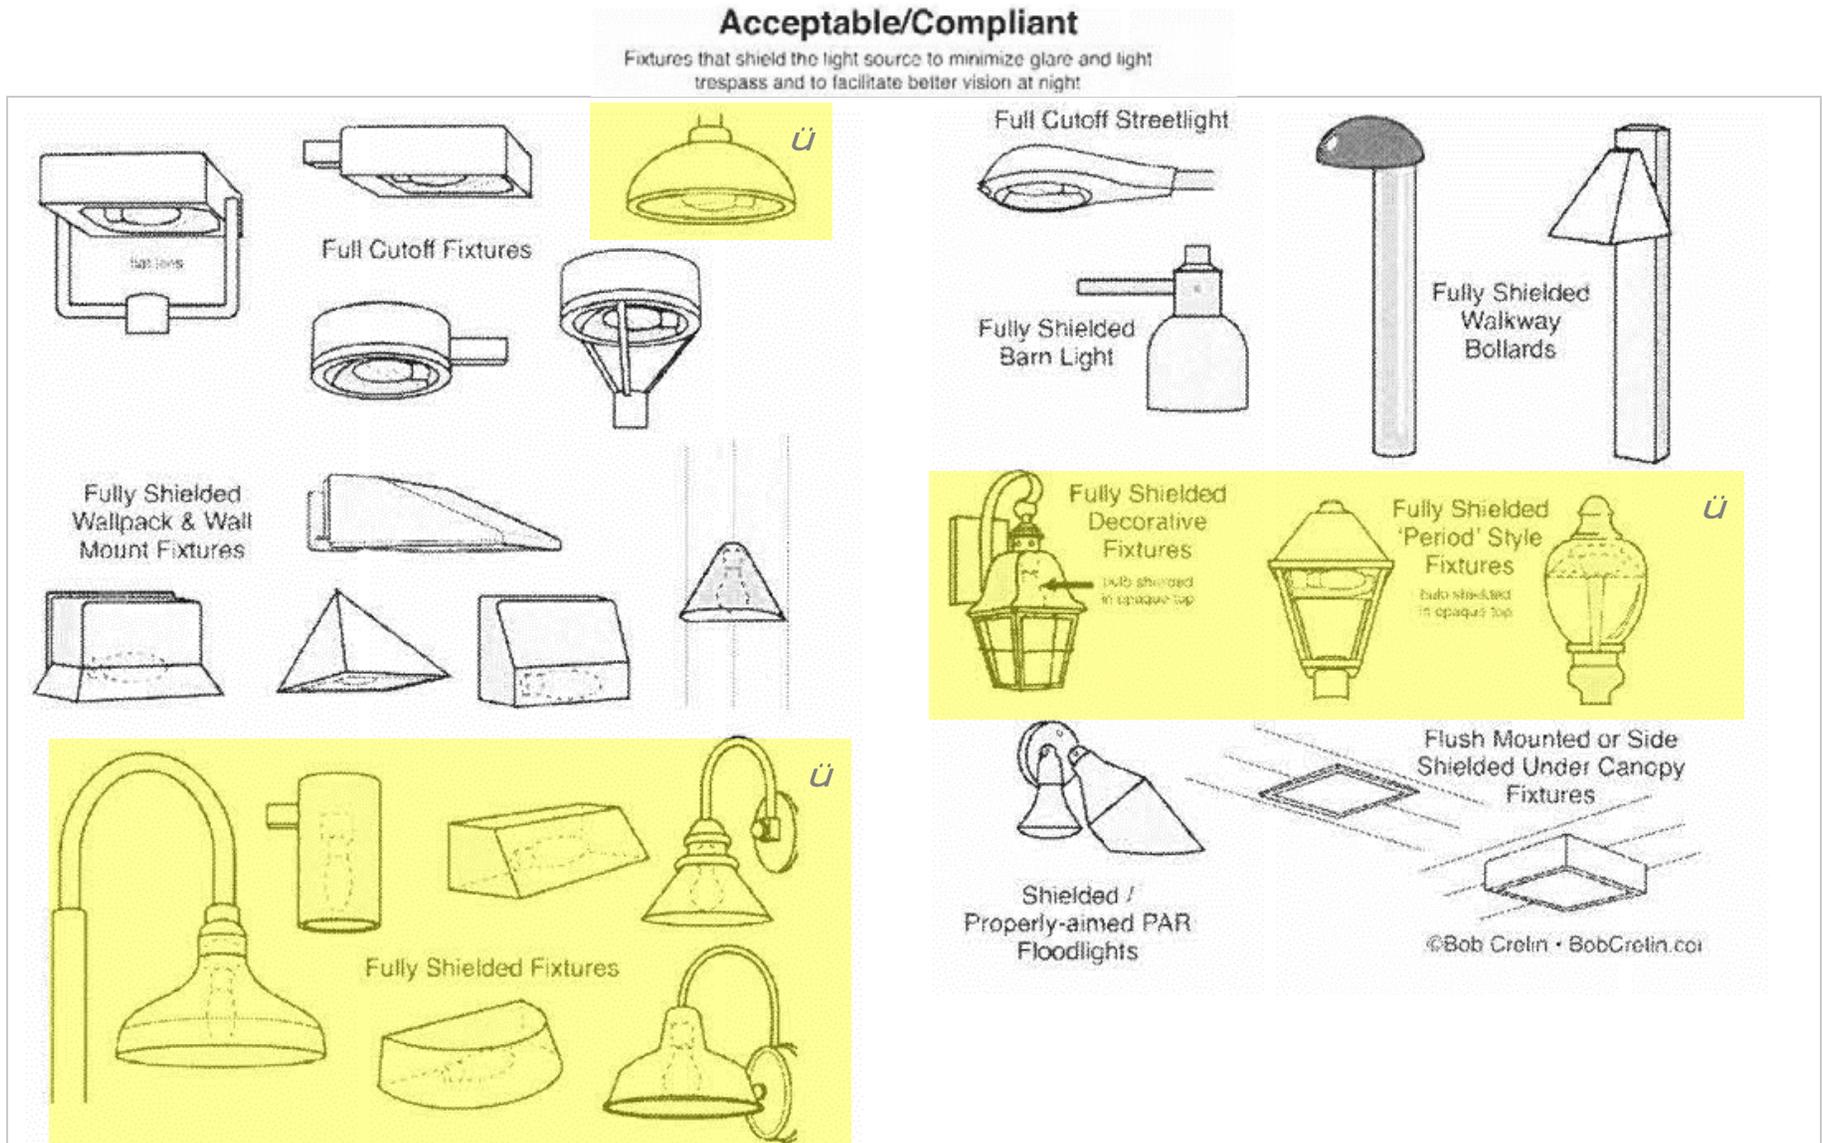
Figure 3-47. Examples of “Acceptable/Compliant” lighting fixtures per Fredericksburg’s Outdoor Lighting Ordinance, with appropriate fixtures for historic buildings highlighted in yellow. Refer to *Section 2* to match the examples with the relevant style(s) and period(s) of construction. Source: “Ordinance No. 2019-16,” City of Fredericksburg, <https://www.fbgtx.org/DocumentCenter/View/2869/Ordinance-2019-16--Outdoor-Lighting>.
