**CITY OF FREDERICKSBURG
HISTORIC REVIEW BOARD**

3. Application #14-04 by Jon Pankratz on behalf of Milton Buckalew and Liza Smith at 110 W. Centre to: *Pp 3 - 15*
 - A) Add a brick veneer wood burning fireplace

5. Application #14-09 by David Sawtelle at 714 W. Main to: *Pp 22 - 38*
 - A) Remove cement stucco from front of building
 - B) Remove non-original trim to reveal original wood framing

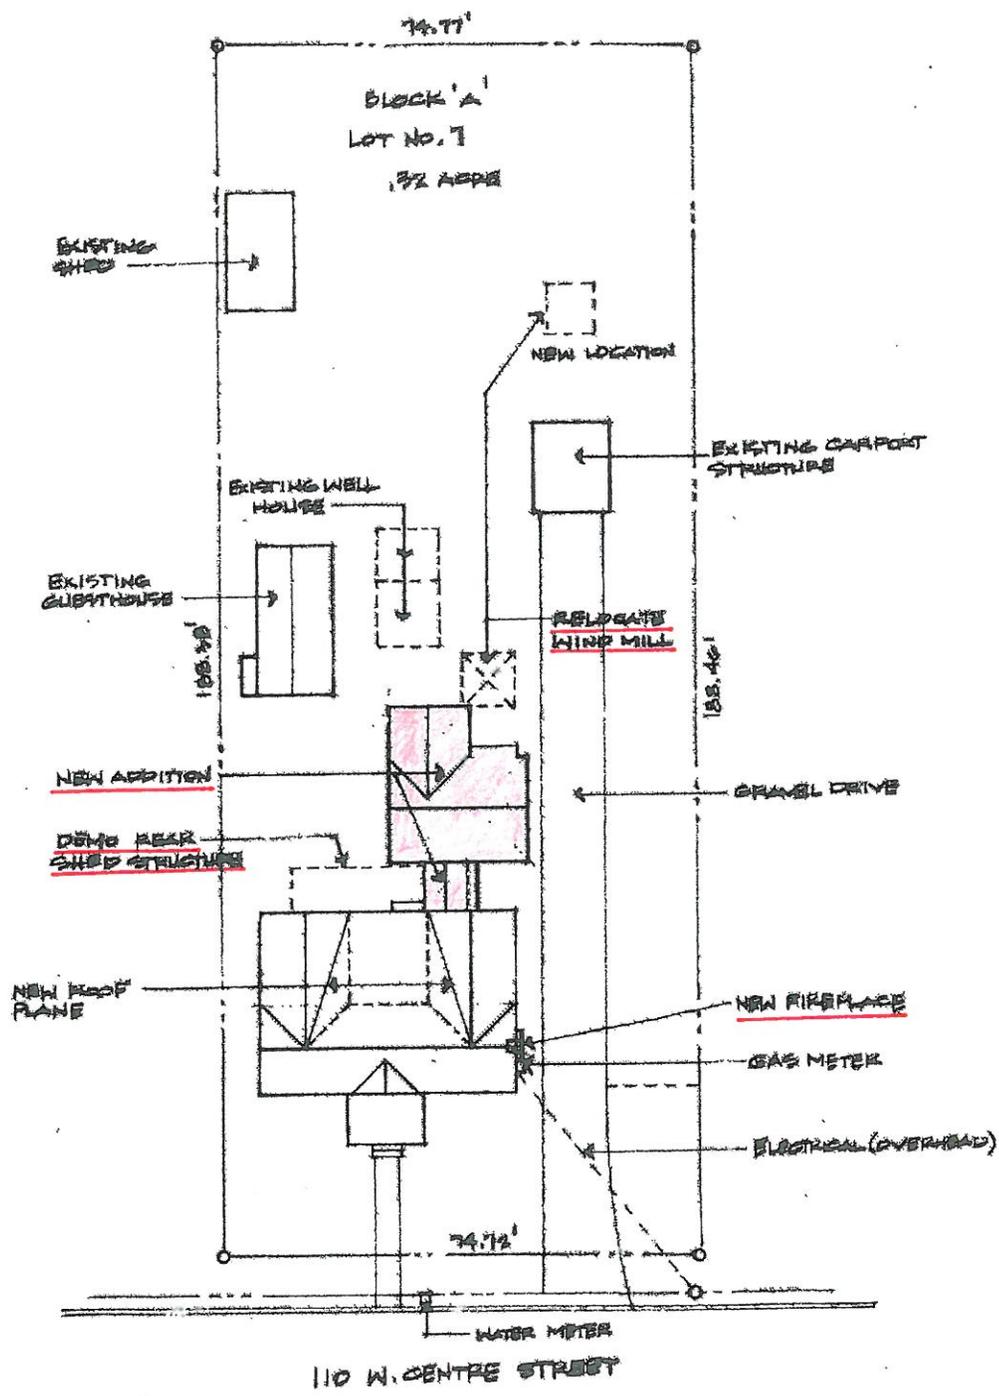
SITE PLAN
110 W. CENTRE

1" = 30' - 0"

Existing wind mill to be relocated to an area to be determined - some location to the rear of the property. See Site Plan.

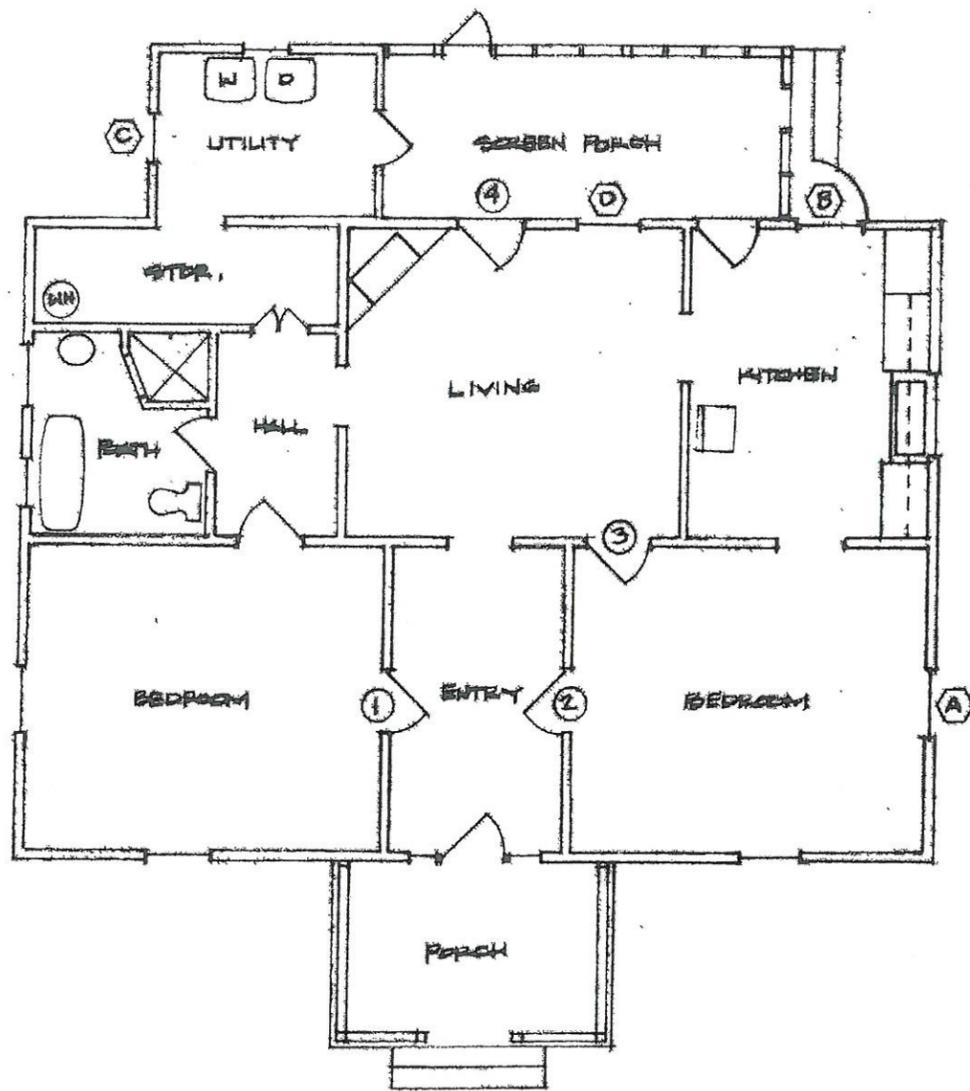
EXISTING FLOOR PLAN
110 W. CENTRE

1120 S.F.
1/8" = 1'-0"

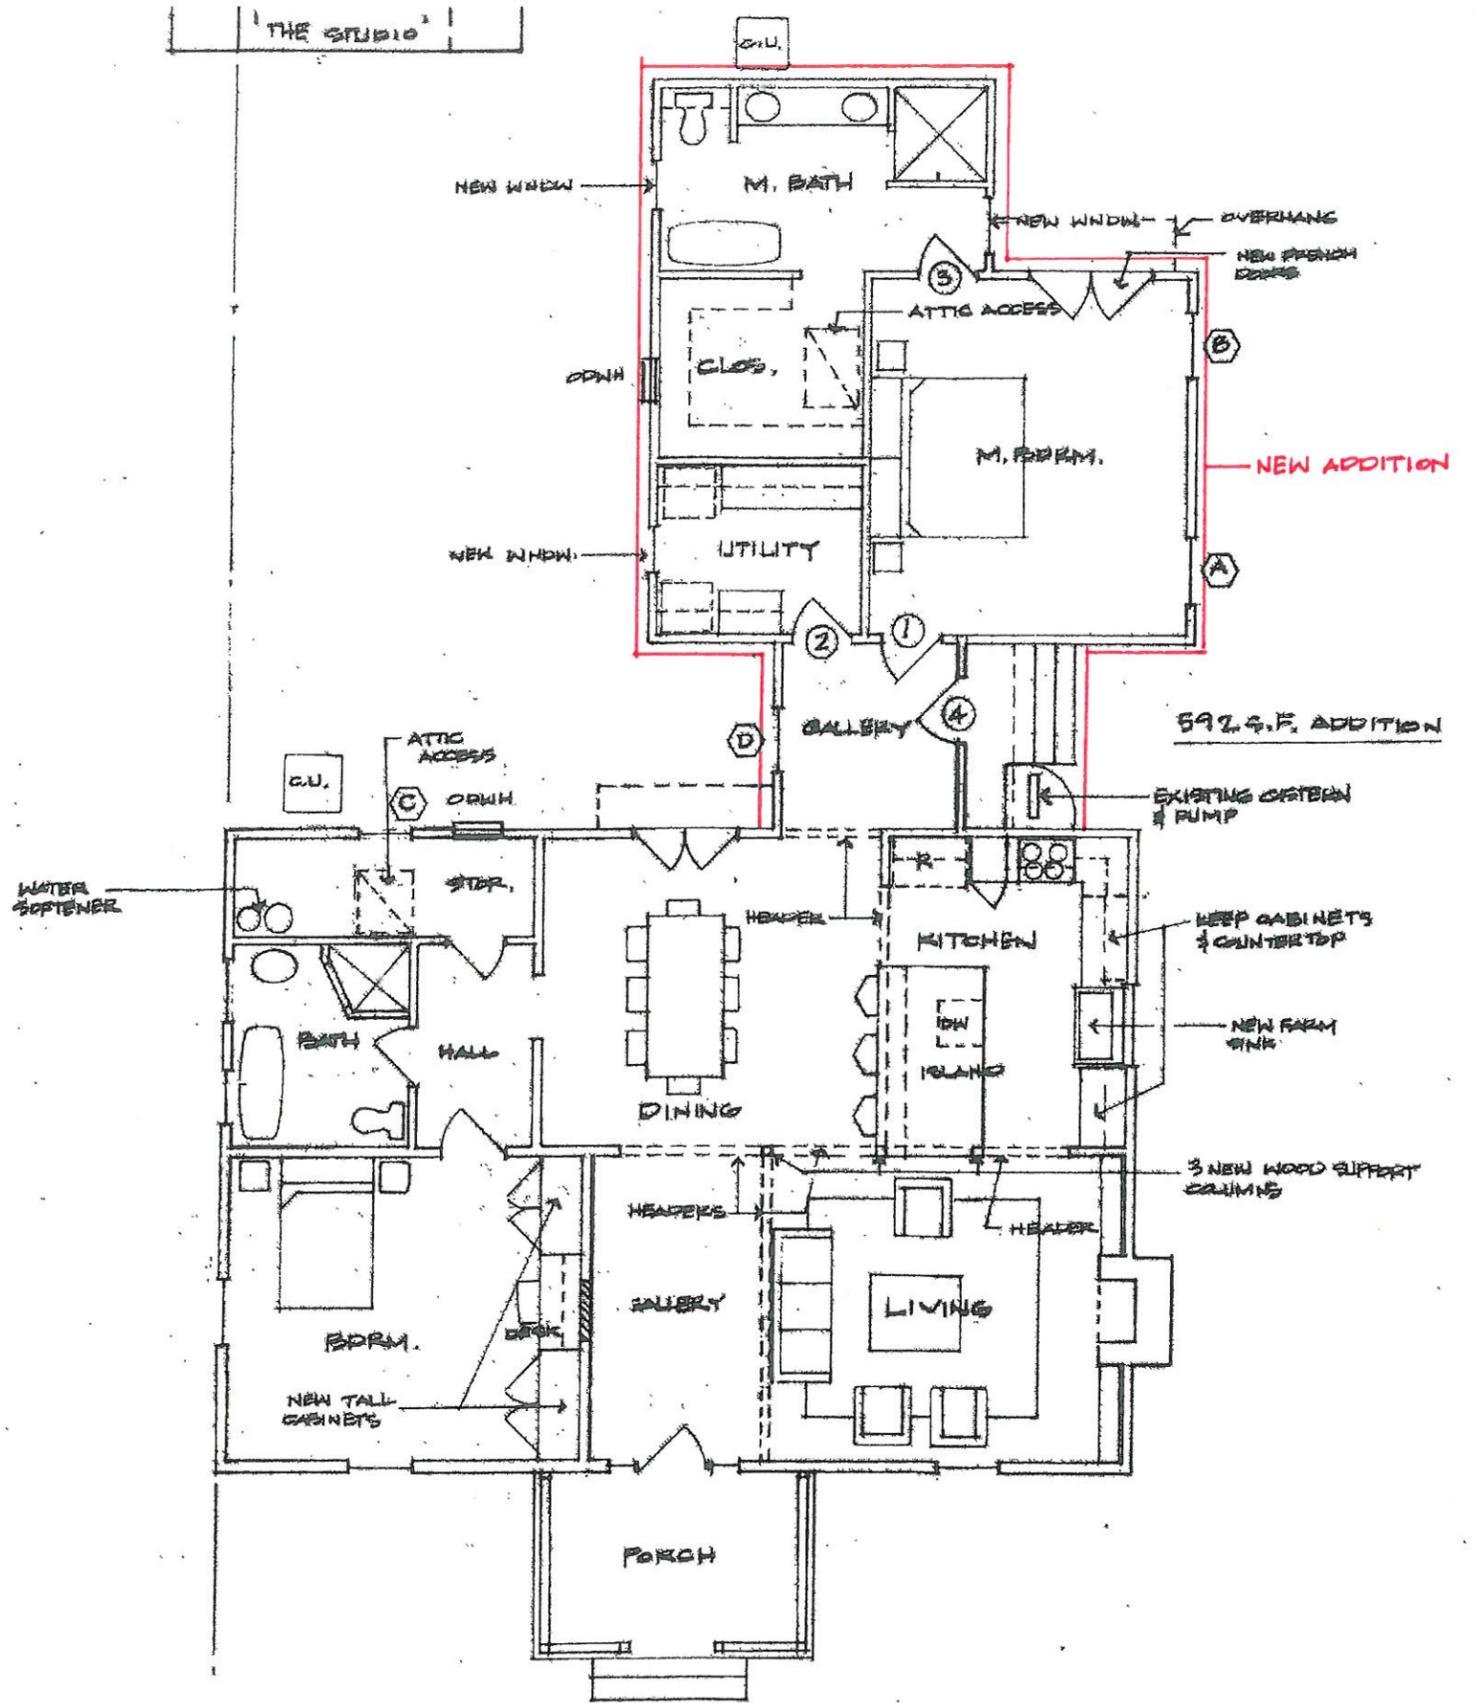
PROPOSED FLOOR PLAN
110 W. CENTRE

1/8" = 1'-0"

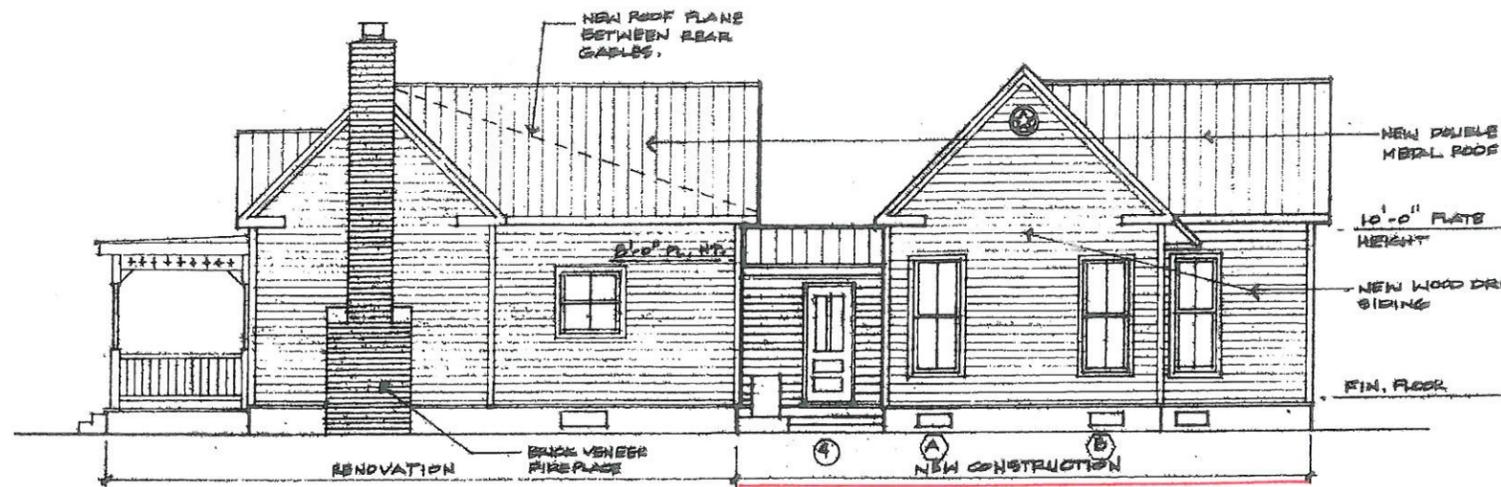
BUILDING ELEVATION
SW FACING
110 W. CENTRE
1/8" = 1'-0"

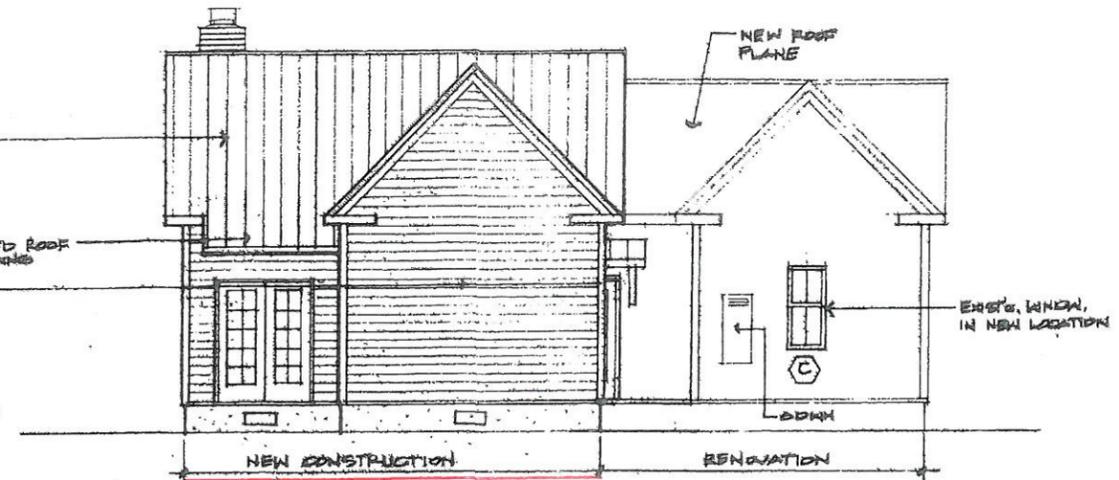
BUILDING ELEVATION
NW FACING
110 W. CENTRE
1/8" = 1'-0"

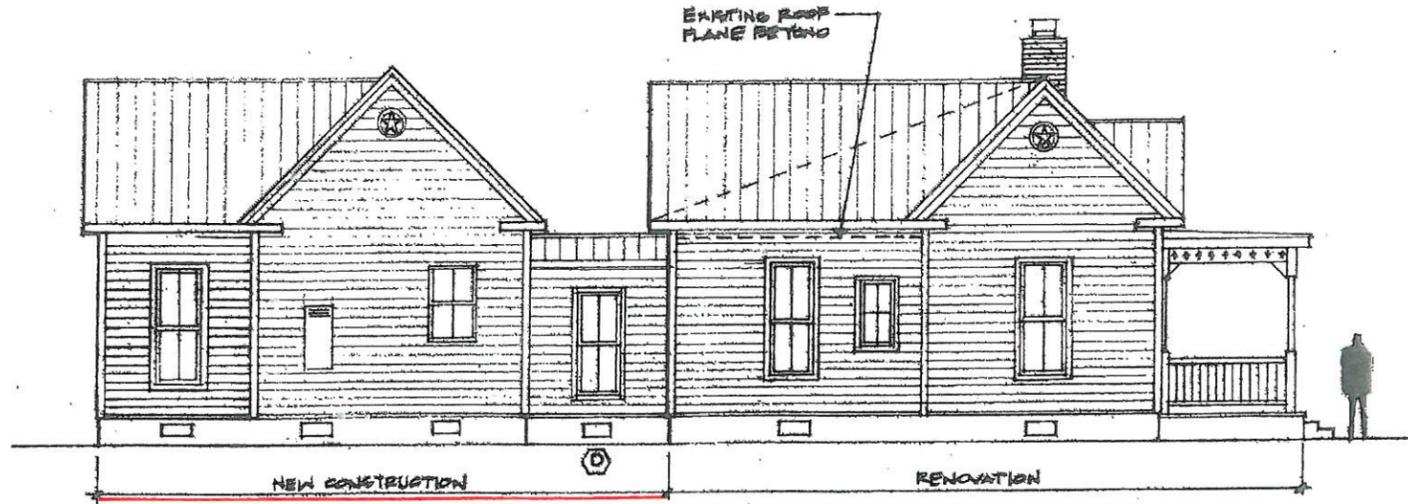
BUILDING ELEVATION
NE FACING
110 W. CENTRE
1/8" = 1'-0"

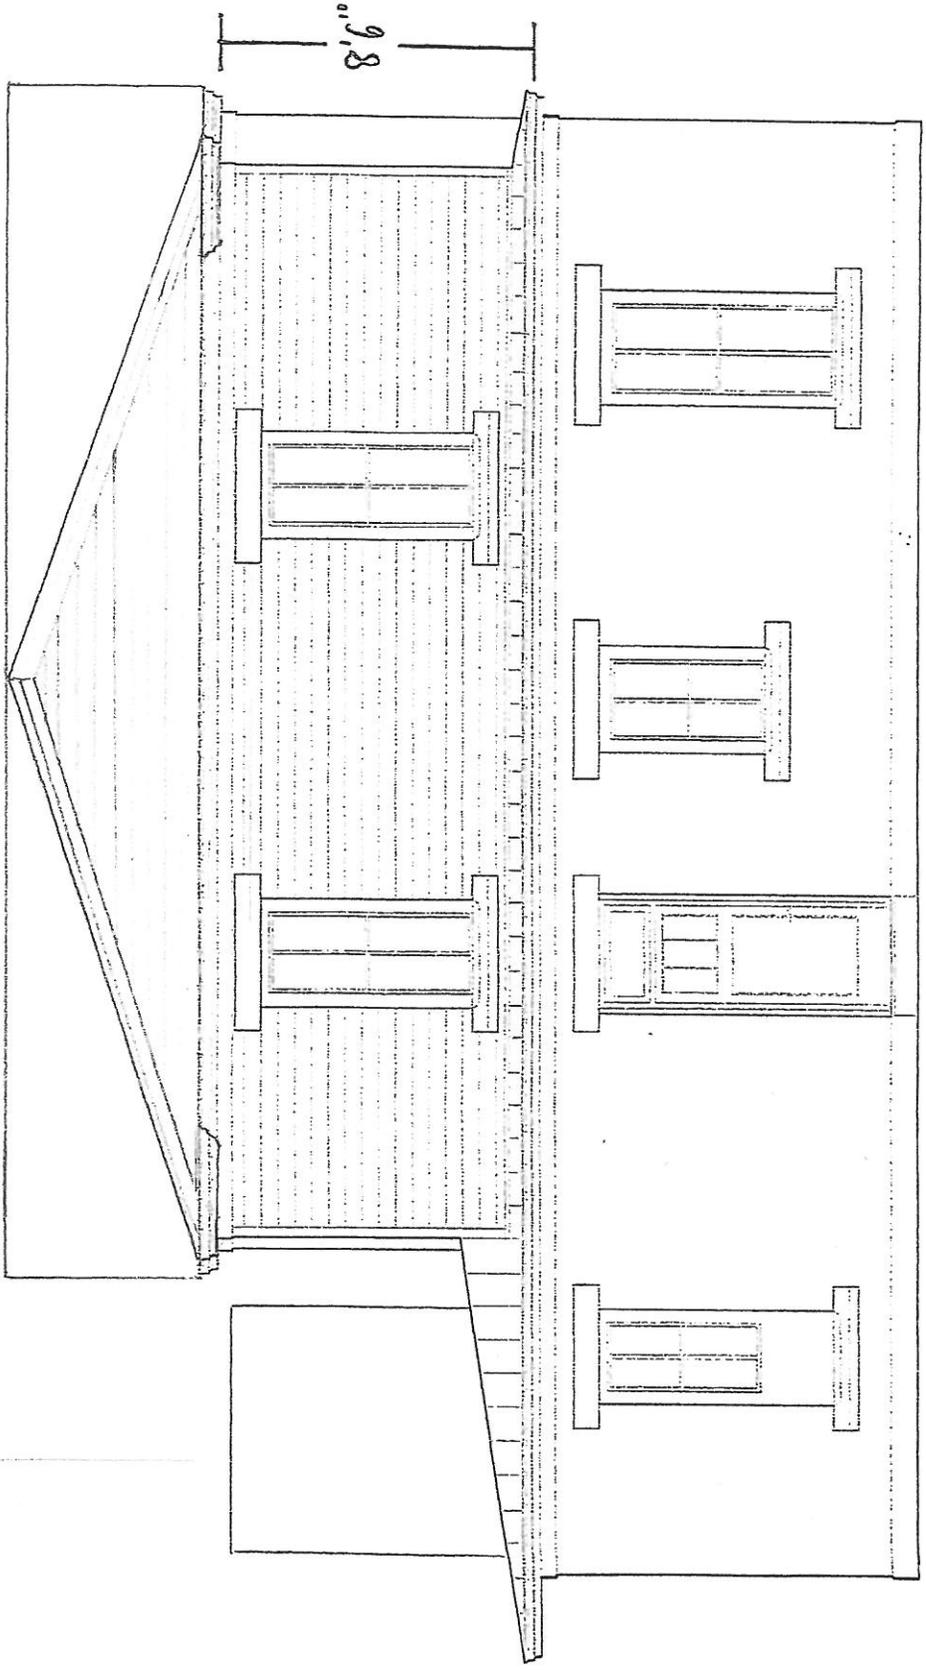
NORTH ELEVATION (FACING REAR OF HOUSE)

The Historic Review Board approved our request for the addition on the condition that we change the roof such that the new faces of the roof that would be visible from the street were hipped. We redrew it such that it was a pure hip roof, back and sides. However, from a compatibility, or matching, standpoint with the existing architecture of the house, which has gables on three of the four sides, we are asking that the back of the new roof also be a gable, rather than a hip. This would help us framing-wise, hence cost-wise to the owner, and be more in keeping with the look of the house.

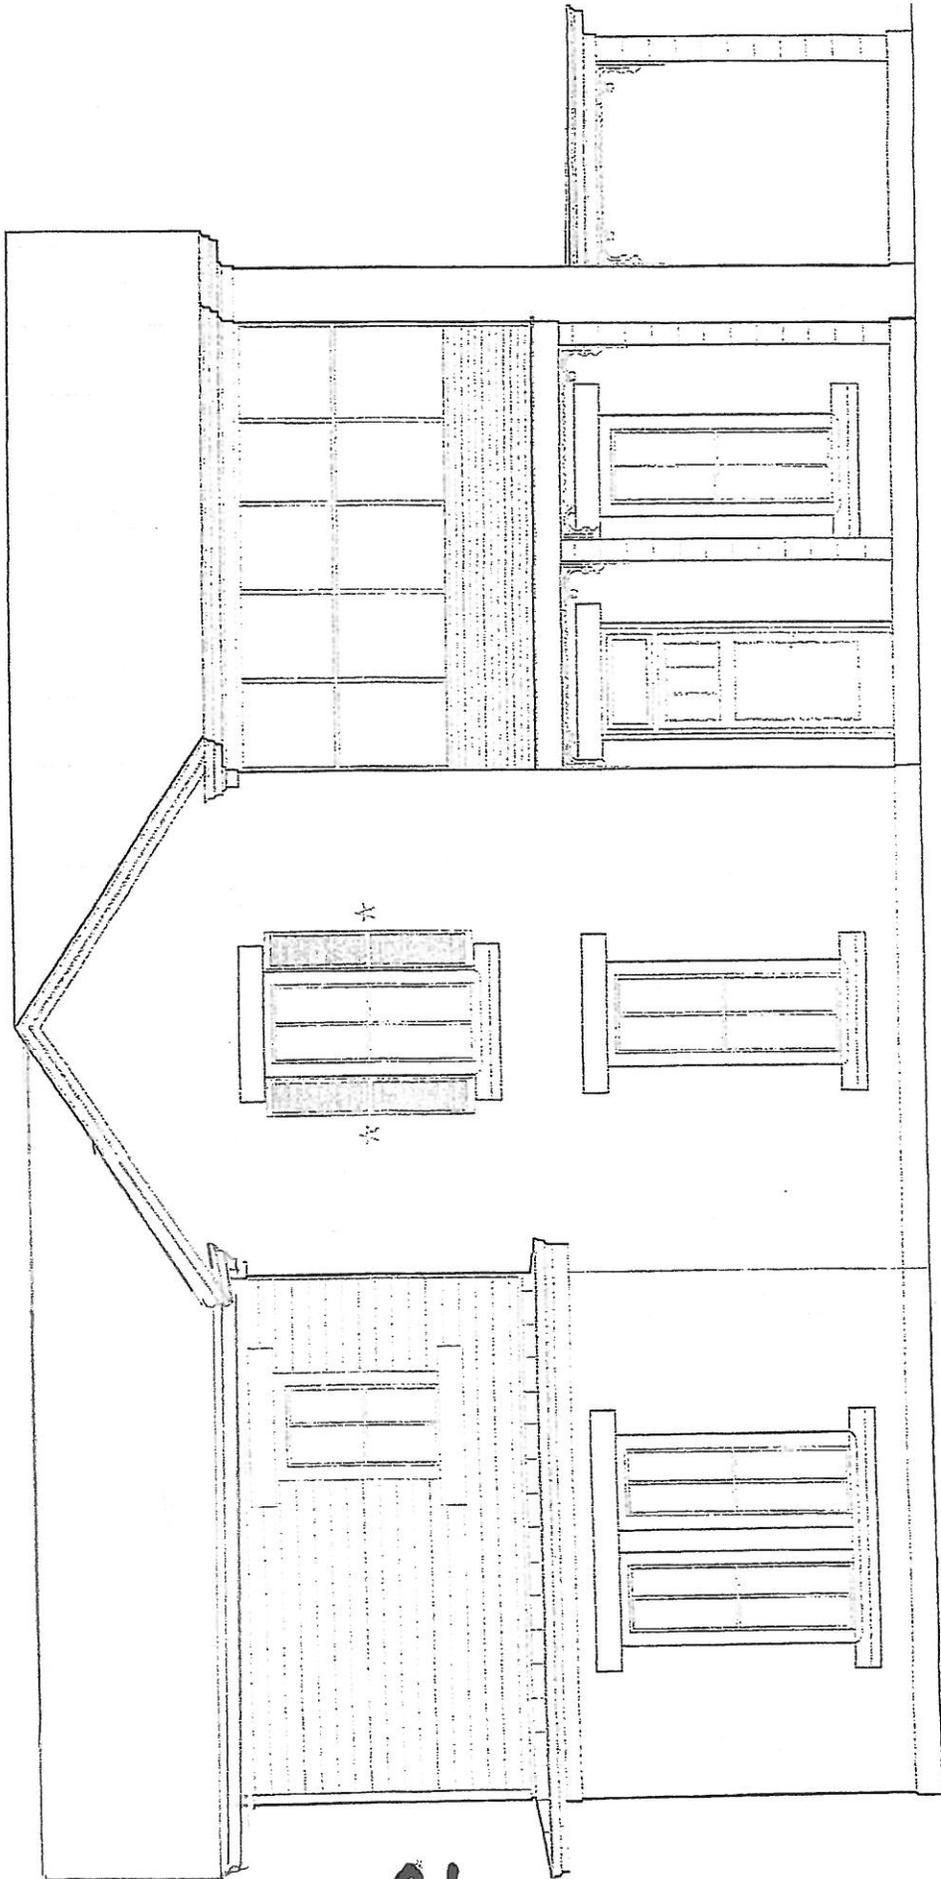
WEST SIDE ELEVATION

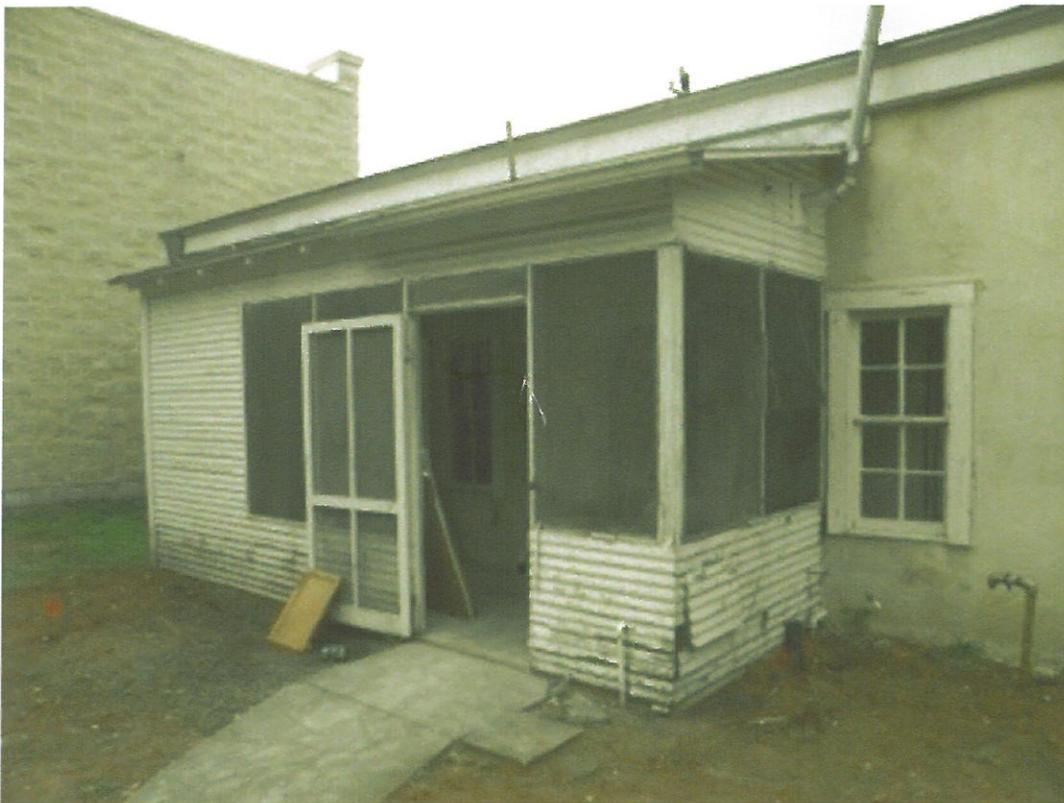
Fig 2 - The rear, north face of the house showing the later wood-framed porch addition.

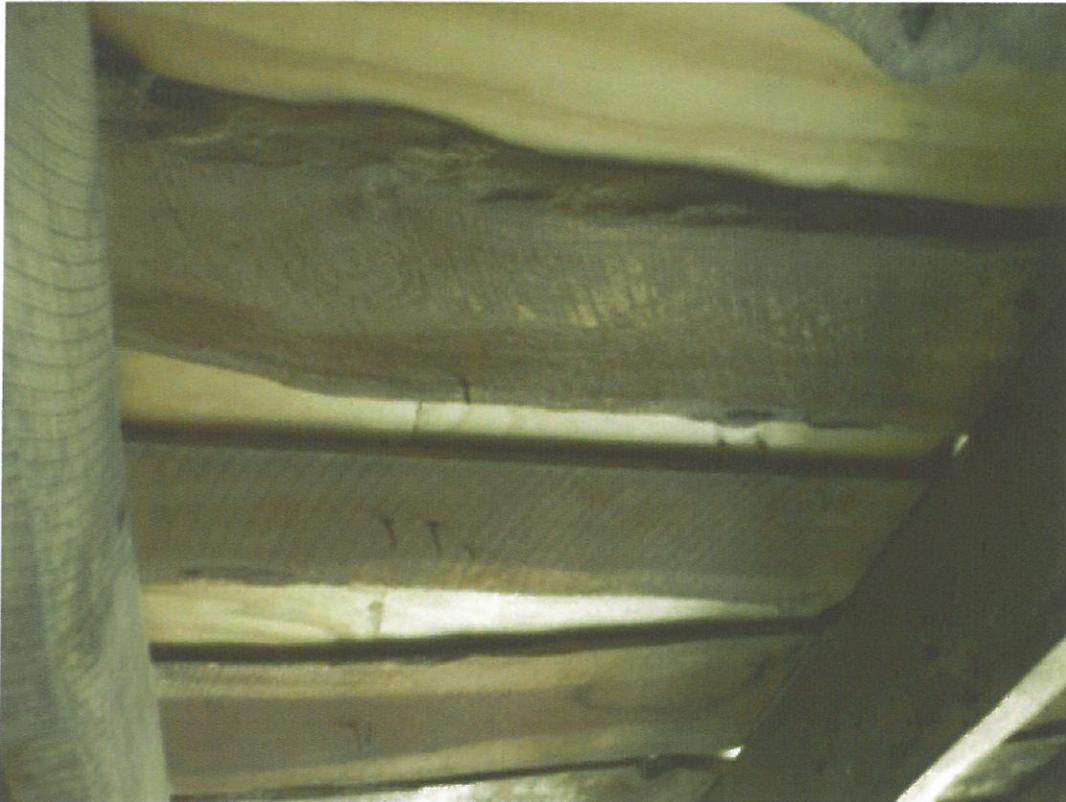
Fig 3 - Original waney-edged roof lath in the attic. A plywood deck and metal roofing has been installed above.

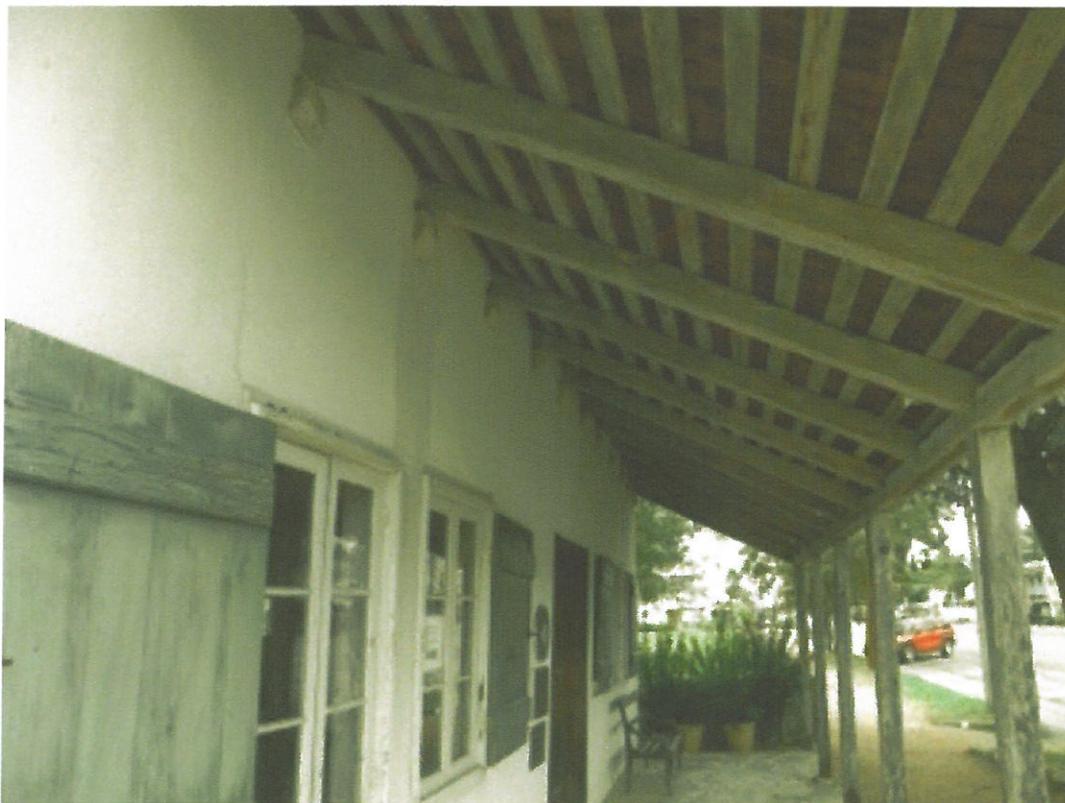
Fig 6 - Although the porch ceiling at the Kammlah House, located at 309 W. Main, pre-dates the Schneider-Klingelhoefer House by 21 years, it gives some interpretation as to how the original porch ceiling might have looked. Note that at the Schneider-Klingelhoefer House, the original nailers were wider, and wane edged.

9. The sawn balusters and railings match the patterns available in the late 1880s-mid 1890s (Fig. 6). The actual materials are reproduction pieces of the older railing. This pattern is from an 1893 Blumer and Kuhn catalog, attached. The top rail material may be older material than the balusters themselves, but together they create an appropriate assembly. The furring strips at the columns are another indicator that the railings pre-date the columns. The railings were likely furred out to fit to the new column width. I believe that the railings were installed when the first scored stucco coating was installed, likely by builder Louis Priess, who lived there from 1883-1890.

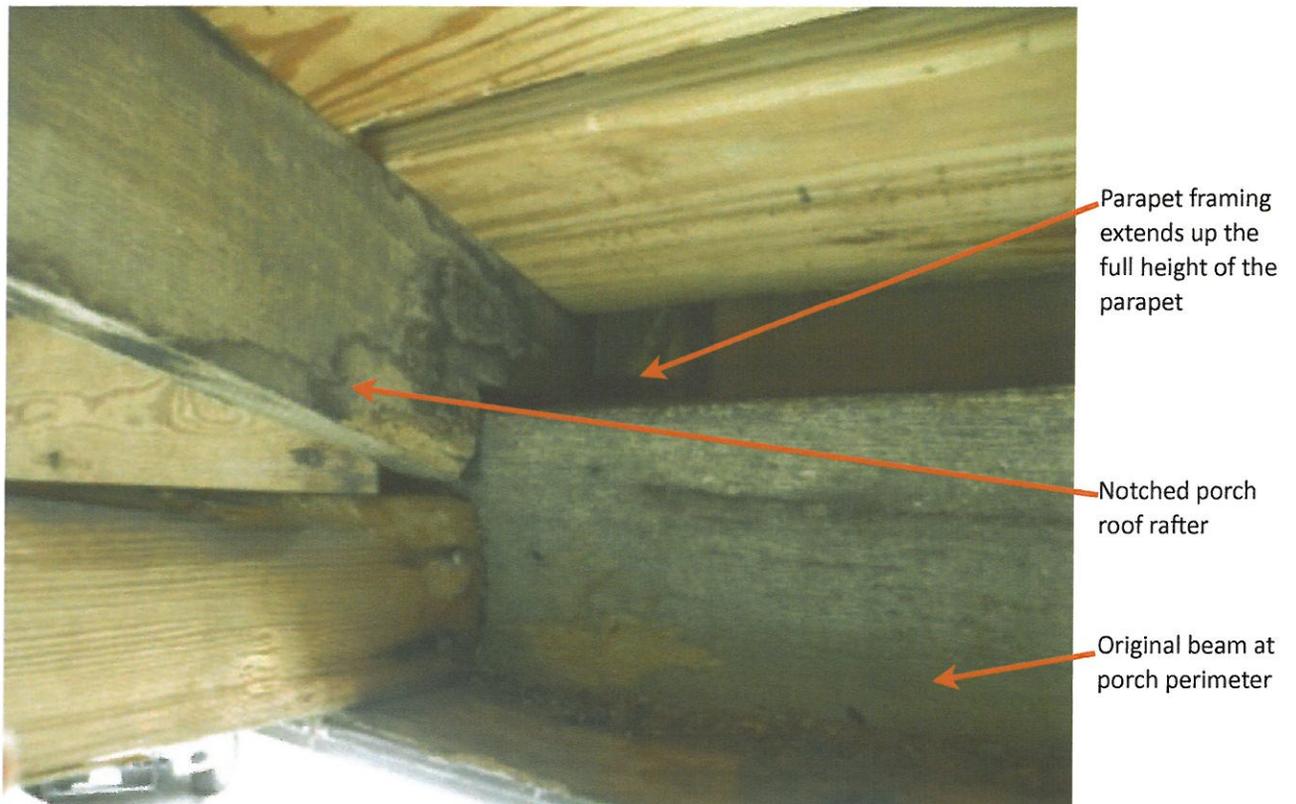
Fig 7 - Closeup view of beam supporting the parapet at the front porch. Note the original notched roof rafter and mortised parapet support.

3. New investigations have revealed that the framing for the tall parapet at the porch perimeter does appear to be original to the house. While the wood cladding and trim of the parapet is not original, we can say with certainty that the beams, some rafters, and the vertical supports for the parapet are original to the building. The beams are mortised in to the original half-timber frame at the ends of the porch. Rafters are notched to the beam, and are attached to the frame above with square nails. Many of these rafters have been replaced over time, and the square nails reused for the replacement 1.75" x 4.75" milled rafters. The vertical supports for the parapet are roughly 2" square, paired with each roof rafter @ roughly 26" o.c., and are notched into the perimeter beam.

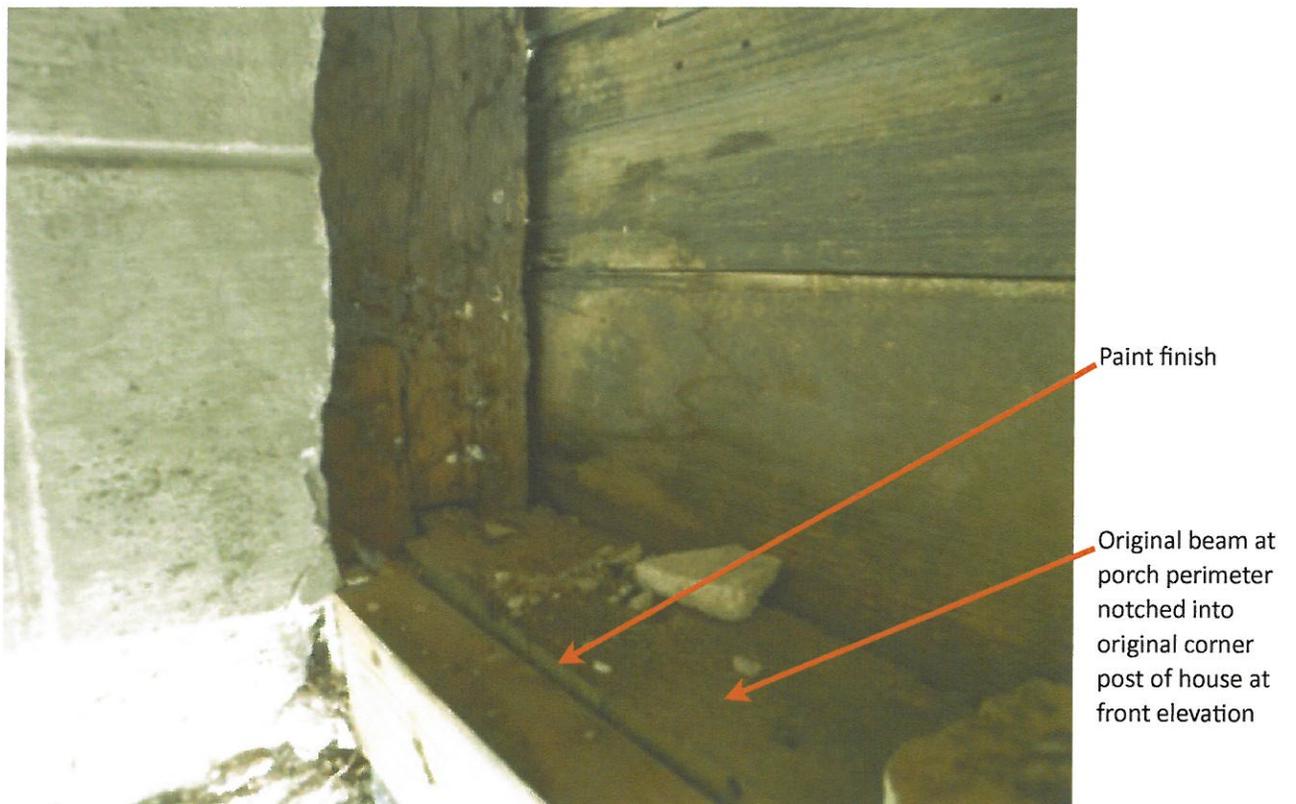
Fig 8 - Closeup view of perimeter beam of porch as it notches into the corner post at the far right corner of the front elevation. Note the paint finish evident on the face of the beam, concealed by later framing.

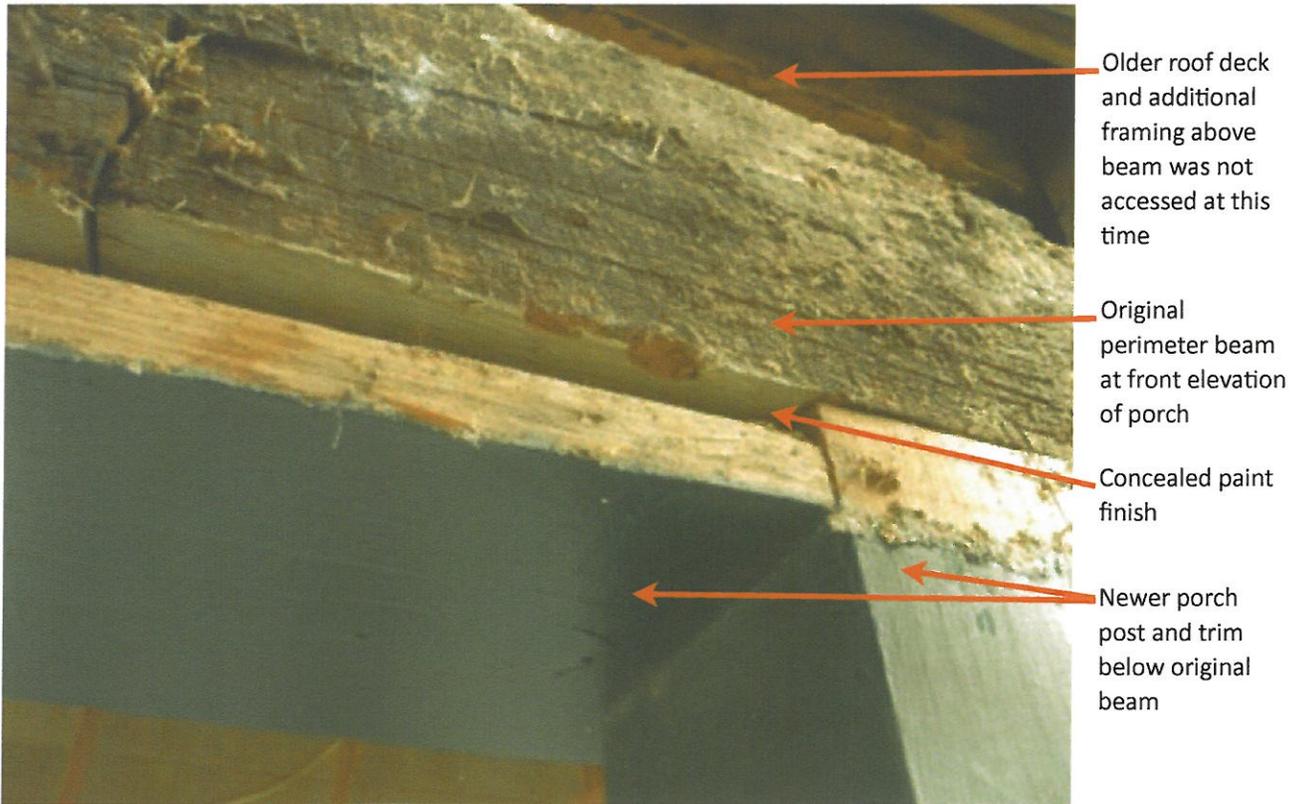
Fig 9 - Closeup view of beam supporting the parapet at the front porch, briefly revealed during selective demo in January, 2014. Note the newer porch post and trim below the beam, the concealed paint finish, and the original scarf joint in the beam.

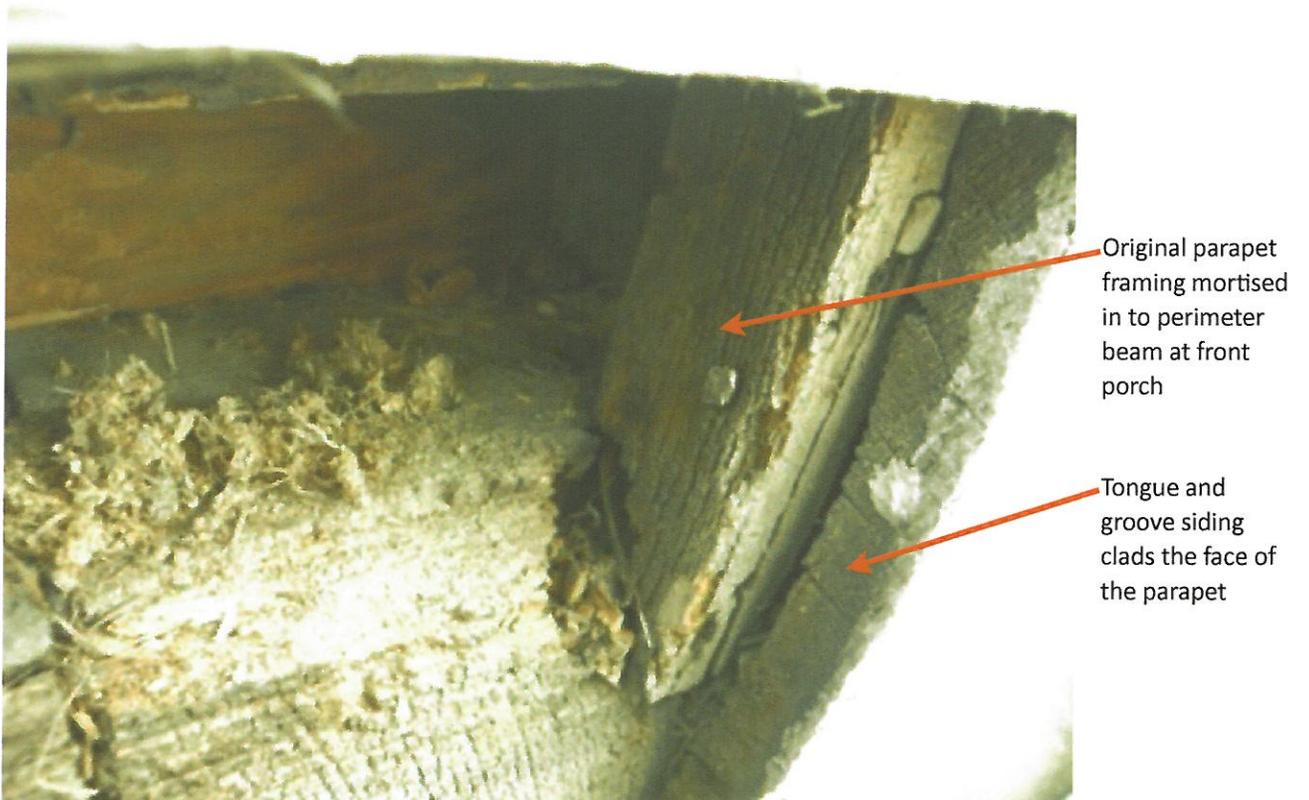
Fig 10 - Closeup view of the vertical parapet framing from the exterior, briefly revealed during selective demo.

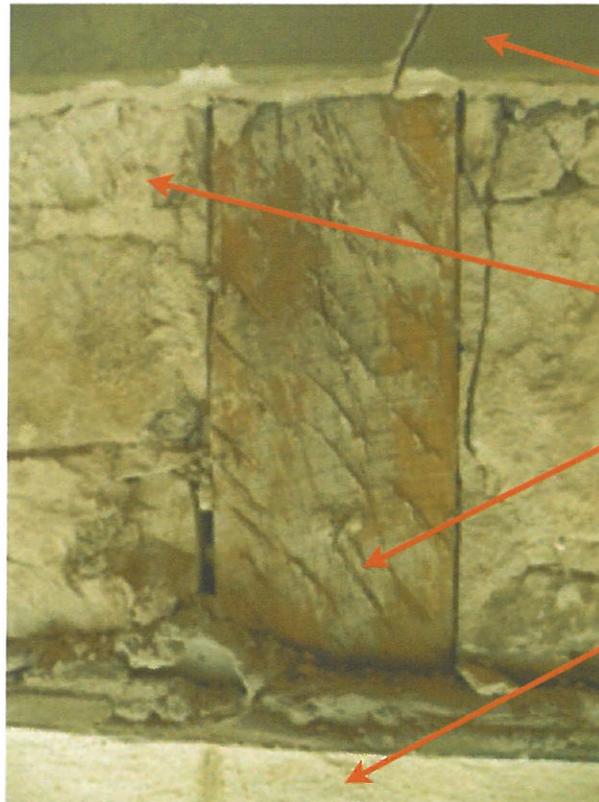
Circa 1883-1890 scored stucco finish, preserve in place to the extent feasible, no less than an 8' x 2'6" area at the left end of the elevation.

Original light stucco finish on stone.

Portland cement based stucco finish to be removed

Fig 11 - View of original timber framing at front wall of the house, providing evidence that the wood was painted and the stone infill was stuccoed originally.

2. Somewhat suprisingly, we found a paint layer on the heavy timber framing below the lime-sand based stucco coating. This paint layer was later scored with an axe to roughen the surface for the application of stucco, evident because the paint breaks at each axe mark. I checked this condition at several locations, and found it consistent.

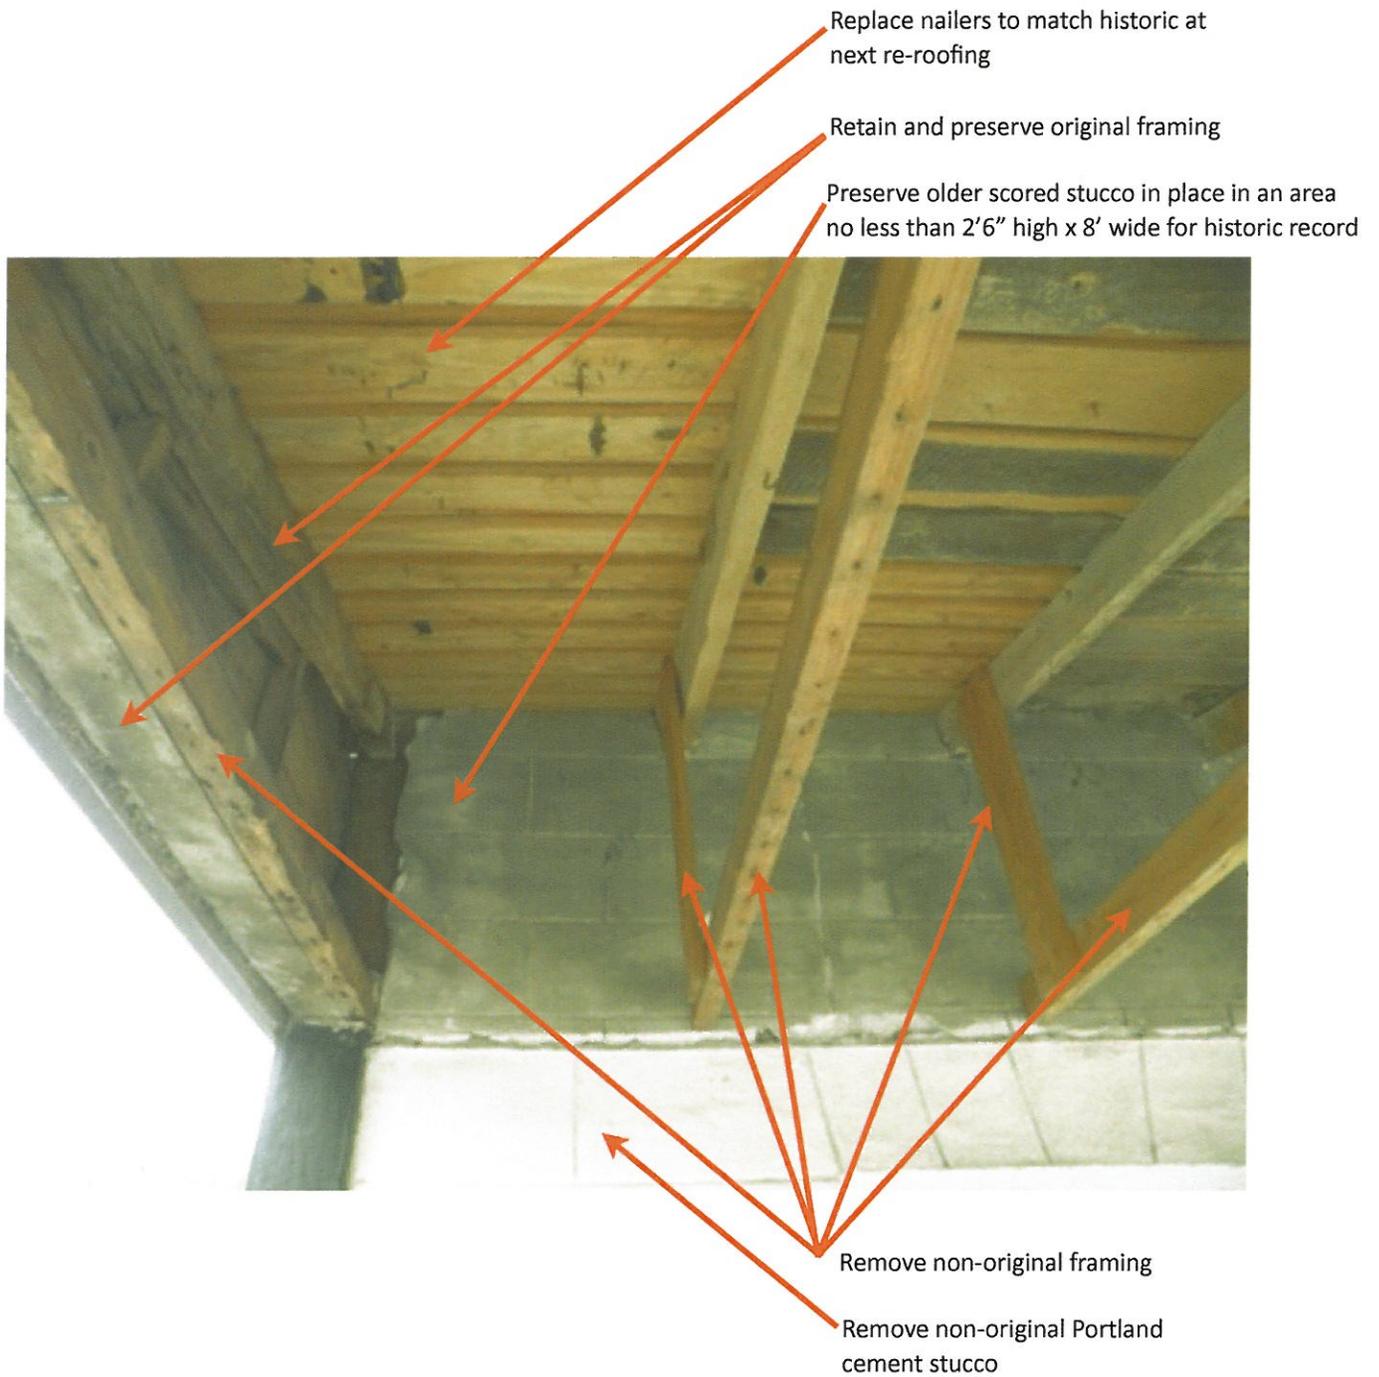
Fig 13 - Photo of left (west) end of front elevation, showing selective demolition, stabilization, and preservation scope.

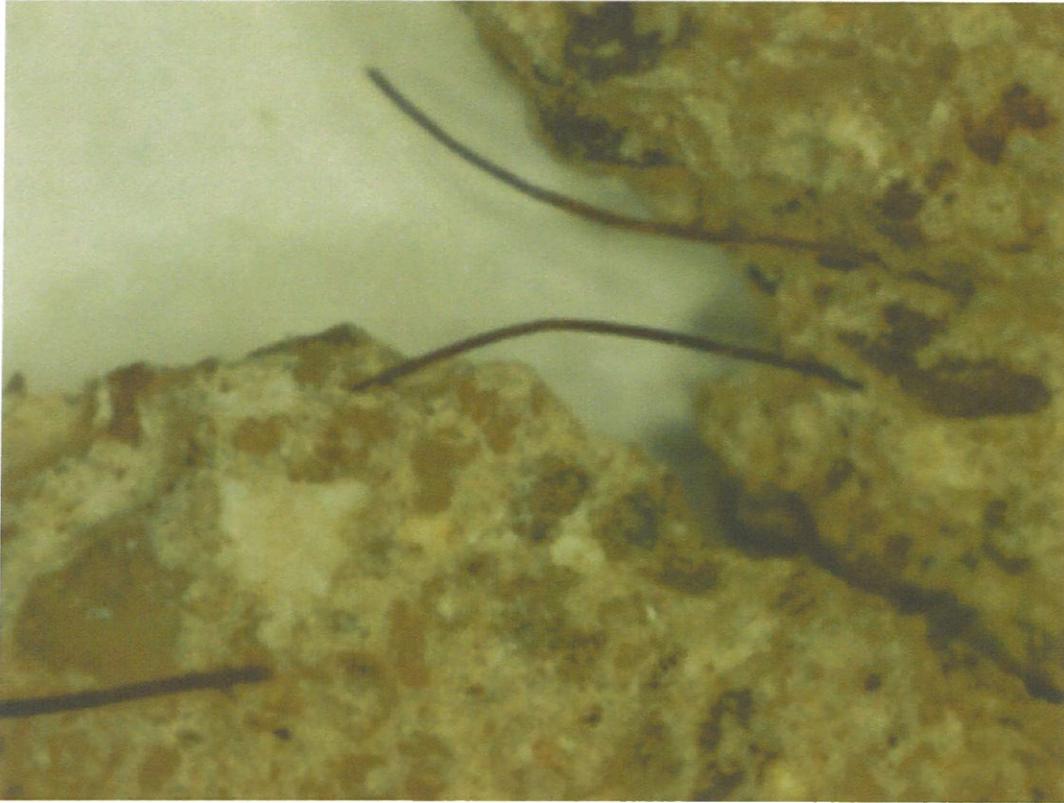
Fig 14 - Original mortar found deep within interior mortar joints, as seen through a microscope. Note the animal hair binder and character of the original sand.

1. Have an original mortar sample and have it analyzed to determine the character of the sand and ratio of lime:sand. I recommend using John Cates at Cates Lab (214/920-5006).
2. Repoint the interior masonry as soon as you receive the results of the mortar analysis, using traditional techniques and mortar. New mortar should match the original in color, composition, texture and tooling. Remove loose and unsound mortar, then repoint in lifts of 3/8" thickness to ensure proper curing. Fill larger voids with small, fitted stones during the repointing, because massive areas of mortar will not cure well. The repointed joints should be flush with the face of the

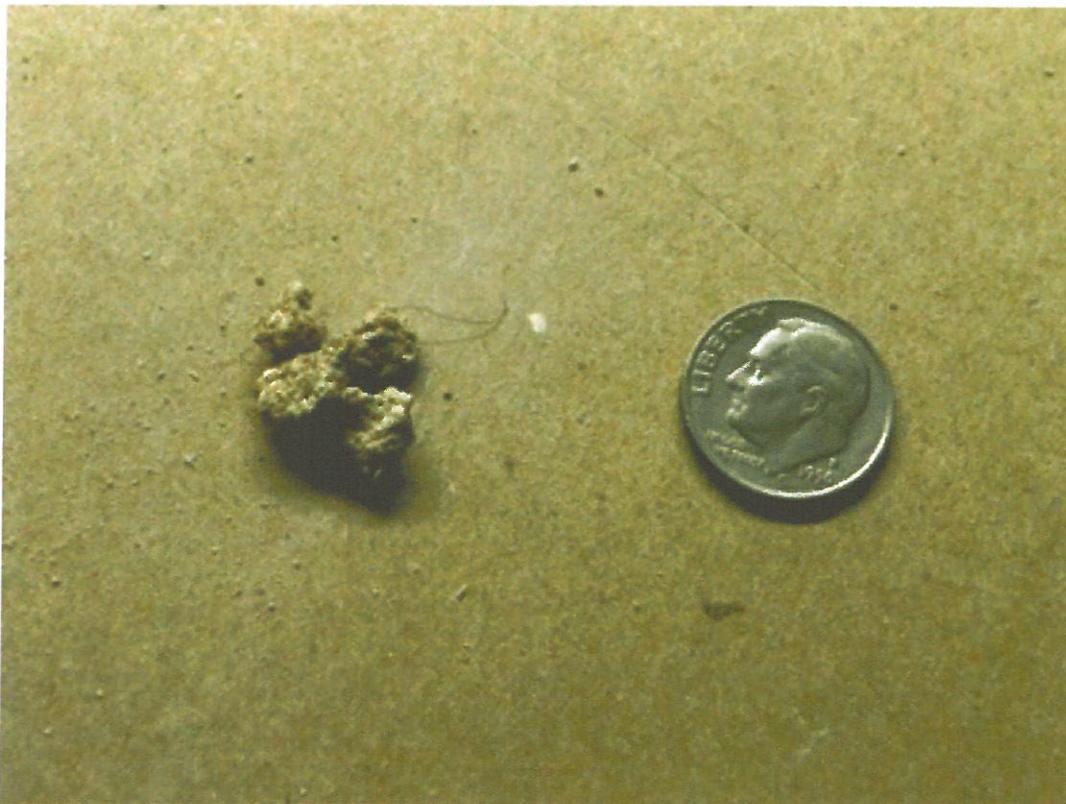
Fig 15 - The same original mortar sample found deep within interior mortar joints, as seen through a standard camera.
