**CITY OF FREDERICKSBURG
HISTORIC REVIEW BOARD**

3. Application #14-04 by Jon Pankratz on behalf of Milton Buckalew and Liza Smith at 110 W. Centre to: *Pp 3 - 15*
 - A) Add a brick veneer wood burning fireplace

5. Application #14-09 by David Sawtelle at 714 W. Main to: *Pp 22 - 38*
 - A) Remove cement stucco from front of building
 - B) Remove non-original trim to reveal original wood framing

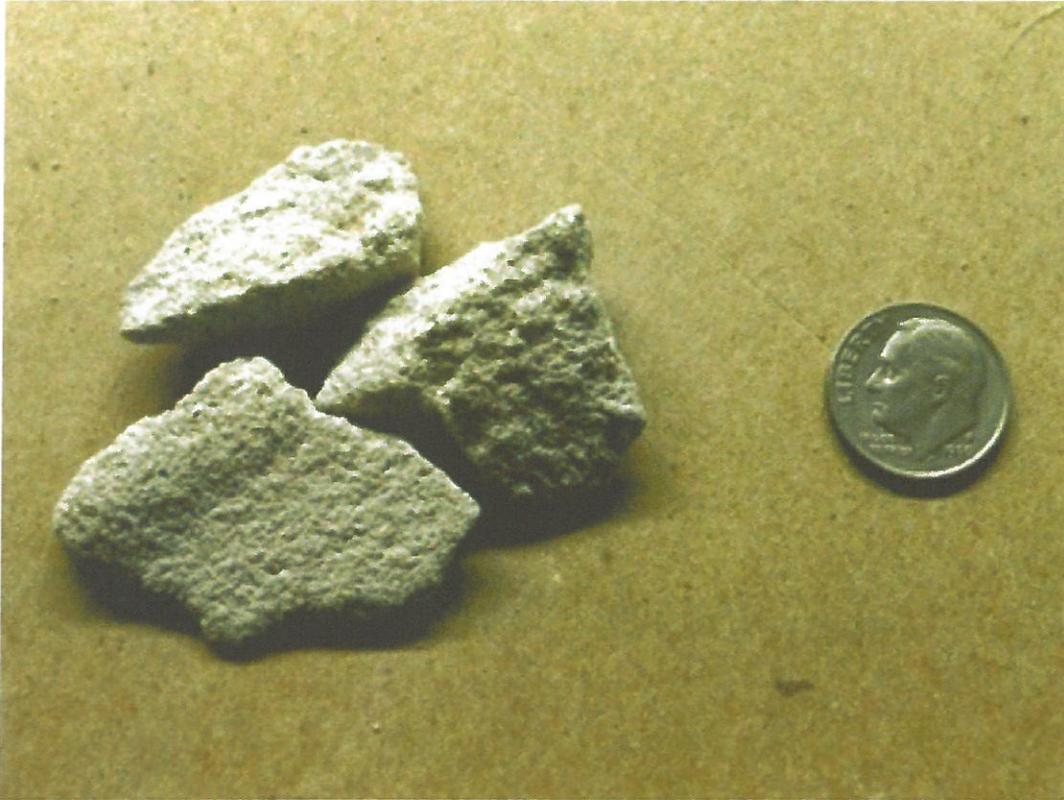
Fig 16 - Fragments of the existing hard Portland Cement exterior coating shows a fine aggregate and no animal hair binder.

11. The exterior is coated with a high-Portland stucco that is poorly detailed, but in good condition. Portland cement stucco is not recommended for use in historic construction of this age, and can cause long-term damage to the stone and wood fachwerk substrate by trapping moisture in the walls and having a significantly different coefficient of expansion than the original materials.

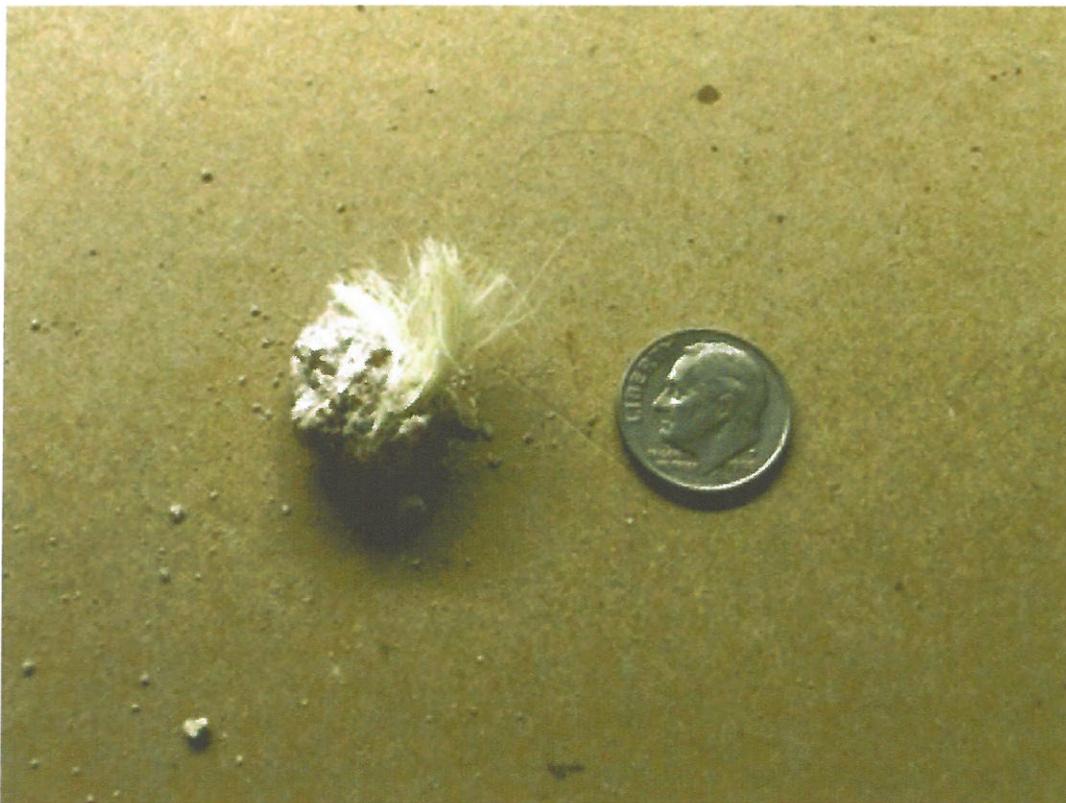
Fig 17 - A sample of a later interior plaster finish with hemp binder.

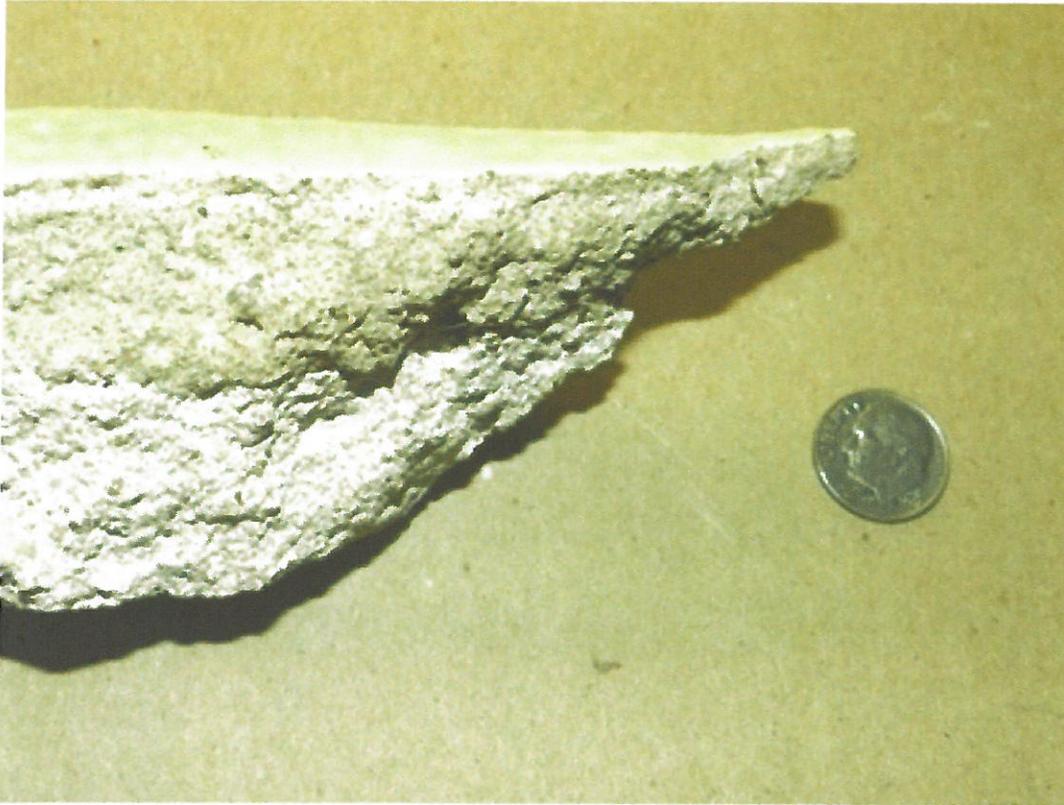
Fig 18 - Interior finish removed from the east wall shows a high Portland cement mortar under a more historically appropriate, higher lime content, animal hair reinforced plaster finish.

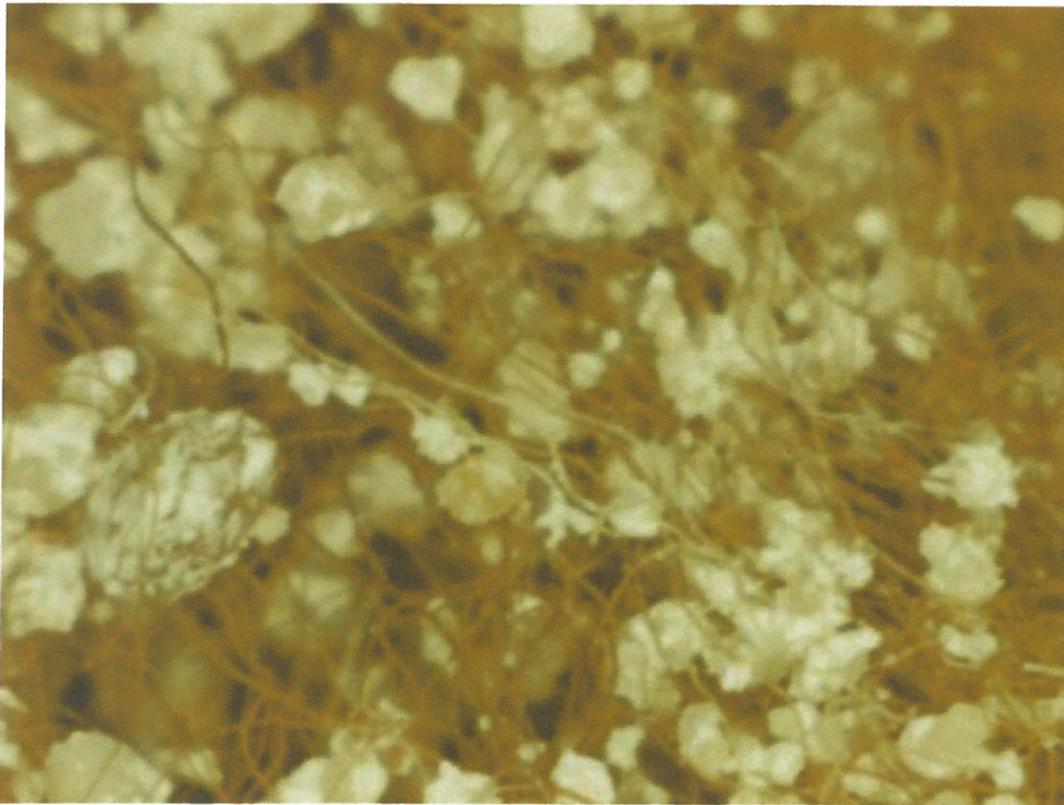
Fig 19 - Microscopic view of the early exterior base coat stucco, which used a very high percentage of animal hair as binder.

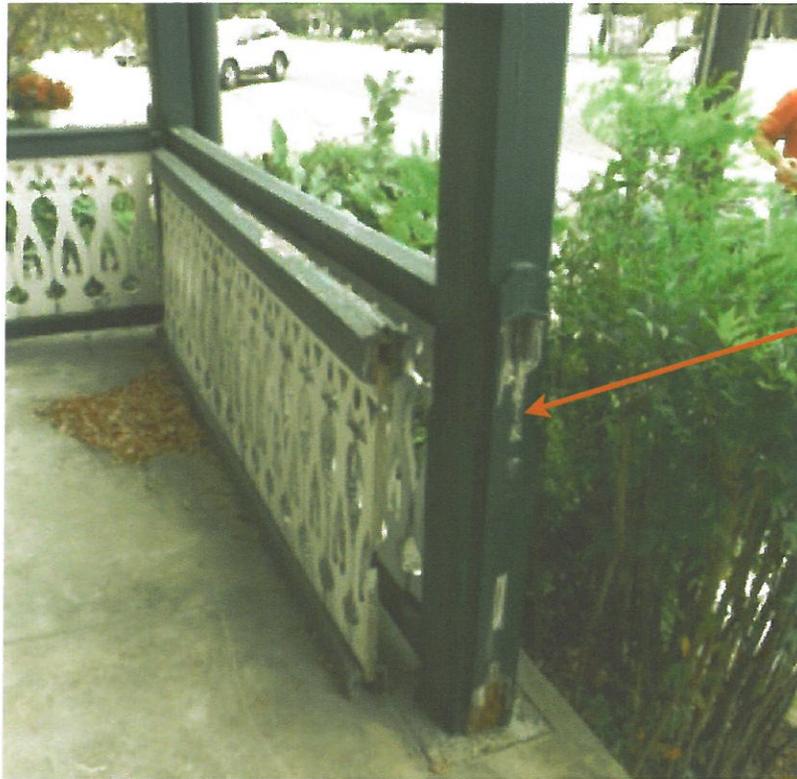
Fig 20 - Sawn balusters match pattern books from an 1893 catalog. Blocking at the columns indicate that the original columns were wider than the replacements, or the railing was adapted to the column spacing.

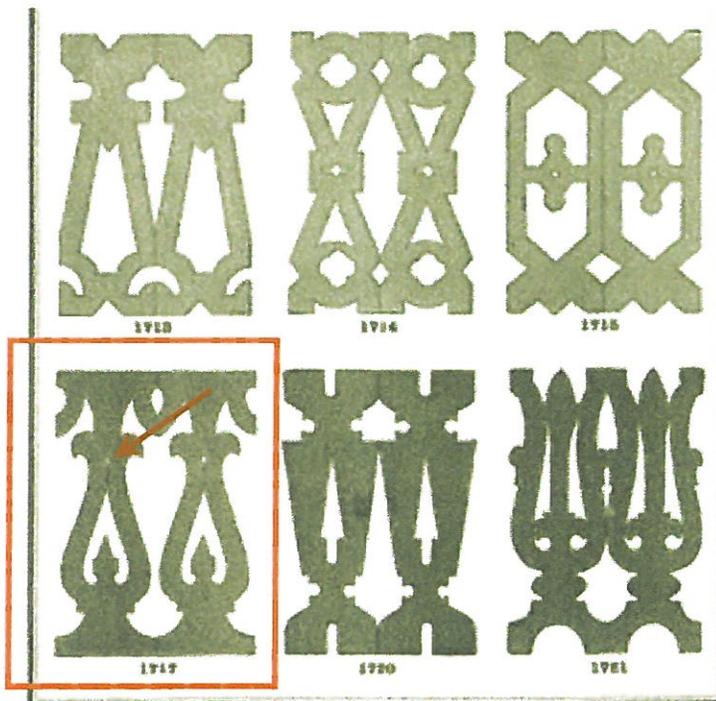
Fig 21 - The sawn balusters at the Schneider-Klingelhoef house (Fig 6) match pattern #1717 of the Blumer and Kuhn Catalog of Premier Millwork, 1893. Note a slight difference in the reproduction balusters, where the small notch is missing.

9. The sawn balusters and railings match the patterns available in the late 1880s-mid 1890s (Fig. 6). The actual materials are reproduction pieces of the older railing. This pattern is from an 1893 Blumer and Kuhn catalog, attached. The top rail material may be older material than the balusters themselves, but together they create an appropriate assembly. The furring strips at the columns are another indicator that the railings pre-date the columns. The railings were likely furred out to fit to the new column width. I believe that the railings were installed when the first scored stucco coating was installed, likely by builder Louis Priess, who lived there from 1883-1890.
